Sidewalk Inventory

DRAFT REPORT

Town of Manchester BTS, Massachusetts

Date: January 24, 2019

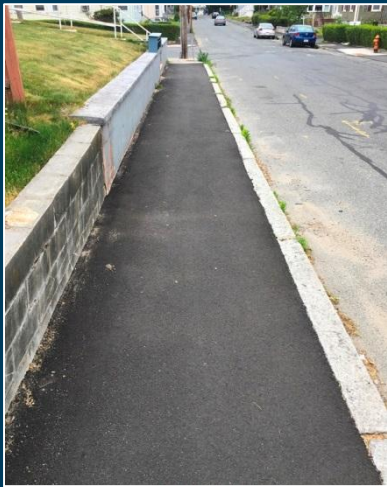
Good

- No distresses identified up to minor surface blemishes and deterioration observed on sidewalk.
- Less than 10% of the sidewalk section requires minor repairs.

GOOD

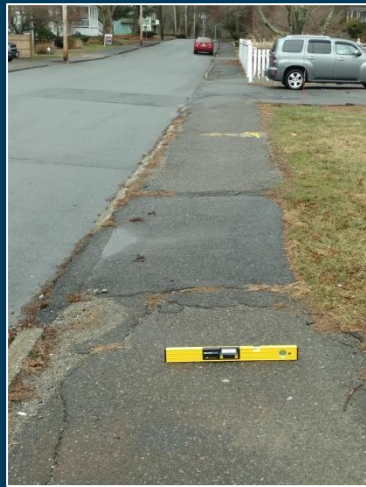
Fair

- Distresses (such as cracking, grass, depressions & bumps, patches and tree root heaves) are starting to develop in a section of sidewalk.
- Between 10% and 25% of the sidewalk section needs repairs.

FAIR

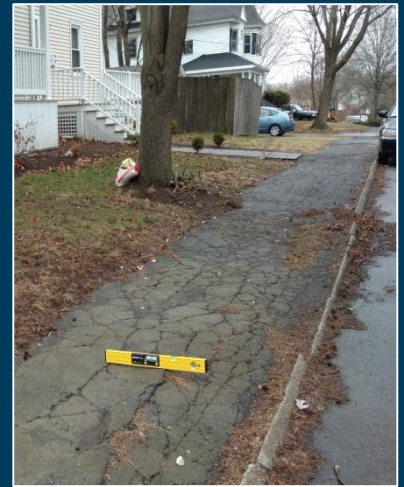
Poor

- Distresses are actively found in a section of sidewalk which may require resurfacing.
- Between 25% and 50% of the sidewalk section needs major repairs or resurfacing.

POOR

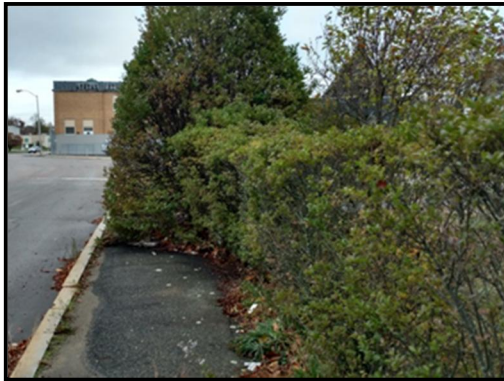
Maintenance

Areas that only require minor attention such as:

- Bushes
- Overhang Trees
- Grass
- Sand

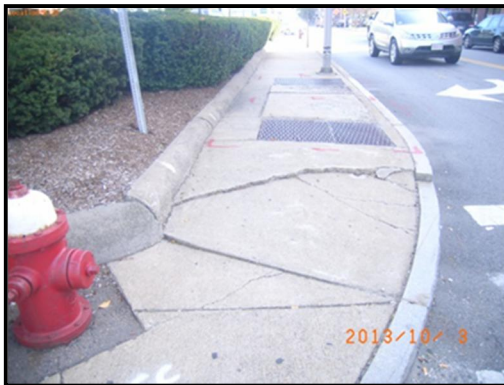
Structural

Areas where repairs must be performed such as:

- Tree Roots
- Poor Patches
- Cracking
- Spalling
- Panel Lifting

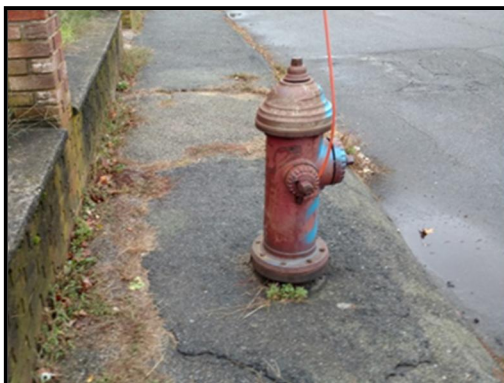
Obstructions

Areas where minimal width is not met due to an object such as:

- Utility Poles
- Hydrants
- Mailboxes
- Signs
