Masconomo Park

Town of Manchester-by-the-Sea ADA Transition Plan

March 2020

Institute for Human Centered Design

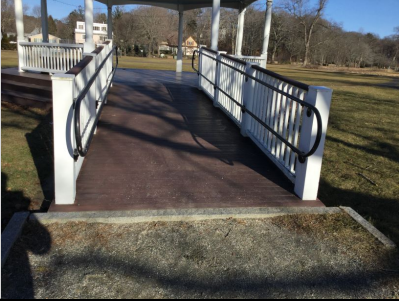
ID	Location	Floor	Room	Element	Type	Photo	Issues	Current Measure	Recommendations	Quantity	Price	Cost Estimation
Approach and Entrance												
Exterior Access Route												
1	Community Bandstand	Ext.		Exterior Access Route	Walkway

Level changes > 1/4"	2"	Alter change in level to be 1/4" high max. (Maintain stone dust path at base of ramp to bandstand.) (Cost based on 20 square feet of stone dust.)	1	160	\$160
2	Book Share Near WWI Memorial	Ext.		Exterior Access Route

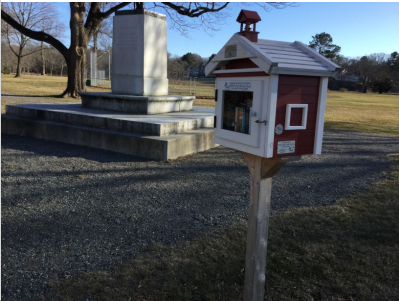
. Accessible route not provided	-	Ensure an accessible route is provided. (Cost base on 6'x48" of stone dust connecting book exchange to stable, firm and slip resistant surface at monument.)	1	192	\$192
Off-Street Parking Lot or Garage												
3	Parking for Masconomo Park and Reed Park and Docks	Ext.		Off-Street Parking Lot or Garage	N/A

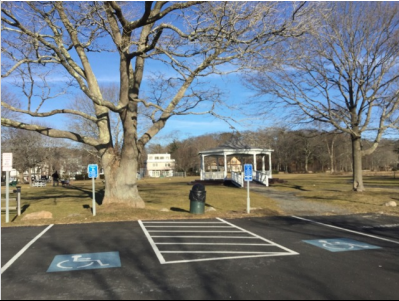
Total # of parking Total # of designated accessible parking spaces Total # of designated van accessible spaces Sign does not have the designation "Van Accessible"	55 1 1 -	Add the designation "Van Accessible" to the sign located at the van accessible space.	1	500	\$500

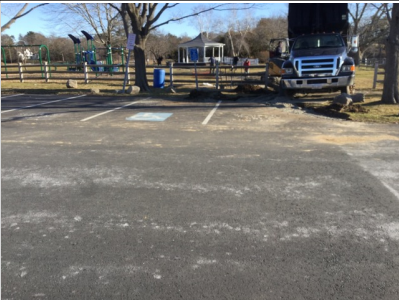
4	Parking for Masconomo Park and Reed Park and Docks	Ext.		Off-Street Parking Lot or Garage	N/A

Access aisle not provided	-	Provide a marked access aisle that is at least 60" wide.	1	300	\$300
Access to Goods and Services

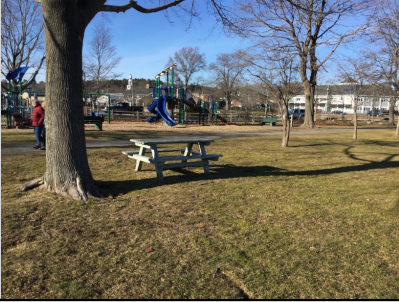
Toe or knee clearance at table not provided Picnic table not on an accessible route	- -	Provide at least one picnic table in this area with toe and knee clearance. Locate picnic table on an accessible route. (Cost based on an accessible picnic table and a 48" min. wide x 10' long stone dust path to picnic table.)	1	1784	\$1784
Benches												
6	Near Playground	Ext.		Benches	N/A

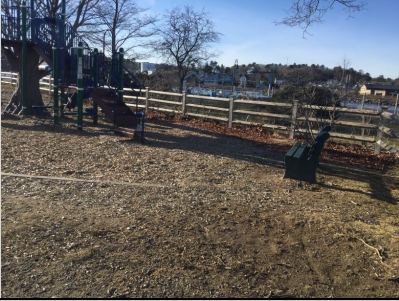
No accessible route to one bench in this area	-	Provide an accessible route to at least one bench in this area. (Cost based on 18'x48" stone dust path to bench.)	1	576	\$576
Bike Racks												
7	Bike Rack	Ext.		Bike Racks	N/A

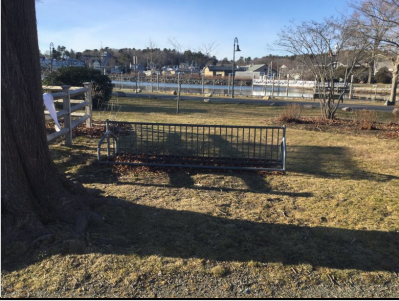
Not connected to an accessible route	-	Ensure bike rack is connected to an accessible route. (Cost based on a 12'x48" stone dust path to bike rack.)	1	384	\$384

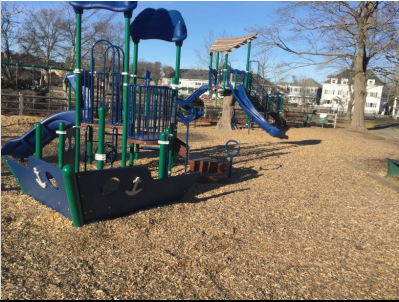
Play and Sport Areas												
Play Areas												
8	Playground	Ext.		Play Areas	N/A

Accessible route not provided at play components Surface not stable, firm, and slip-resistant	- -	Provide a compliant impact-attenuating surface under and around the play components and a stable, firm and slip resistant route around the playground. (Cost estimate for 150 sq. ft. of poured in place rubber surface and 180' x 48" min. of stone dust completing a path around the playground.)	1	7860	\$7860

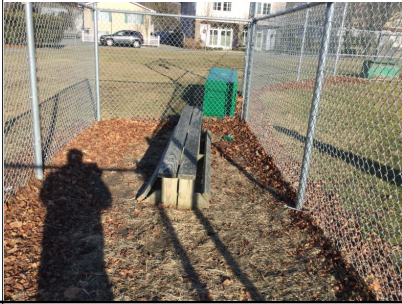
Not connected to an accessible-route	-	Ensure player seating is connected to an accessible route. (Cost based on a 48" wide min. x 12' stone dust path to team seating on first base side of baseball field.)		384	\$0
10	Baseball Field Third Base Side	Ext.		Field	Baseball

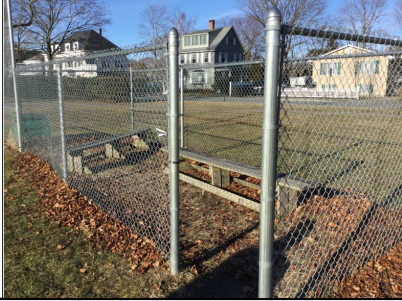
Not connected to an accessible-route	-	Ensure player seating is connected to an accessible route. (Cost based on a 48" wide min. x 60' stone dust path to team seating on third base side of baseball field.)	1	1920	\$1920
Best Practice												
Bench												
11	Near Entry	Ext.		Bench	N/A

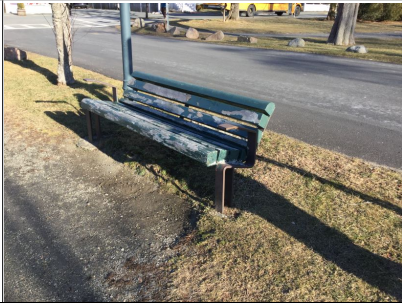
Recommend providing a 36"x48" stable, firm and slip resistant surface at end of bench positioned to allow shoulder alignment with a person on the bench for someone using a wheeled mobility device.	1	-	\$0
