Sweeney Park

Town of Manchester-by-the-Sea ADA Transition Plan

March 2020

**Town of Manchester by-the-Sea
Sweeney Park**

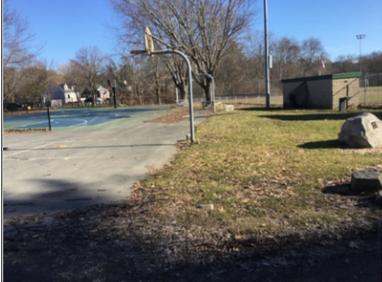
ID	Location	Floor	Room	Element	Type	Photo	Issues	Current Measure	Recommendations	Quantity	Price	Cost Estimation
Approach and Entrance												
Exterior Access Route												
1	Towards Second Basketball Court	Ext.		Exterior Access Route	Walkway

Accessible route not provided	-	Ensure an accessible route is provided to the second basketball court. (Cost based on 137 ft. long 48" min. wide stone dust path)	1	4384	\$4384
Access to Goods and Services												
Doors, Doorways, & Gates												
2	Press Box	Ext.		Doors, Doorways, & Gates	N/A

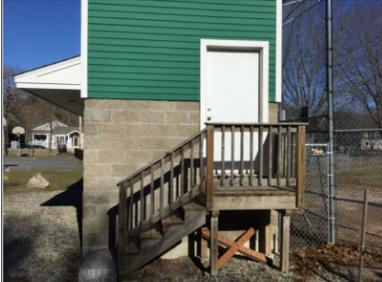
Hardware not operable with a closed fist	-	Provide hardware that can be operable with one hand and not require tight grasping, pinching, or twisting of the wrist.	1	484	\$484
3	Bill Burgess Canteen	Ext.		Doors, Doorways, & Gates	N/A

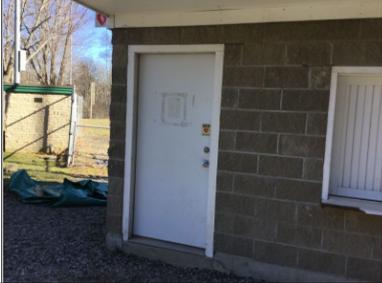
Hardware not operable with a closed fist	-	Provide hardware that can be operable with one hand and not require tight grasping, pinching, or twisting of the wrist.	1	484	\$484

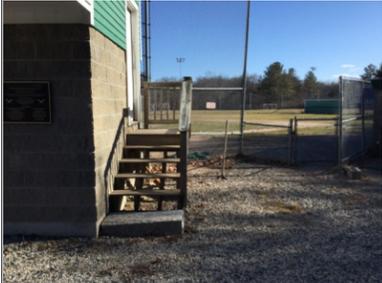
Stairways												
4	Press Box	Ext.		Stairways	Exterior

Stair has open risers	-	Ensure stairs have closed risers. (Cost based on closing four (4) wood risers.)	1	64	\$64

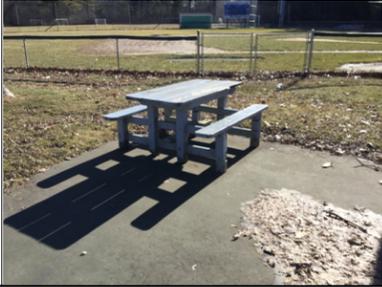
Toe or knee clearance at table not provided	-	Provide at least one picnic table with toe and knee clearance.	1	1400	\$1400
Additional Access												
Drinking Fountains												
6	Near Press Box	Ext.		Drinking Fountains	N/A

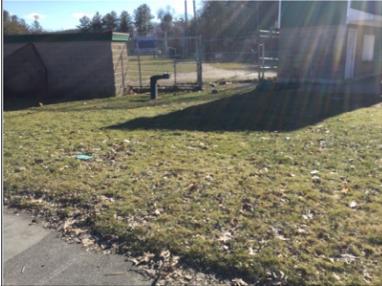
Fountain not on accessible route No drinking fountain provided for standing users	- -	Provide an accessible route to the drinking fountain. Provide an additional drinking fountain for standing users. (Cost based on a 24 ft. long x 48" wide min. stone dust path and a drinking fountain for standing users).	1	4796	\$4796
Play and Sport Areas												
Field												
7	Baseball	Ext.		Field	Baseball

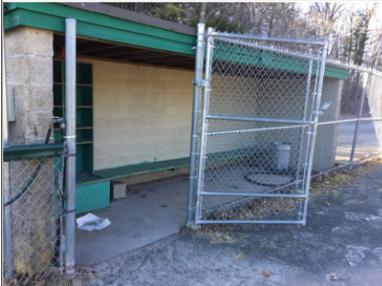
Accessible spaces are not provided at team seating	-	Provide a 36" x 48" clear floor space at team seating bench in each dugout.	2	Labor	\$0

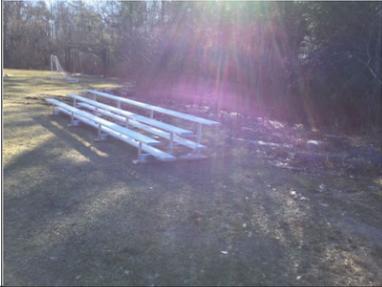
8	Fan Seating Softball	Ext.		Field	Softball

Accessible spaces are not provided at team seating Not connected to an accessible-route	- -	Provide a 36" x 48" clear floor space at bleacher seating. Ensure bleacher is connected to an accessible route. (Cost based on a 60'x48" min. stone dust path to bleachers and a 36'x48' asphalt patch at bleachers.)	1	2160	\$2160

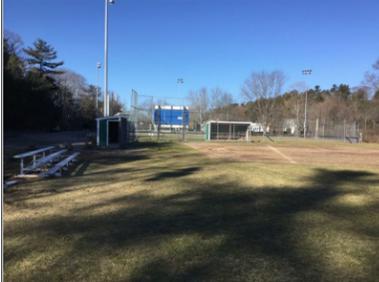
Accessible spaces not provided at sidelines seating	-	Provide a 36" x 48" clear floor space at sidelines seating. (Cost based on a 36'x48' asphalt patch.)	1	240	\$240
10	Baseball Fan Seating	Ext.		Field	Baseball

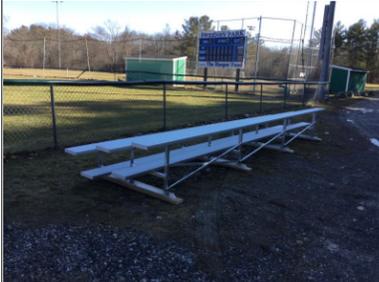
Accessible spaces not provided at sidelines seating	-	Provide a 36" x 48" clear floor space at sidelines seating. (Cost based on a 36'x48' asphalt patch.)	1	240	\$240
11	Team Seating Softball	Ext.		Field	Softball

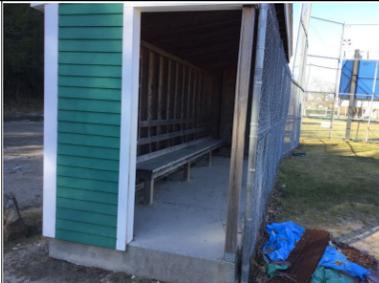
Not connected to an accessible-route	-	Ensure softball team seating is connected to an accessible route. (Provide a concrete walkway 48" wide min. with a running slope of 1:20 (5.00%) max. and a cross slope of 1:50 (2.00%) max. (Cost based on two (2) 6'x4' of concrete walkways, one at each softball field dugout.)	2	384	\$768

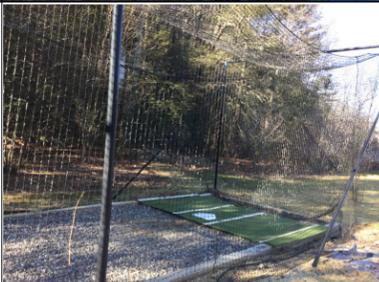
12	Softball Bullpen	Ext.		Field	Softball

Practice areas are not on an accessible route	-	Provide an accessible route to practice areas (softball bullpen). (Cost based on a 180'x48" min. stone dust path to edge of bullpen.)	1	5760	\$5760
13	Soccer Field	Ext.		Field	Soccer

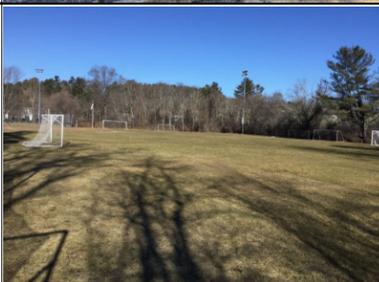
No accessible route to all areas of sports activity	-	Provide an accessible route to the soccer field. (Cost based on a 60'x48" min. stone dust path to the edge of sport activity at the soccer field.)	1	1920	\$1920

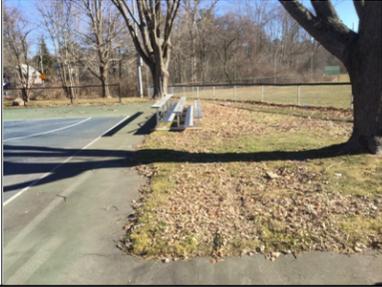
Accessible spaces are not provided at sidelines seating	-	Provide a 36" x 48" clear floor space at sidelines seating. (Cost based on an asphalt 36"x48" patch alongside the bleachers.)	1	240	\$240
Best Practice												
Picnic Table												
15	Near Second Basketball Court	Ext.		Picnic Table	N/A

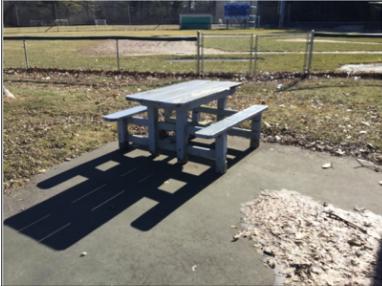
Recommend providing a 48" min. stable, firm and slip resistant surface around the accessible picnic table.	1	-	\$0
