## Manchester-by-the-Sea, Massachusetts

## Outdoor Areas

## Black Beach

## Town of Manchester-by-the-Sea ADA Transition Plan

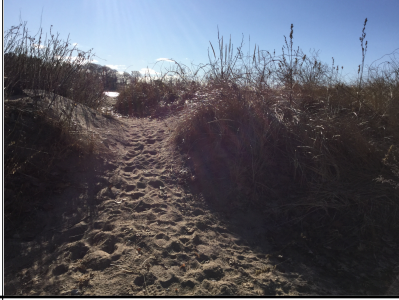
Beach route not provided	33'	Provide an accessible route that is firm and stable.  (Cost based on 78" wide x 33' long beach mat extending from the start of the beach access route to the top of the dune.)	1	1909	\$1909
2	Route to Ocean by Beach Access Point at West End of Beach	Ext.		Beach Access Routes	Removable

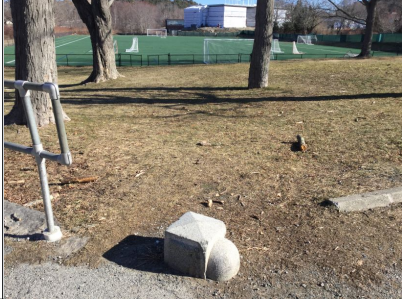
Accessible route not provided	-	Ensure an accessible route is provided to the field entrance (gate opening in fence at east end of field). Note: The route from this corner of the parking lot had the least steep running slopes.  (Cost based on a 48" wide min. x 90' long stone dust path from parking lot to gate in fence.)	1	2880	\$2880
<b>Off-Street Parking Lot or Garage</b>												
2		Ext.		Off-Street Parking Lot or Garage	N/A

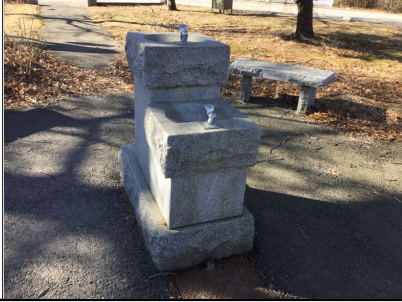
Clear floor space not provided	-	Provide a 30" by 48" clear floor space positioned for a forward approach. Ensure there is 27" min. knee clearance under both fountains.  (Cost based on a new Hi-Lo drinking fountain.)	1	4216	\$4216
<b>Best Practice</b>												
<b>Striping</b>												
6	Path From Water Fountain and Benches to East End Parking Lot	Ext.		Striping	N/A

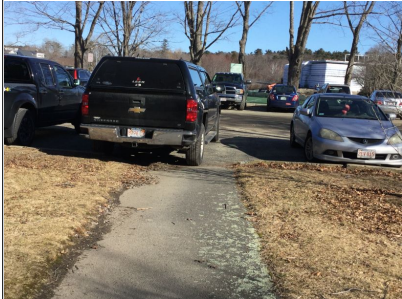
Recommend providing 48" min. wide striping at end of path from water fountain and benches to parking area to prevent visitors from parking in such a way as to block the accessible route.	1	-	\$0

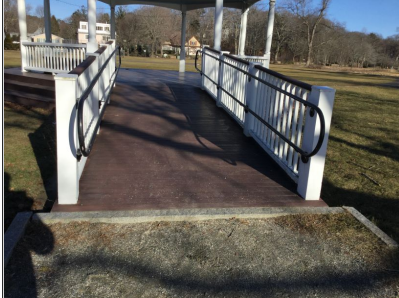
Level changes > 1/4"	2"	Alter change in level to be 1/4" high max. (Maintain stone dust path at base of ramp to bandstand.)  (Cost based on 20 square feet of stone dust.)	1	160	\$160
2	Book Share Near WWI Memorial	Ext.		Exterior Access Route

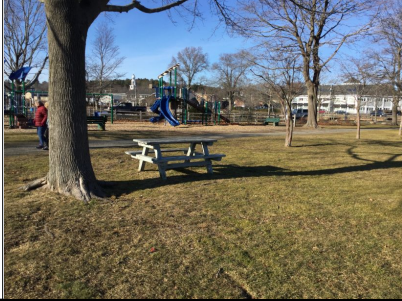
Toe or knee clearance at table not provided Picnic table not on an accessible route	- -	Provide at least one picnic table in this area with toe and knee clearance. Locate picnic table on an accessible route.  (Cost based on an accessible picnic table and a 48" min. wide x 10' long stone dust path to picnic table.)	1	1784	\$1784
<b>Benches</b>												
6	Near Playground	Ext.		Benches	N/A

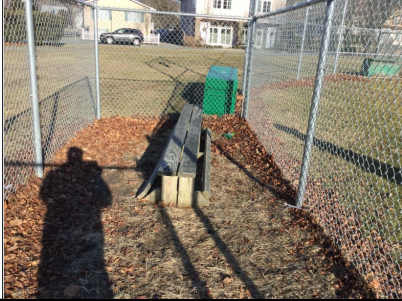
Not connected to an accessible-route	-	Ensure player seating is connected to an accessible route.  (Cost based on a 48" wide min. x 12' stone dust path to team seating on first base side of baseball field.)		384	\$0
10	Baseball Field Third Base Side	Ext.		Field	Baseball

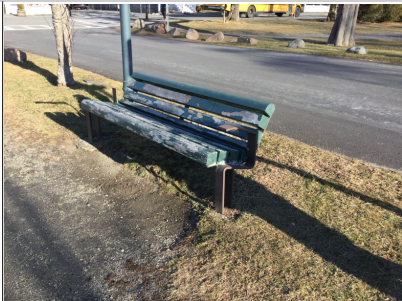
Recommend providing a 36"x48" stable, firm and slip resistant surface at end of bench positioned to allow shoulder alignment with a person on the bench for someone using a wheeled mobility device.	1	-	\$0

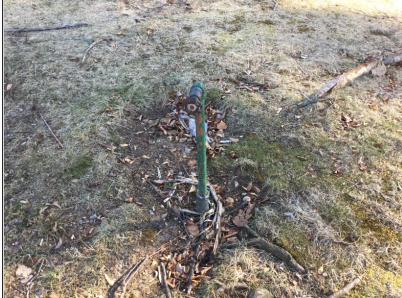
Element not on an accessible route Not operable with a closed fist	- -	Ensure 5% of the water spigots are located on an accessible route. Provide hardware that can be operable with one hand and does not require tight grasping, pinching, or twisting of the wrist. (Cost based on a 48" wide min. x 6' long stone dust path to a water spigot and accessible spigot hardware that can be used with a closed fist.)	2	442	\$884
<b>Best Practice</b>												
<b>Benches</b>												
2	Cemetery Grounds	Ext.		Benches	N/A

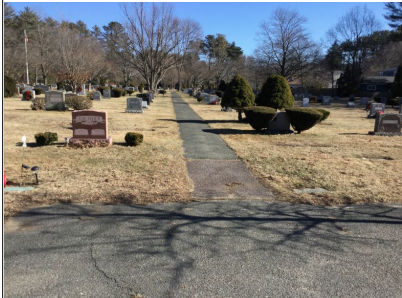
Recommend providing benches at several locations in the cemetery grounds, placing benches on an accessible route, and including some benches both with and without armrests.	1	-	\$0

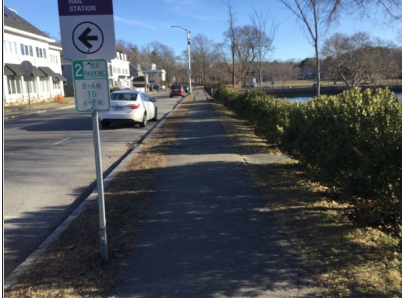
Recommend providing one on-street accessible parking space near the entrance to the park.	1	-	\$0

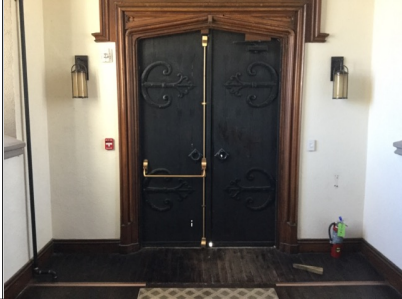
Threshold not beveled Door requires > 15 lbs. of force to open	- 17 lbs	Bevel threshold. Adjust closers so doors do not require more than 15 pounds of force.	1	150	\$150
<b>Access to Goods and Services</b>												
<b>Means of Egress</b>												
2	Main Entrance	1		Means of Egress	N/A

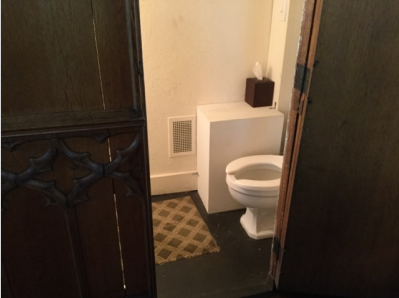
Turning space not provided Accessible plumbing fixtures or stalls not provided	- -	Provide an accessible single-user toilet room.	1	24604	\$24604

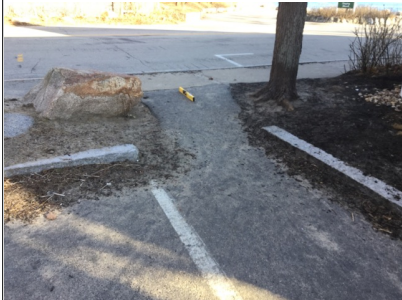
Running slope > 1:20 (5.00%)	6%	Reduce the running slope to be no steeper than 1:20 (5.00%).	1	240	\$240
<b>Beach Access Routes</b>												
2	Beach Access Route	Ext.		Beach Access Routes	Removable

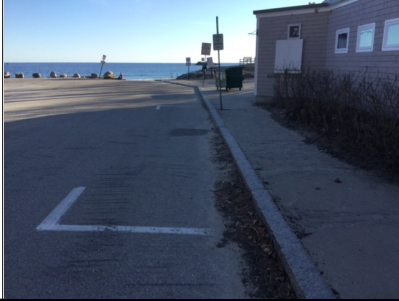
Not connected to an accessible route Access aisle not provided		Provide a curb ramp to ensure the passenger loading zone is connected to an accessible route. Provide a marked access aisle that is at least 60" wide and that extends the full length of the vehicle.  (Cost based on a marked access aisle and a new curb ramp.)	1	3400	\$3400
6	Passenger Loading Zone	Ext.		Passenger Loading Zones	N/A

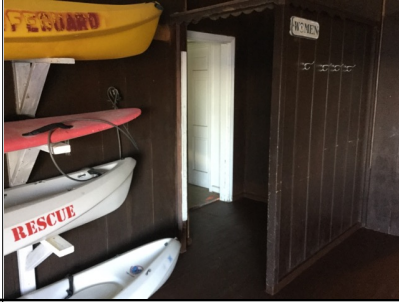
Maneuvering clearance(s) not provided	-	Relocate boats to maintained the required maneuvering clearance at the doorway.	1	Labor	\$0
10	Women's Toilet Room	1		Doors, Doorways, & Gates	Toilet Room

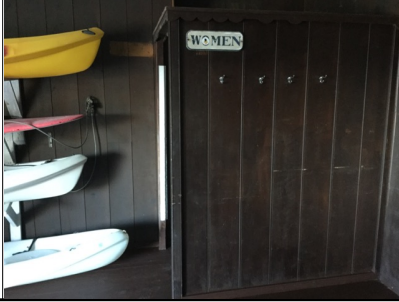
Raised characters not provided Braille not provided	- -	Provide text with raised characters duplicated in braille.	1	232	\$232
<b>Service Counter</b>												
15	Concession Stand	Ext.		Service Counter	N/A

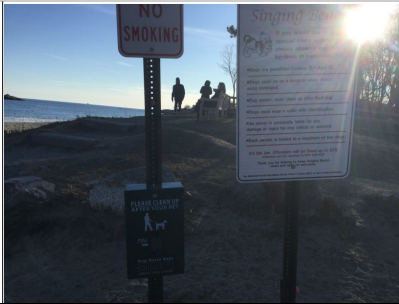
Element not on an accessible route	-	Ensure dog waste bag dispenser is located on an accessible route. (Relocate dispenser so it is at a surface that is stable, firm and slip resistant.)	1	Labor	\$0
17	Women's Toilet Room	1		Operable Parts	N/A

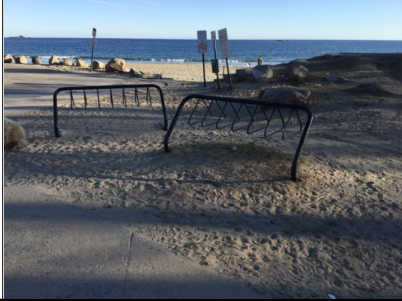
Not connected to an accessible route	-	Ensure bike racks are located on an accessible route.	1	Labor	\$0
<b>Toilet &amp; Bathing Rooms</b>												
<b>Overall Access</b>												
20	Women's and Men's Toilet Rooms	1		Overall Access	Toilet Room

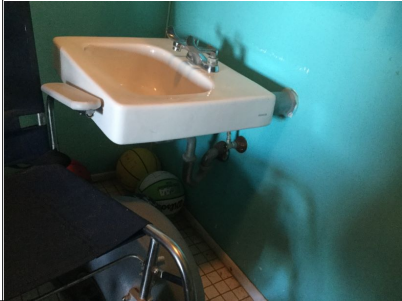
Exposed plumbing underneath	-	Insulate or otherwise configure pipes to prevent contact, for at least one lavatory.	1	92	\$92
22	Women's Toilet Room	1		Lavatory	N/A

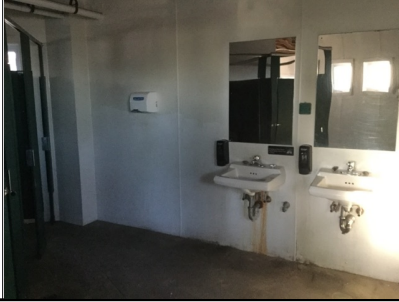
Exposed plumbing underneath Dispensers not within reach range	- 54"	Insulate or otherwise configure pipes to prevent contact, for at least one lavatory. Relocate dispenser to 42" max. above the floor.	2	798	\$1596
<b>Single-User Toilet</b>												
24	Single-User Toilet Room	1		Single-User Toilet

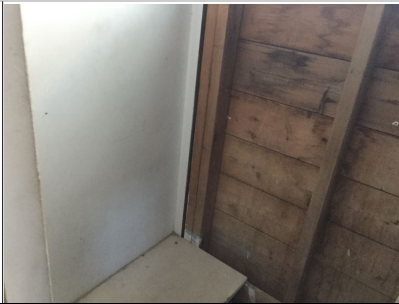
5% Accessible not provided		Provide at least one accessible changing area with a turning space. Provide a bench that is between 17" - 19" above the finished floor, 48" long and between 20" - 24" wide. Ensure a 30" by 48" is provided adjacent to the bench. Ensure the bench has back support or is affixed to a wall.	1	5866	\$5866

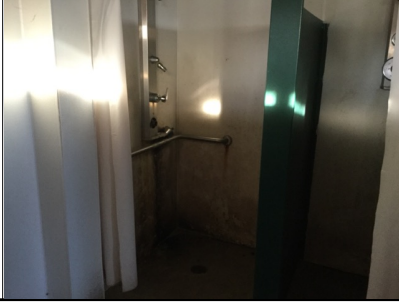
Size of shower compartment non compliant	43"x43"	Provide a transfer shower that is 36" by 36".	1	9832	\$9832
<b>Best Practice</b>												
<b>Bench</b>												
29	Viewing Platform	Ext.		Bench	N/A

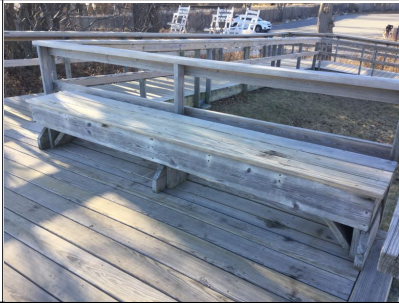
Recommend providing 36"x48" clear floor space at one end of bench on viewing platform.	1	-	\$0
<b>Stairs</b>												
30	Stairs From Viewing Platform	Ext.		Stairs

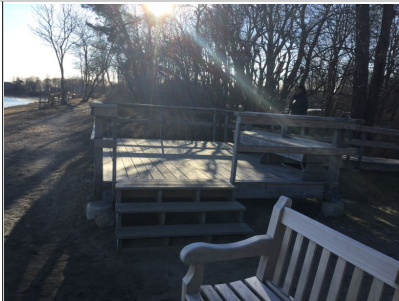
Recommend closing risers and providing handrails on both sides.	1	-	\$0

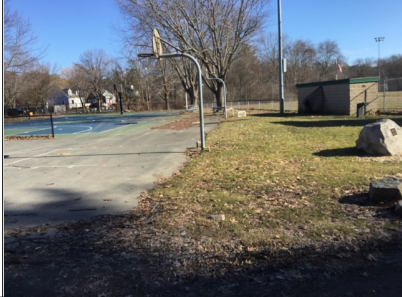
Accessible route not provided	-	Ensure an accessible route is provided to the second basketball court.  (Cost based on 137 ft. long 48" min. wide stone dust path)	1	4384	\$4384
<b>Access to Goods and Services</b>												
<b>Doors, Doorways, &amp; Gates</b>												
2	Press Box	Ext.		Doors, Doorways, & Gates	N/A

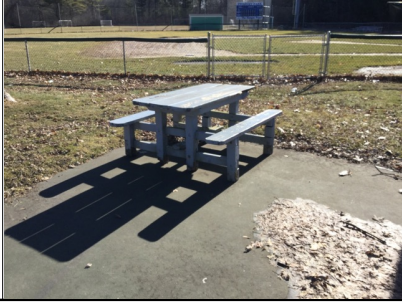
Toe or knee clearance at table not provided	-	Provide at least one picnic table with toe and knee clearance.	1	1400	\$1400
<b>Additional Access</b>												
<b>Drinking Fountains</b>												
6	Near Press Box	Ext.		Drinking Fountains	N/A

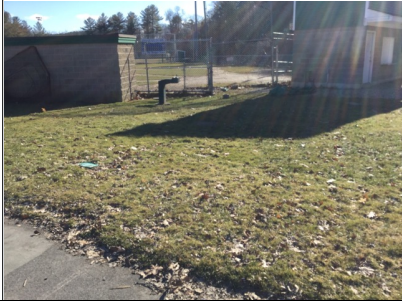
Fountain not on accessible route No drinking fountain provided for standing users	- -	Provide an accessible route to the drinking fountain. Provide an additional drinking fountain for standing users.  (Cost based on a 24 ft. long x 48" wide min. stone dust path and a drinking fountain for standing users).	1	4796	\$4796
<b>Play and Sport Areas</b>												
<b>Field</b>												
7	Baseball	Ext.		Field	Baseball

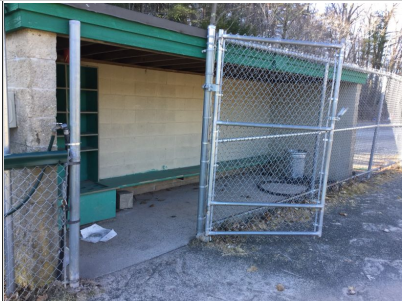
Accessible spaces are not provided at team seating	-	Provide a 36" x 48" clear floor space at team seating bench in each dugout.	2	Labor	\$0

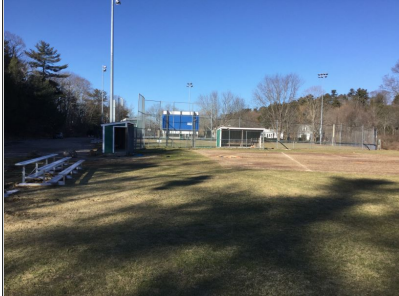
Accessible spaces not provided at sidelines seating	-	Provide a 36" x 48" clear floor space at sidelines seating.  (Cost based on a 36'x48' asphalt patch.)	1	240	\$240
10	Baseball Fan Seating	Ext.		Field	Baseball

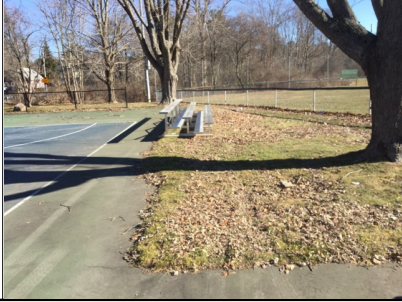
Accessible spaces are not provided at sidelines seating	-	Provide a 36" x 48" clear floor space at sidelines seating.  (Cost based on an asphalt 36"x48" patch alongside the bleachers.)	1	240	\$240
<b>Best Practice</b>												
<b>Picnic Table</b>												
15	Near Second Basketball Court	Ext.		Picnic Table	N/A

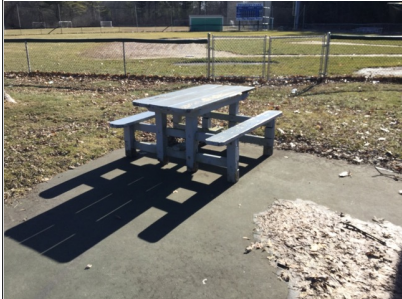
Recommend providing a 48" min. stable, firm and slip resistant surface around the accessible picnic table.	1	-	\$0

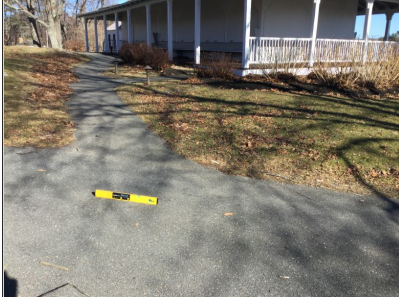
Cross slope > 1:48 (2.08%)	6.1%	Reduce cross slope to be no steeper than 1:48 (2.08%).  (Cost based on 6'x4' of asphalt to reduce slope at \$10 a square foot.)	1	240	\$240
2	Towards Toilet Rooms	Ext.		Exterior Access Route	Walkway

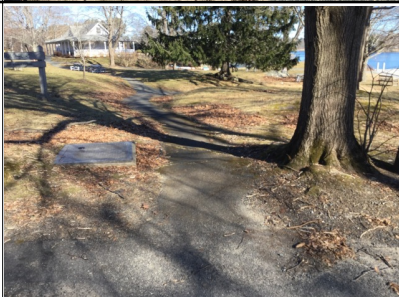
Not maintained in an operable working condition	-	Ensure the accessible route is maintained in operable working condition.  Cost based on a 60 ft. long by 4 ft wide asphalt route.	1	2400	\$2400
5	Walkway From Parking Towards Gazebo	Ext.		Exterior Access Route	Walkway

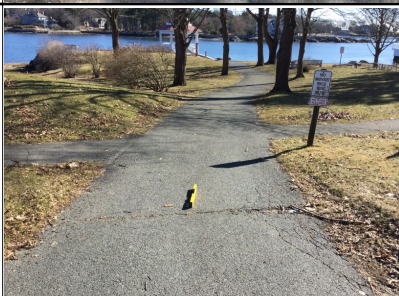
Running slope > 1:20 (5.00%)	8.2%	Reduce the running slope to be no steeper than 1:20 (5.00%).  (Cost to reduce excessive running slope not provided.)	1	-	\$0

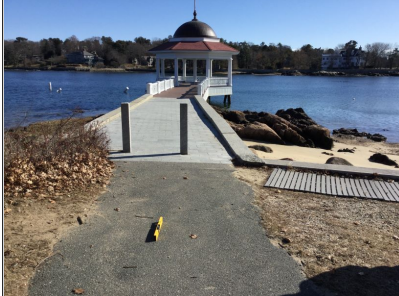
Running slope > 1:20 (5.00%)	8.6%	Reduce the running slope to be no steeper than 1:20 (5.00%).  (Cost to reduce excessive running slope not provided.)	1	-	\$0
7	Towards Chowder House	Ext.		Exterior Access Route	Walkway	 	Accessible route not provided	-	Relocate tables to ensure the min. 36' width is maintained at the accessible route.	1	Labor	\$0
8	Horseshoe Pits	Ext.		Exterior Access Route	Exterior

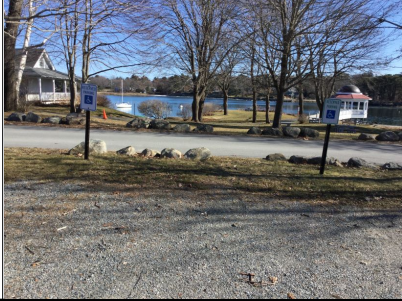
Total # of parking Total # of designated accessible parking spaces Access aisle < 96" wide at van space Sign does not have the designation "Van Accessible" Sign < 60" above finished grade	55 2 - - 38"	Provide a marked access aisle that is at least 96" wide. Add the designation "Van Accessible" to the sign located at the van accessible space. Locate sign with the bottom of the sign 60" above the ground.	1	800	\$800
<b>Access to Goods and Services</b>												
<b>Doors, Doorways, &amp; Gates</b>												
12	Women's Toilet Room	1		Doors, Doorways, & Gates	Toilet Room

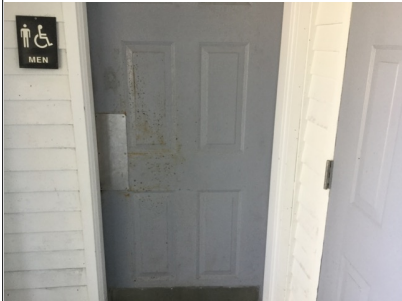
Door requires > 5 lbs of force to open	9 lbs	Adjust closers so doors do not require more than 5 pounds of force to open.	1	Labor	\$0
<b>Picnic Tables</b>												
14	Near Parking	Ext.		Picnic Tables	N/A

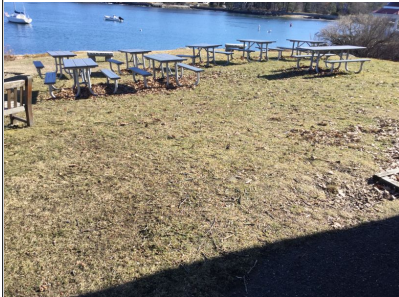
Picnic table not on an accessible route	-	Locate picnic table on an accessible route.  (Cost based on a 30'x48" wide min. 30' asphalt path to the accessible picnic table in this area. Ensure walkway has a running slope of 1:20 (5.00%) max. and a cross slope of 1:50 (2.00%) max.)	1	1200	\$1200
17	Near Gazebo	Ext.		Picnic Tables	N/A	 	Picnic table not on an accessible route	-	Locate accessible picnic table in this area on an accessible route.  (Cost based on a 30'x48" wide min. 30' asphalt path to at least one of the horseshoe pits in this area. Ensure walkway has a running slope of 1:20 (5.00%) max. and a cross slope of 1:50 (2.00%) max.)	1	1200	\$1200

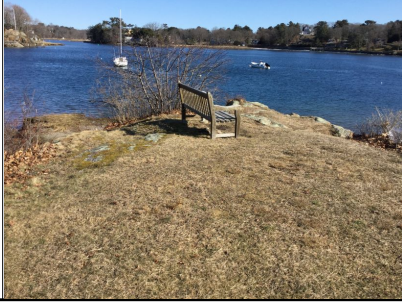
No accessible route to one bench in this area	-	Provide an accessible route to at least one bench in this area.  (Cost based on a 30'x48" wide min. 30' asphalt path to at least one of the horseshoe pits in this area. Ensure walkway has a running slope of 1:20 (5.00%) max. and a cross slope of 1:50 (2.00%) max.)	1	1200	\$1200
<b>Bike Racks</b>												
21		Ext.		Bike Racks	N/A

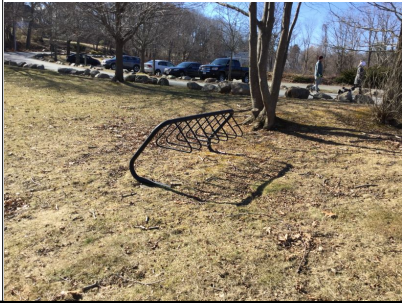
Not connected to an accessible route	-	Ensure bike racks are connected to an accessible route.  (Cost based on a 18'x48" wide min. 15' asphalt path to bike rack. Ensure walkway has a running slope of 1:20 (5.00%) max. and a cross slope of 1:50 (2.00%) max.)	1	600	\$600
<b>Toilet &amp; Bathing Rooms</b>												
<b>Lavatory</b>												
22	Women's Toilet Room	Ext.		Lavatory	N/A

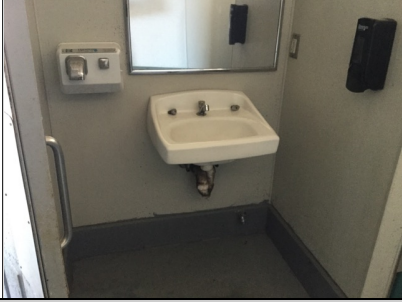
Exposed plumbing underneath	-	Insulate or otherwise configure pipes to prevent contact, for at least one lavatory.	1	92	\$92

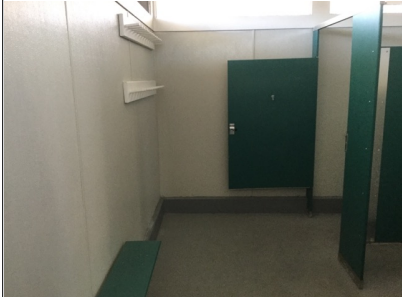
Door with malfunctioning self-closing hinge Coat hook > 48"	- 57"	Repair hinge. Lower coat hook so that it is no higher than 48" above the finished floor.	1	150	\$150

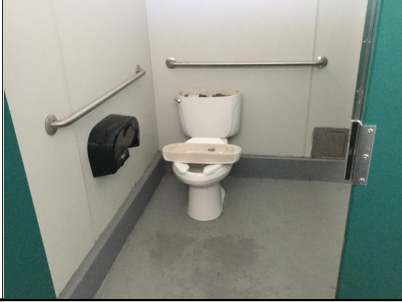
Flush control not on open side	-	Provide the flush control on the open side of the toilet (transfer side).	1	374	\$374
<b>Urinal</b>												
25	Men's Toilet Room	Ext.		Urinal	N/A

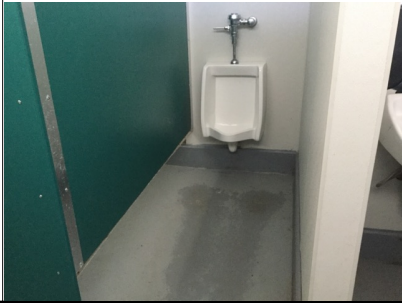
Clear floor space not provided at urinal	-	Remove partition to provide a 30" min. by 48" min. clear floor space positioned for a forward approach.	1	256	\$256
<b>Additional Access</b>												
<b>Drinking Fountains</b>												
26	By Toilet Rooms	Ext.		Drinking Fountains	Seated

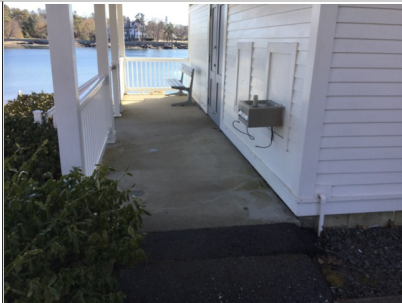
No drinking fountain provided for standing users	-	Provide an additional drinking fountain for standing users or install a Hi-Lo drinking fountain.	1	4028	\$4028
<b>Sink</b>												
27	Kitchen			Sink	Other

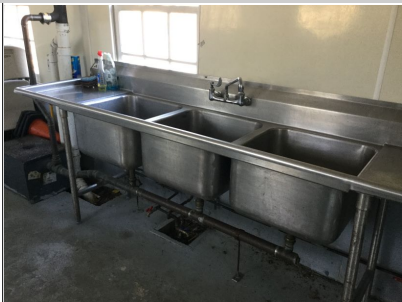
Toe and knee clearances not provided	-	Ensure there is a 27" knee clearance positioned for a forward approach to sink.  (Cost based on a sink with the required minimum toe and knee clearance.)	1	1686	\$1686

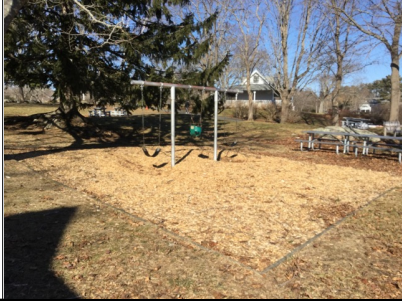
Accessible route not provided to playground Accessible route not provided at play components Surface not stable, firm, and slip-resistant	- - -	Provide an accessible route to and around the playground. (30'x48" wide min. asphalt.) Provide an accessible route that is 60" min. wide to each play component in the playground. (Poured-in-place rubber.) Provide a compliant impact-attenuating surface under and around the play components. (25 sq.' poured-in-place rubber.) (Cost includes poured-in-place rubber.)	1	11150	\$11150
<b>Best Practice</b>												
<b>Bench</b>												
29	Women's Toilet Room & Men's Toilet Room	Ext.		Bench	N/A

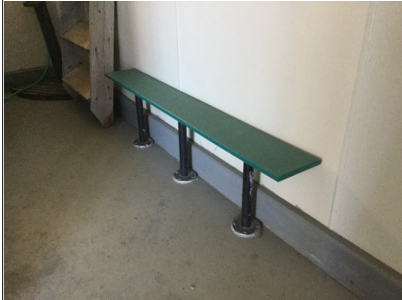
Recommend having a bench that is between 20" and 24" deep.	2	-	\$0
30	Chowder House Exterior by Ocean	Ext.		ench	N/A

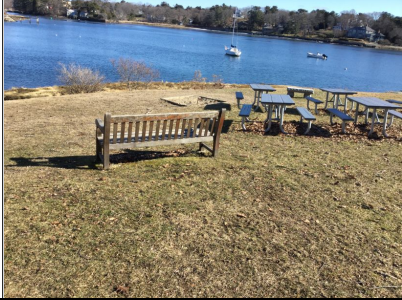
Recommend providing a 36"x48" stable, firm and slip resistant surface at the end of at least one bench in each area positioned so that an individual with a wheeled mobility device can have shoulder alignment with a companion seated on the bench.	1	-	\$0

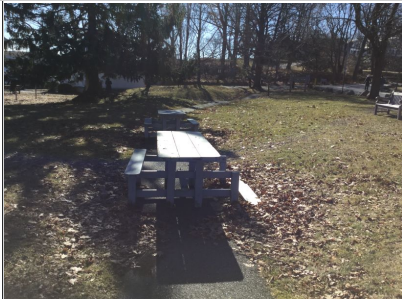
Recommend providing a 48" stable, firm and slip resistant surface around the exterior of all accessible picnic tables.	1	-	\$0

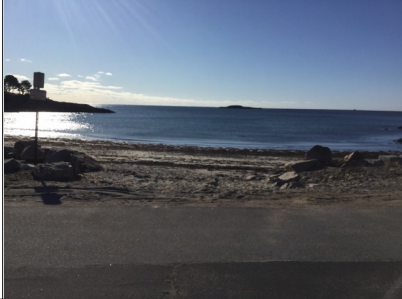
Beach route not provided	-	Provide an accessible beach access route that is firm and stable. Ensure the accessible route extends to the high tide level. (Provide a beach mat that is at least 72" wide and extends to the high tide level.)  (Cost based on a 72" wide min. by 80' long beach mat.)	1	3899	\$3899
<b>Off-Street Parking Lot or Garage</b>												
2	Parking Lot	Ext.		Off-Street Parking Lot or Garage	Visitor

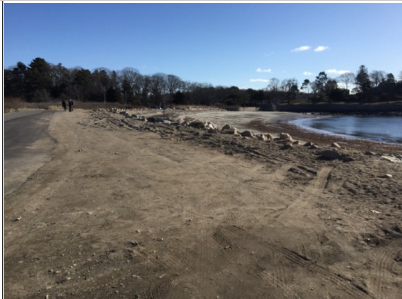
Recommend providing benches along the route.	1	-	\$0
<b>Wayfinding</b>												
4	19 Ocean Street	Ext.		Wayfinding	N/A

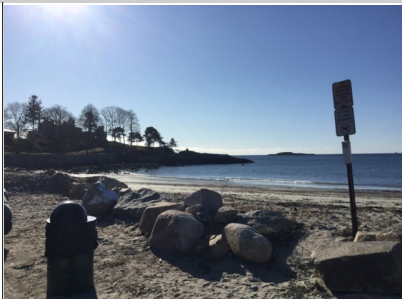
Recommend providing a sign with the beach name.	1	-	\$0
