## Manchester-by-the-Sea, Massachusetts

January 2021

## Municipal Buildings

## Town of Manchester-by-the-Sea ADA Transition Plan

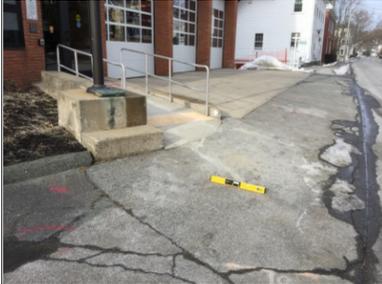
ID	Location	Floor	Room	Element	Type	Photo	Issues	Current Measure	Recommendations	Quantity	Price	Cost Estimation
<b>Approach and Entrance</b>												
<b>Exterior Access Route</b>												
1	Towards Main Entrance	Ext.		Exterior Access Route	Sidewalk

Cross slope > 1:50 (2.00%)	3.3%	Reduce cross slope to be no steeper than 1:50 (2.00%) in all directions.	1	-	\$0
<b>Off-Street Parking Lot or Garage</b>												
2	Parking Lot	Ext.		Off-Street Parking Lot or Garage	Employee

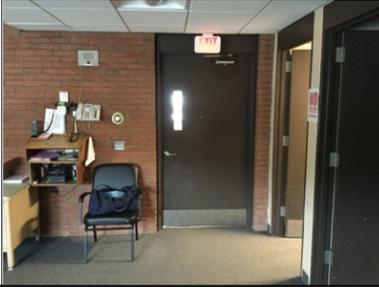
ID	Location	Floor	Room	Element	Type	Photo	Issues	Current Measure	Recommendations	Quantity	Price	Cost Estimation
<b>Means of Egress</b>												
5				Means of Egress	N/A

Tactile exit sign not provided	-	Ensure tactile exit signs with raised characters and braille are provided at exit doors. Mount signs between 48"- 60" above finished floor located on the latch side of the door.	1	232	\$232
6	Meeting Room	1		Means of Egress	N/A

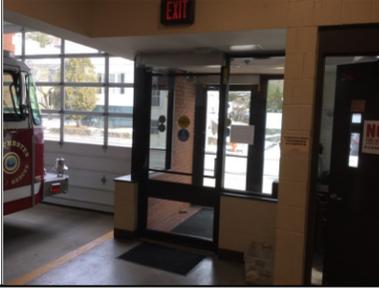
ID	Location	Floor	Room	Element	Type	Photo	Issues	Current Measure	Recommendations	Quantity	Price	Cost Estimation
10	Exit	1		Means of Egress	111

Illuminated ISA symbol not provided (MAAB)	-	Provide an illuminated International Symbol of Accessibility.	1	200	\$200
<b>Doors, Doorways, &amp; Gates</b>												
11	Towards Meeting Room	1		Doors, Doorways, & Gates	Meeting Room

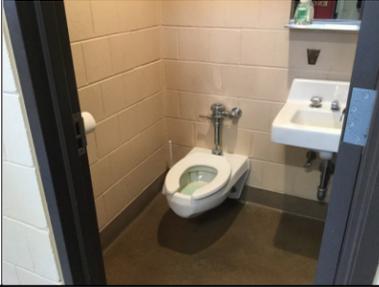
ID	Location	Floor	Room	Element	Type	Photo	Issues	Current Measure	Recommendations	Quantity	Price	Cost Estimation
<b>Overall Access</b>												
15	Women's Toilet Room	1		Overall Access	Toilet Room

Turning space not provided Accessible plumbing fixtures or stalls not provided	- -	Provide one accessible single-user toilet room.	1	24604	\$24604
16	Men's Toilet Room	1		Overall Access	Toilet Room

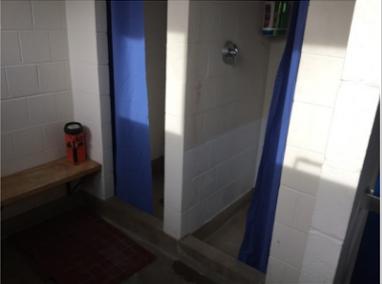
ID	Location	Floor	Room	Element	Type	Photo	Issues	Current Measure	Recommendations	Quantity	Price	Cost Estimation
<b>Best Practice</b>												
<b>Transfer Shower</b>												
20	Men's Toilet Room	1		Transfer Shower	N/A

-	Recommend providing an accessible shower.	1	-	\$0

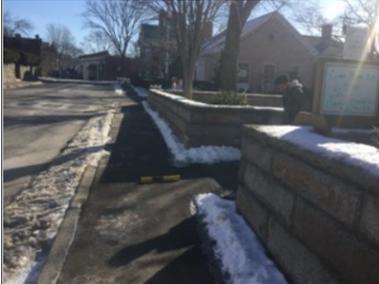
ID	Location	Floor	Room	Element	Type	Photo	Issues	Current Measure	Recommendations	Quantity	Price	Cost Estimation
<b>Approach and Entrance</b>												
<b>Exterior Access Route</b>												
1	Central/ Union Street at Path to Main Entrance	Ext.		Exterior Access Route	Sidewalk

Cross slope > 1:50 (2.00%)	4.5%	Reduce cross slope to be no steeper than 1:50 (2.00%).  (Cost for 3'x3' of asphalt to correct slope.)	1	90	\$90
2	Path to Children's Area Entrance	Ext.		Exterior Access Route	Exterior

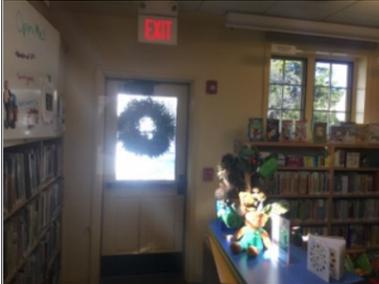
ID	Location	Floor	Room	Element	Type	Photo	Issues	Current Measure	Recommendations	Quantity	Price	Cost Estimation
<b>Means of Egress</b>												
6	Exit to Ramp	1		Means of Egress	N/A

Tactile exit sign not provided Illuminated Int. Symbol of Acc. not provided	-	Ensure tactile exit signs with raised characters and braille are provided at exit doors. Mount signs between 48"- 60" above finished floor located on the latch side of the door. Provide a sign with an illuminated International Symbol of Accessibility (ISA).	1	432	\$432
7	Central/ Union Street Exit	1		Means of Egress	N/A

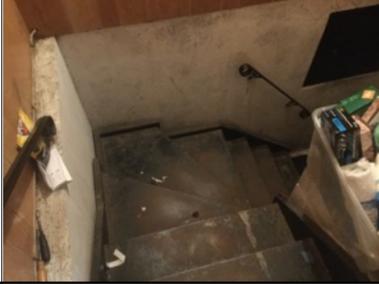
Accessible route not provided	-	Providing an accessible route to the basement Friends of Library area may be technically infeasible. To provide program access, recommend relocating the Friends of the Library area to an accessible location as needed.	1	Labor	\$0

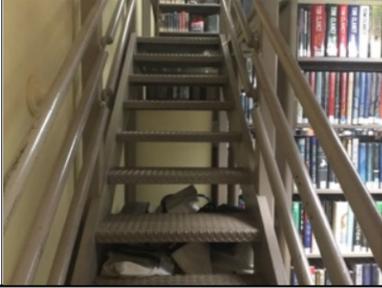
ID	Location	Floor	Room	Element	Type	Photo	Issues	Current Measure	Recommendations	Quantity	Price	Cost Estimation
11	Stairs to Mezzanine	1		Interior Access Route	N/A

Accessible route not provided	- -	Provide an accessible route to the mezzanine teen area.  (Cost based on a new interior lift.)	1	21660	\$21660
<b>Doors, Doorways, &amp; Gates</b>												
12	Staff Office	1		Doors, Doorways, & Gates	Office

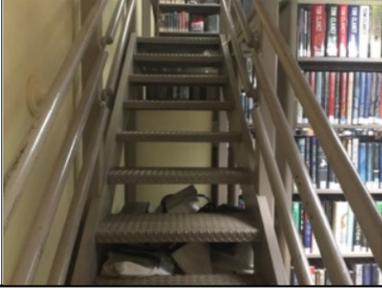
ID	Location	Floor	Room	Element	Type	Photo	Issues	Current Measure	Recommendations	Quantity	Price	Cost Estimation
16	Stairs to Mezzanine	1		Stairways	Interior

Stair has open risers	-	Ensure stairs have closed risers.  (Cost based on filling in 16 metal risers.)	1	2624	\$2624
<b>Service Counter</b>												
17	Circulation Desk	1		Service Counter	N/A

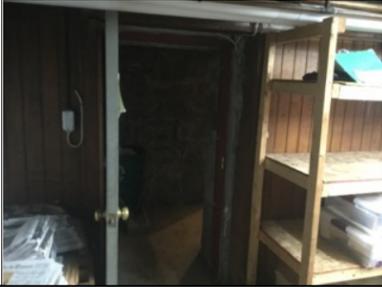
ID	Location	Floor	Room	Element	Type	Photo	Issues	Current Measure	Recommendations	Quantity	Price	Cost Estimation
<b>Ceiling Height</b>												
20	Friends of Library Volunteer Area	B		Ceiling Height	N/A

Recommend providing a sign at the entrance to the Friends of the Library area that reads, 'Low Ceiling' as the ceiling is just 72" high.	1	-	\$0
<b>Entrance Door</b>												
21	Door at Ramp to Children's Area	Ext.		Entrance Door	N/A

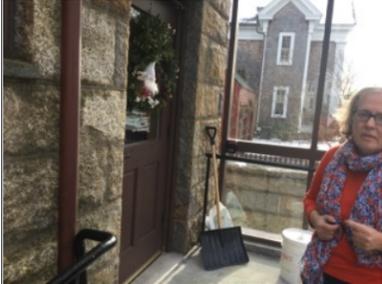
Recommend providing an automatic door opener.  (The opening force for the door is at the heavy end of the allowable range, but multiple library users have said the door is too heavy for them to open when carrying books and in similar situations.)	1	-	\$0
<b>On-Street Parking</b>												
22	Church Street Parking	Ext.		On-Street Parking	N/A

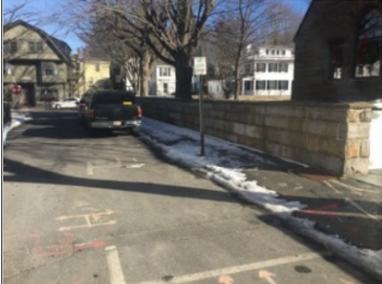
Recommend designating the street parking space closest to the route to the ramp by the children's area entrance as accessible by installing a sign with the International Symbol of Accessibility (ISA) with the base of the sign 60" min. and the top of the sign 96" max. above the ground.	1	-	\$0

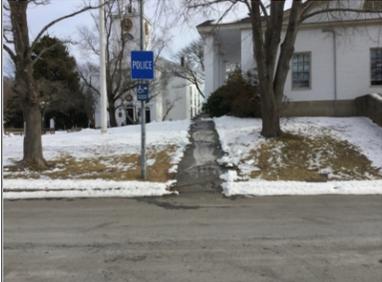
ID	Location	Floor	Room	Element	Type	Photo	Issues	Current Measure	Recommendations	Quantity	Price	Cost Estimation
<b>Approach and Entrance</b>												
<b>Exterior Access Route</b>												
1	Across From Seaside 1 Building	1		Exterior Access Route	Walkway

Route not maintained in operable working condition	-	Ensure the accessible route is maintained in operable working conditions.	1	-	\$0
2	Towards Main Entrance	Ext.		Exterior Access Route	Walkway

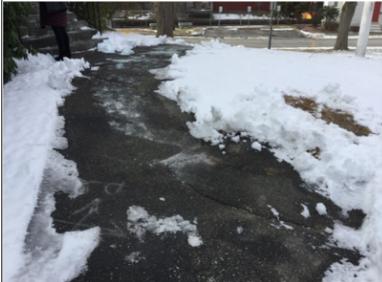
Cross slope > 1:50 (2.00%)	2.7%	Reduce cross slope to be no steeper than 1:50 (2.00%).	1	-	\$0
<b>Entrance</b>												
3	Main Entrance	Ext.		Entrance	Main Entrance

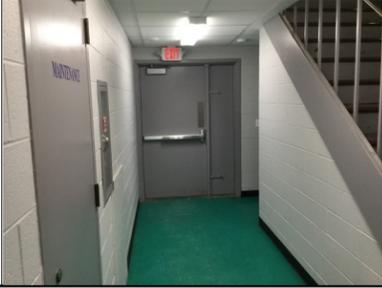
ID	Location	Floor	Room	Element	Type	Photo	Issues	Current Measure	Recommendations	Quantity	Price	Cost Estimation
5	Emergency Exit	G		Means of Egress	N/A

Tactile exit sign not provided Illuminated ISA symbol not provided (MAAB)	- -	Ensure a tactile exit sign with raised characters and braille is provided at exit door. Mount sign between 48"- 60" above finished floor located on the latch side of the door. Provide an illuminated sign with the International Symbol of Accessibility.	1	432	\$432
<b>Interior Access Route</b>												
6	Executive Officer	1		Interior Access Route	N/A

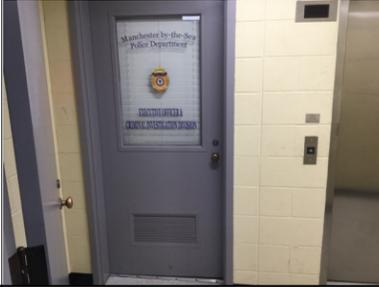
ID	Location	Floor	Room	Element	Type	Photo	Issues	Current Measure	Recommendations	Quantity	Price	Cost Estimation
<b>Signage</b>												
10	Executive Officer & Criminal Investigation Division	1		Signage	Designation

Raised characters not provided on sign Braille not provided on sign Sign not located on the latch side of the door	- - -	Provide text with raised characters duplicated in braille on sign. Locate sign alongside the door on the latch side.	1	232	\$232
11	Towards Holding Cells	G		Signage	Designation

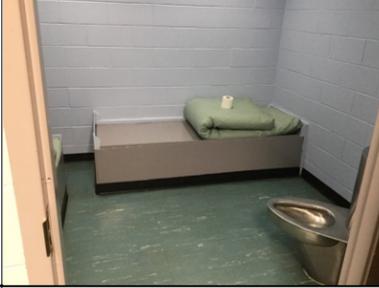
ID	Location	Floor	Room	Element	Type	Photo	Issues	Current Measure	Recommendations	Quantity	Price	Cost Estimation
15	Female/ Juvenile Holding Cell	G		Detention Facilities	Women's

Mobility cell lacks 60" turning space	-	Remove one of the beds to ensure that a 60" turning space is provided.	1	Labor	\$0
16	Female/ Juvenile Holding Cell	G		Detention Facilities	Other

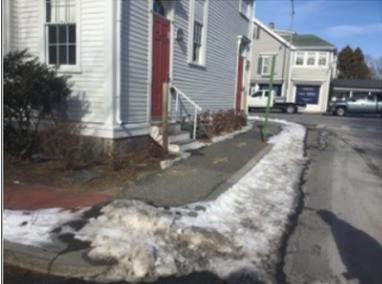
ID	Location	Floor	Room	Element	Type	Photo	Issues	Current Measure	Recommendations	Quantity	Price	Cost Estimation
<b>Approach and Entrance</b>												
<b>Exterior Access Route</b>												
1	Walkway by Parking	Ext		Exterior Access Route	Walkway

Route not maintained in operable working condition	-	Ensure the accessible route is maintained in operable working condition (remove snow).	1	Labor	\$0
2	Walkway to Museum Accessible Entrance	Ext		Exterior Access Route	Exterior

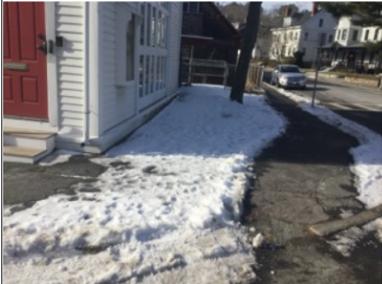
Route not maintained in operable working condition	-	Ensure the accessible route is maintained in operable working condition (remove snow).	1	Labor	\$0
<b>Off-Street Parking Lot or Garage</b>												
3	Parking	Ext.		Off-Street Parking Lot or Garage	N/A

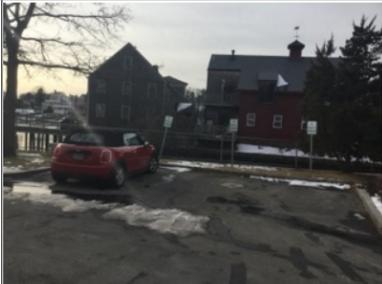
Total # of parking Total # of designated accessible parking spaces Vehicle space < 132" wide at van space Access aisle < 60" wide at car/van space Sign not provided Sign does not have the designation "Van Accessible"	4 - - -	Provide a van accessible parking space that is at least 132" wide min. with a marked access aisle that is at least 60" wide min. Provide a sign with the International Symbol of Accessibility (ISA). Add the designation "Van Accessible" to the sign located at the van accessible space, and mount the sign 60" min. and 96" max. above the ground.	1	1850	\$1850

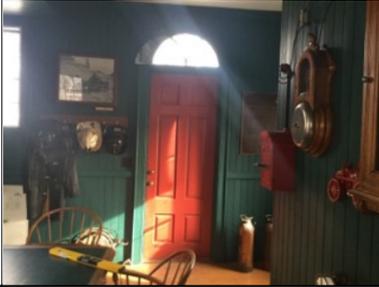
ID	Location	Floor	Room	Element	Type	Photo	Issues	Current Measure	Recommendations	Quantity	Price	Cost Estimation
<b>Means of Egress</b>												
5	Egress to Stairs	1		Means of Egress	N/A

Illuminated exit sign not provided Tactile exit sign not provided	- -	Ensure illuminated exit signs are provided at exits and exit doors. Ensure tactile exit signs with raised characters and braille are provided at exit doors. Mount signs between 48"- 60" above finished floor located on the latch side of the door.	1	432	\$432
6	Accessible Exit to Ramp	1		Means of Egress	N/A

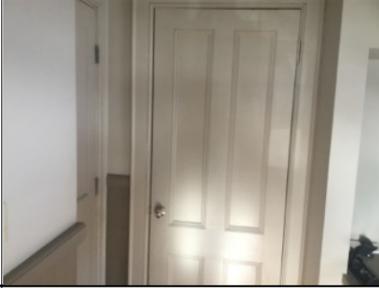
ID	Location	Floor	Room	Element	Type	Photo	Issues	Current Measure	Recommendations	Quantity	Price	Cost Estimation
10	Planning Office	2		Doors, Doorways, & Gates	Circulation

Hardware not operable with a closed fist	-	Provide hardware that can be operable with one hand and not require tight grasping, pinching, or twisting of the wrist.	1	484	\$484
11	Entrance to Conservation and Planning Offices	Ext		Doors, Doorways, & Gates	Other

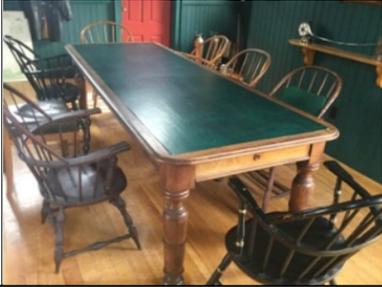
ID	Location	Floor	Room	Element	Type	Photo	Issues	Current Measure	Recommendations	Quantity	Price	Cost Estimation
<b>Dining or Work Surfaces</b>												
15	Museum Meeting Room	1		Dining or Work Surfaces	Work Surface

Knee or toe clearance not provided	24'	Provide at least 1 work surface with 27" min. knee and toe clearance.	1	700	\$700
<b>Toilet &amp; Bathing Rooms</b>												
<b>Overall Access</b>												
16	Single-User Toilet Room	1		Overall Access	Toilet Room

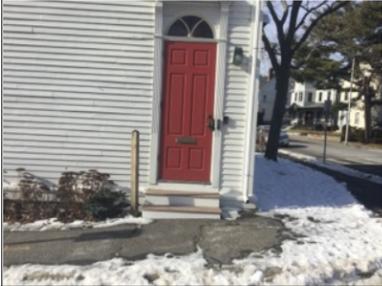
Recommend providing handrails with extensions at bottom landing on both sides of stair.	1	-	\$0
<b>Stairway Railing</b>												
21	Stairway to Offices	2		Stairway Railing	N/A

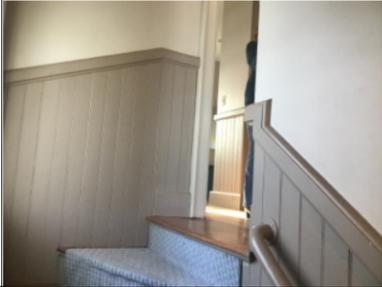
Recommend providing vertical handrail above existing railing at top of stairs.	1	-	\$0
<b>Stairways</b>												
22	Entrance to Museum and Meeting Space	Ext		Stairways	N/A

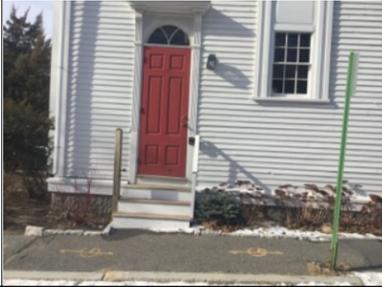
Recommend providing handrails with extensions at bottom landing on both sides of stair.	1	-	\$0

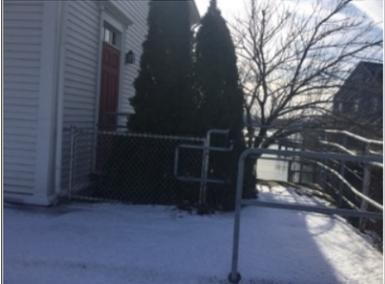
ID	Location	Floor	Room	Element	Type	Photo	Issues	Current Measure	Recommendations	Quantity	Price	Cost Estimation
<b>Walkway</b>												
23	Elevated Walkway to Museum and Meeting Space Accessible Entrance	Ext		Walkway	N/A

Recommend providing edge protection along the elevated portion of walkway along the north side of the building that leads to the museum and meeting space accessible entrance.	1	-	\$0

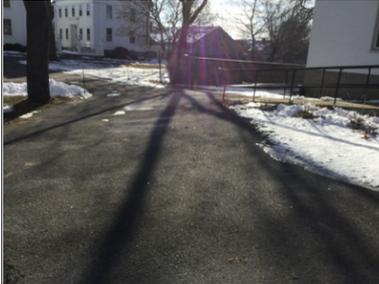
ID	Location	Floor	Room	Element	Type	Photo	Issues	Current Measure	Recommendations	Quantity	Price	Cost Estimation
<b>Approach and Entrance</b>												
<b>Exterior Access Route</b>												
1	Route From Library			Exterior Access Route	Walkway

Cross slope > 1:50 (2.00%)		Reduce cross slope to be no steeper than 1:50 (2.00%).  Note: This area is going to be redesigned.	1	-	\$0
2	North Side Main Entrance	Ext.		Exterior Access Route	Walkway

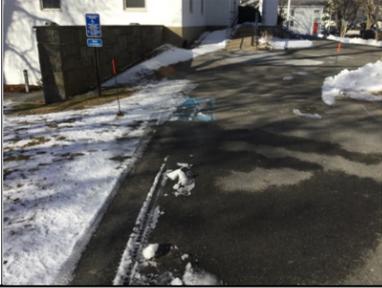
ID	Location	Floor	Room	Element	Type	Photo	Issues	Current Measure	Recommendations	Quantity	Price	Cost Estimation
6	Parking - East Side	Ext.		Off-Street Parking Lot or Garage	Visitor

Access aisle not provided	-	Provide a marked access aisle that is at least 96" wide.	1	300	\$300
<b>Exterior Ramp</b>												
7	Towards Accessible Entrance - East Side	Ext.		Exterior Ramp	N/A

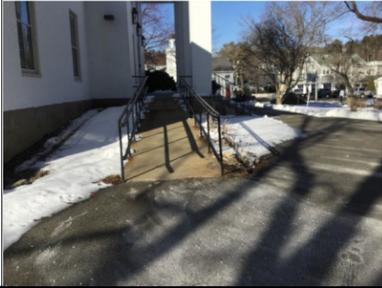
Ramp < 48" wide Running slope > 1:12 (8.3%) Not maintained in operable working condition	44.5" 11.8% -	Widen ramp so that the clear width is 48" min. Reduce running slope to be no steeper than 1:12 (8.3%). Ensure the ramp is maintained in operable working condition.	1	14646	\$14646
<b>Entrance</b>												
8	East Side - Accessible Entrance	B		Entrance	Secondary Entrance

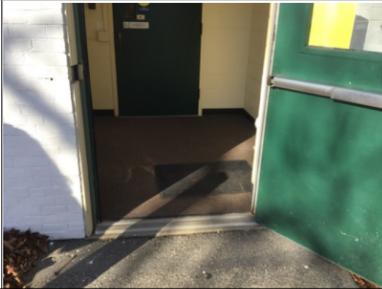
Mat not securely attached Threshold not beveled	- -	Secure the mat. Bevel threshold.	1	150	\$150
<b>Access to Goods and Services</b>

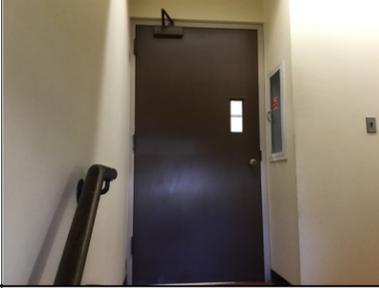
ID	Location	Floor	Room	Element	Type	Photo	Issues	Current Measure	Recommendations	Quantity	Price	Cost Estimation
10	Exit - Near Selectmen Town Admin.	1		Means of Egress	N/A

Floor level designation not provided	-	Provide a sign on the interior of the stairway enclosure indicating the floor level.	1	232	\$232
11	Near Town Clerk - Parking Clerk	1		Means of Egress	N/A

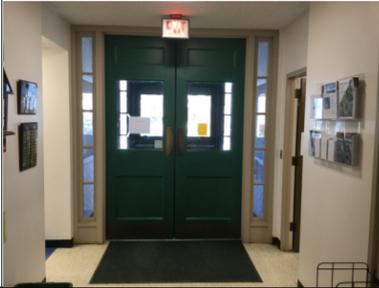
Illuminated ISA symbol not provided (MAAB) Mat not securely attached	-	Provide an illuminated International Symbol of Accessibility. Secure the mat to prevent tripping hazard.	1	200	\$200
12	Egress Near Room 9	2		Means of Egress	111

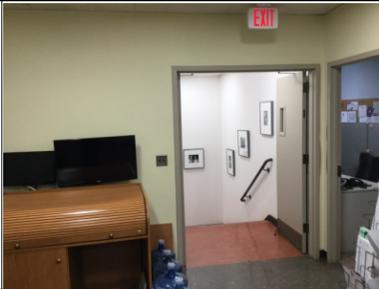
Tactile exit sign not provided	-	Ensure a tactile exit sign with raised characters and braille is provided at exit door. Mount sign between 48"- 60" above finished floor located on the latch side of the door.	1	232	\$232
13	Exit Near Meeting Room	2		Means of Egress	N/A

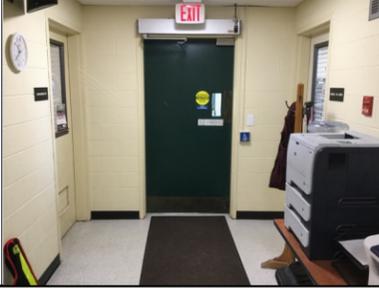
ID	Location	Floor	Room	Element	Type	Photo	Issues	Current Measure	Recommendations	Quantity	Price	Cost Estimation
15	Hallway - Near Harbormaster Office	B		Means of Egress	N/A

Illuminated ISA symbol not provided (MAAB) Mat not securely attached	-	Provide an illuminated International Symbol of Accessibility. Secure the mat to prevent tripping hazard.	1	200	\$200
<b>Interior Access Route</b>												
16	Town Clerk - Parking Clerk	1	4	Interior Access Route	N/A

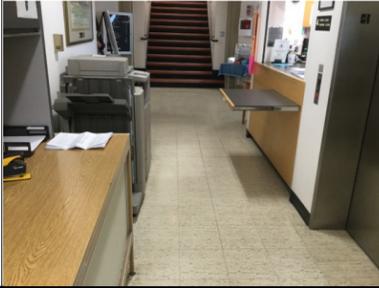
Route < 36" wide	29"	Relocate printer to ensure that a clear width of 36" min. is maintained at the accessible route.	1	Labor	\$0
17	Selectmen's Meeting Room	2	5	Interior Access Route	N/A

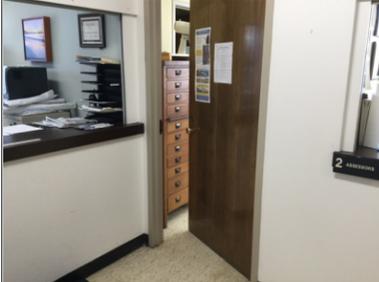
ID	Location	Floor	Room	Element	Type	Photo	Issues	Current Measure	Recommendations	Quantity	Price	Cost Estimation
20	Assessors	1	2	Doors, Doorways, & Gates	Office

Hardware not operable with a closed fist		Provide hardware that can be operable with one hand and not require tight grasping, pinching, or twisting of the wrist.	1	484	\$484
21	Town Clerk - Parking Clerk	1	4	Doors, Doorways, & Gates	Office

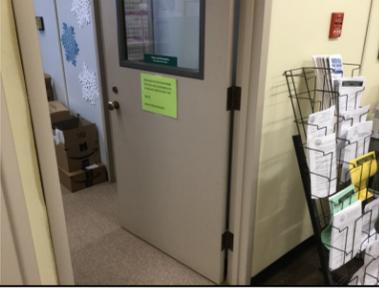
ID	Location	Floor	Room	Element	Type	Photo	Issues	Current Measure	Recommendations	Quantity	Price	Cost Estimation
25	Parks and Recreations	2	9	Doors, Doorways, & Gates	Office

Hardware not operable with a closed fist	-	Provide hardware that can be operable with one hand and not require tight grasping, pinching, or twisting of the wrist.	1	484	\$484
26	Council on Aging	B		Doors, Doorways, & Gates	Office

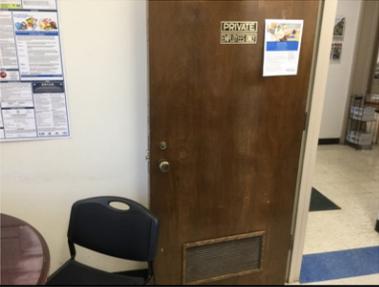
ID	Location	Floor	Room	Element	Type	Photo	Issues	Current Measure	Recommendations	Quantity	Price	Cost Estimation
<b>Signage</b>												
30	Employee Break Room	1		Signage	Designation

Raised characters not provided Braille not provided Sign not located on the latch side of the door	- - -	Provide text with raised characters duplicated in braille. Locate sign alongside the door on the latch side.	1	232	\$232
31	Selectmen Town Administration	1	3	Signage	Designation

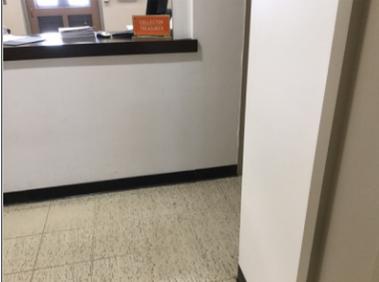
ID	Location	Floor	Room	Element	Type	Photo	Issues	Current Measure	Recommendations	Quantity	Price	Cost Estimation
35	Collector Treasures	1	1	Signage	Designation

Non glare finish and contrast not provided on sign	-	Install a sign with a non-glare finish with characters that have a high contrast to the background.	1	232	\$232
36	Parks and Recreations	2	9	Signage	Designation

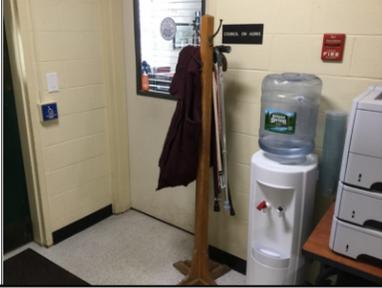
ID	Location	Floor	Room	Element	Type	Photo	Issues	Current Measure	Recommendations	Quantity	Price	Cost Estimation
40	Council on Aging	B		Signage	Designation

18" by 18" clear space not provided	-	Ensure a clear 18" min. by 18" min. clear floor space is provided. Ensure the clear floor space is centered on the tactile characters	1	Labor	\$0
<b>Service Counter</b>												
41	Assessors	1	2	Service Counter	N/A

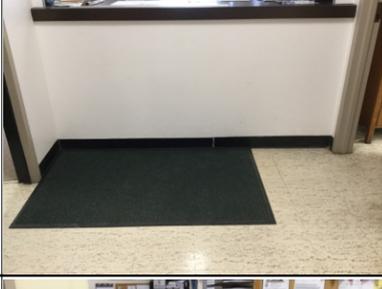
Counter > 36" high Mat not securely attached	42" -	Provide a counter that is 36" max. above the ground or finished floor. Secure the mat to prevent tripping hazard.	1	880	\$880

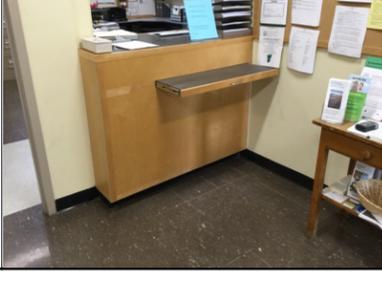
Clear floor space is not provided	-	Relocate table to maintain the required 30" min. by 48" min. clear floor space at the counter.	1	Labor	\$0

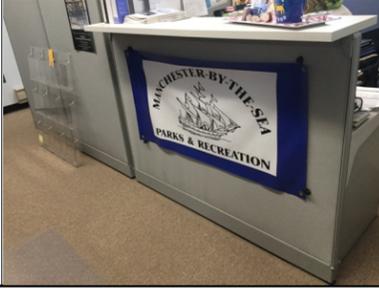
ID	Location	Floor	Room	Element	Type	Photo	Issues	Current Measure	Recommendations	Quantity	Price	Cost Estimation
45	Parks and Recreations	2	9	Service Counter	234

Counter > 36" high	46"	Provide a counter that is 36" max. above the finished floor.	1	880	\$880
<b>Operable Parts</b>												
46	Lobby	1	1	Operable Parts	Other

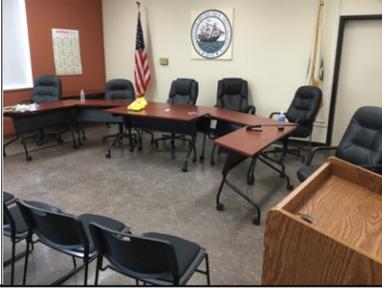
ID	Location	Floor	Room	Element	Type	Photo	Issues	Current Measure	Recommendations	Quantity	Price	Cost Estimation
50	Selectmen's Meeting Room	2	5	Assembly Area	N/A

Assistive listening devices not provided	-	If audible communication is integral to the use of the space, provide an assistive listening system.	1	1214	\$1214
<b>Toilet &amp; Bathing Rooms</b>												
<b>Overall Access</b>												
51	Men's and Women's Toilet Rooms	2		Overall Access	Toilet Room

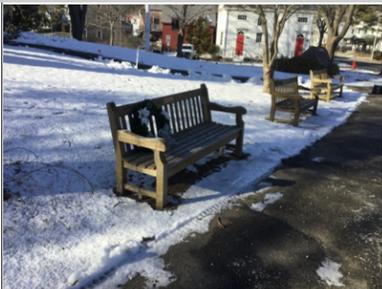
Recommend providing a 30" by 48" clear floor space adjacent to the benches.	1	-	\$0

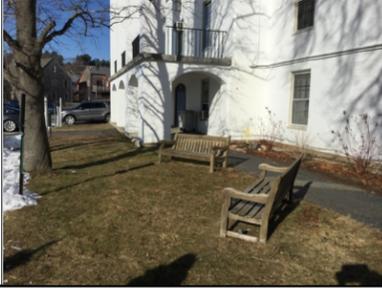
ID	Location	Floor	Room	Element	Type	Photo	Issues	Current Measure	Recommendations	Quantity	Price	Cost Estimation
54	South Side of Building	Ext.		Benches	N/A

Recommend providing a 30" by 48" clear floor space adjacent to the benches.	1	-	\$0
<b>Directory</b>												
55	Lobby	1	1	Directory	N/A

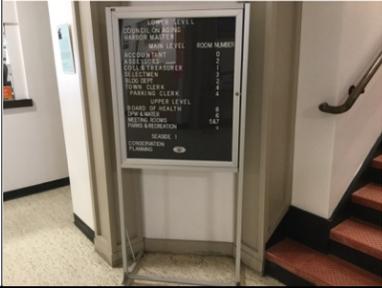
Recommend relocating the directory to avoid glare.	1	-	\$0
56	Across From Elevator	1	1	Directory	N/A

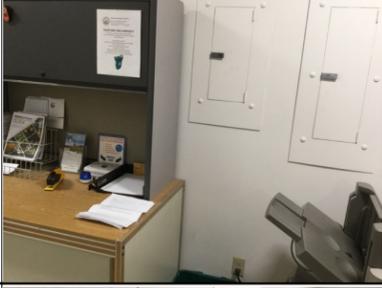
Recommend providing a directory here.	1	-	\$0
57	Across From Elevator	2		Directory	N/A

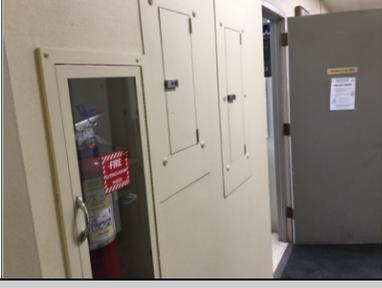
Recommend providing a directory here.	1	-	\$0
<b>EV Parking Space</b>												
58	Parking Lot - Accessible EV Space	Ext.		EV Parking Space	N/A

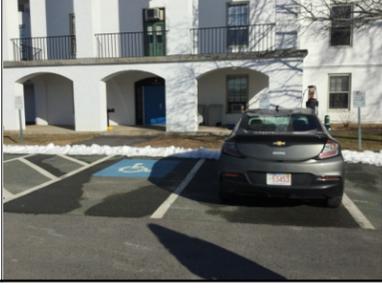
Recommend providing an accessible route on both sides of the vehicle spaces that connects to the charging station.	1	-	\$0

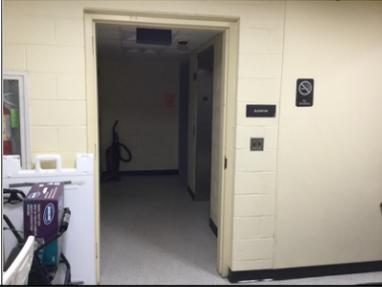
ID	Location	Floor	Room	Element	Type	Photo	Issues	Current Measure	Recommendations	Quantity	Price	Cost Estimation
<b>Signage</b>												
59	Towards Elevator	B		Signage	N/A

Recommend providing a more visible sign.	1	-	\$0
<b>Stairs</b>												
60	From 1st Floor to 2nd Floor	1		Stairs	N/A

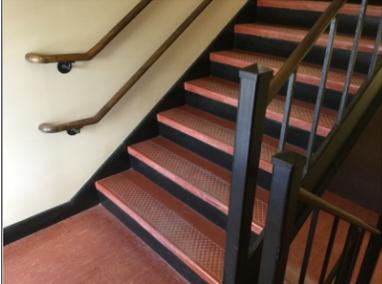
Recommend adding contrasting strips at the edge of each step at interior stairs.	1	-	\$0
61	From 1st Floor to 2nd Floor	2		Stairs	N/A

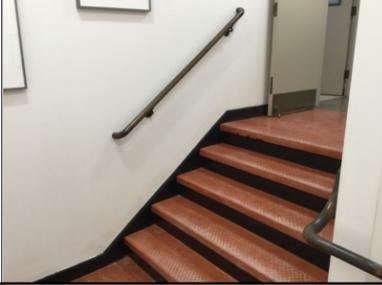
-	Recommend providing handrail extensions at top and bottom of stairs.	1	-	\$0
62	Main Entrance	Ext.		Stairs	N/A

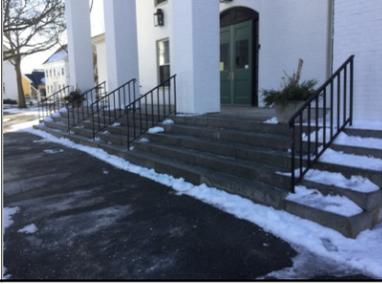
-	Recommend adding contrasting strips at the edge of each step at exterior stairs.	1	-	\$0

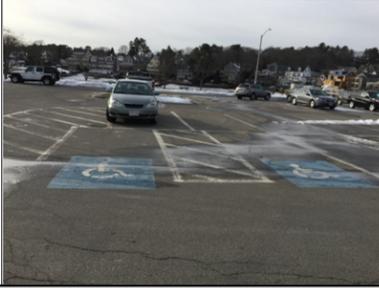
Total # of parking Total # of designated accessible parking spaces Total # of designated van accessible spaces Vehicle space < 96" wide at car space Vehicle space < 132" wide at van space Access aisle < 96" wide at van space Sign not provided Sign does not have the designation "Van Accessible"	75 2 - 88" - 56" - -	Provide a car accessible space 96" wide min. with an access aisle 60" wide min. (re-stripe.) Provide a van accessible space near the ramp to the accessible entrance 96" wide min. with an access aisle 96" wide min. (Relocate one accessible space.) Provide a sign with the International Symbol of Accessibility (ISA) at both spaces. Add the designation "Van Accessible" to the van parking space sign.	1	2950	\$2950
