### NOTIFICATION TO OWNER ACTION REQUIRED

Property Address: **39 COOLIDGE POINT ROAD, MANCHESTER-BY-THE-SEA**

# Title 5 Official Inspection Form

June 22, 2023

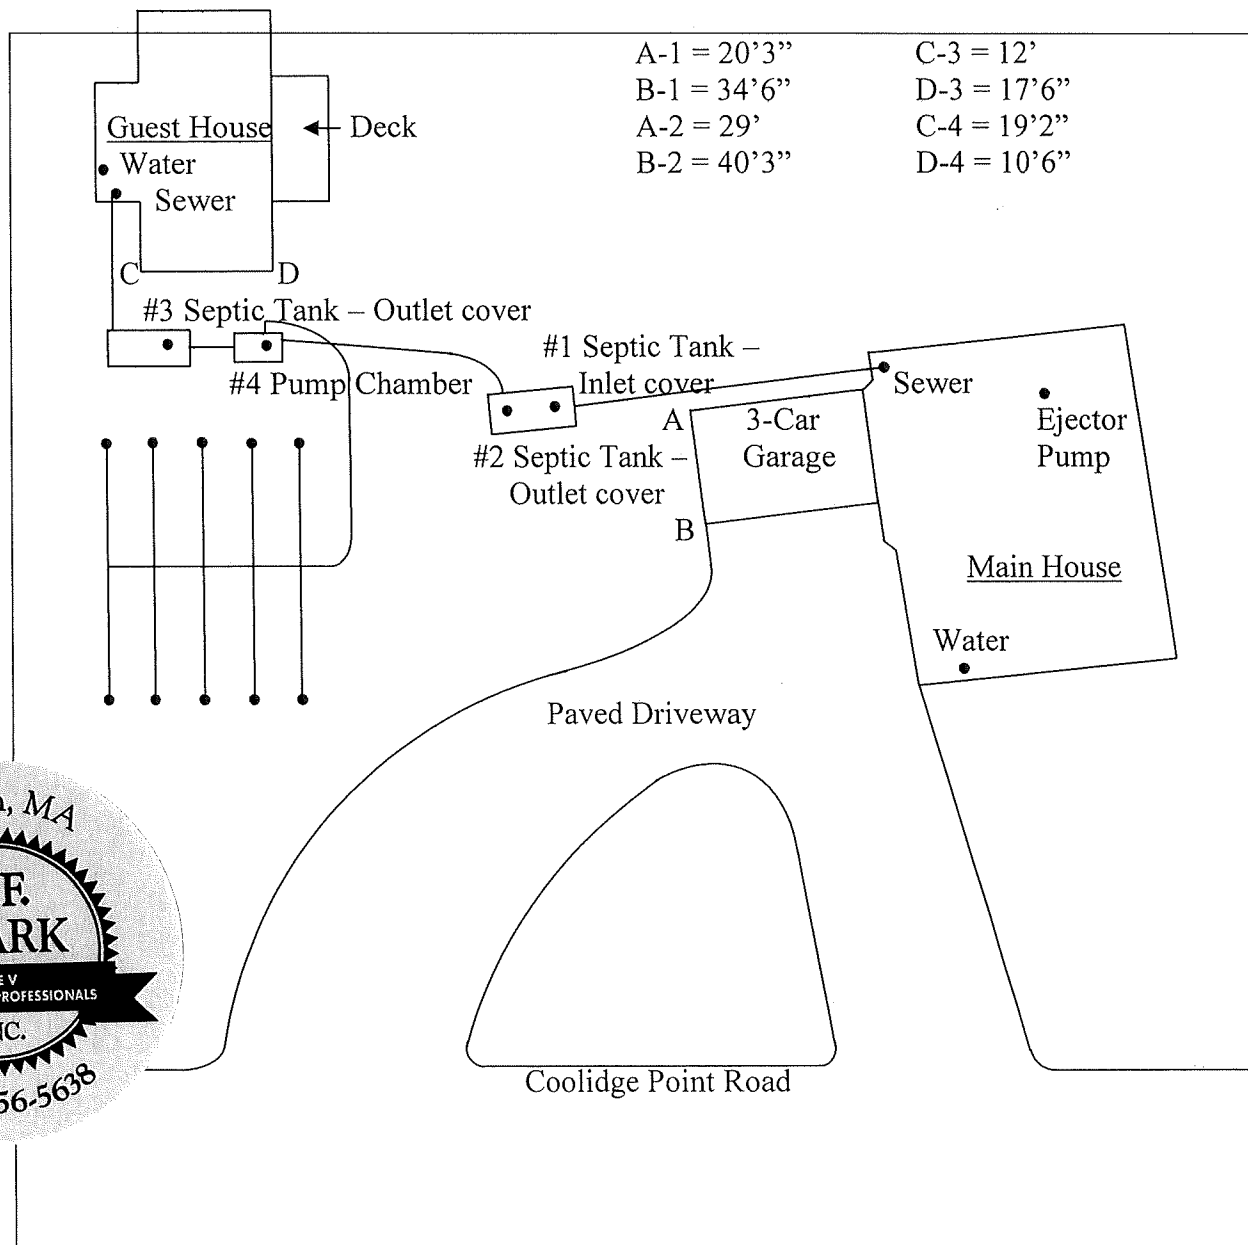
Provide a view of the sewage disposal system, including ties to at least two permanent reference landmarks or benchmarks. Locate all wells within 100 feet. Locate where public water supply enters the building. Check one of the boxes below:
