Property Address: **35 COOLIDGE POINT ROAD, MANCHESTER-BY-THE-SEA**
servicing the MAIN HOUSE and CARRIAGE HOUSE

RE: 35 Coolidge Point – Main House & Carriage House
Manchester-by-the-Sea, MA

Title 5 Official Inspection Form

35 Coolidge Point - Main House

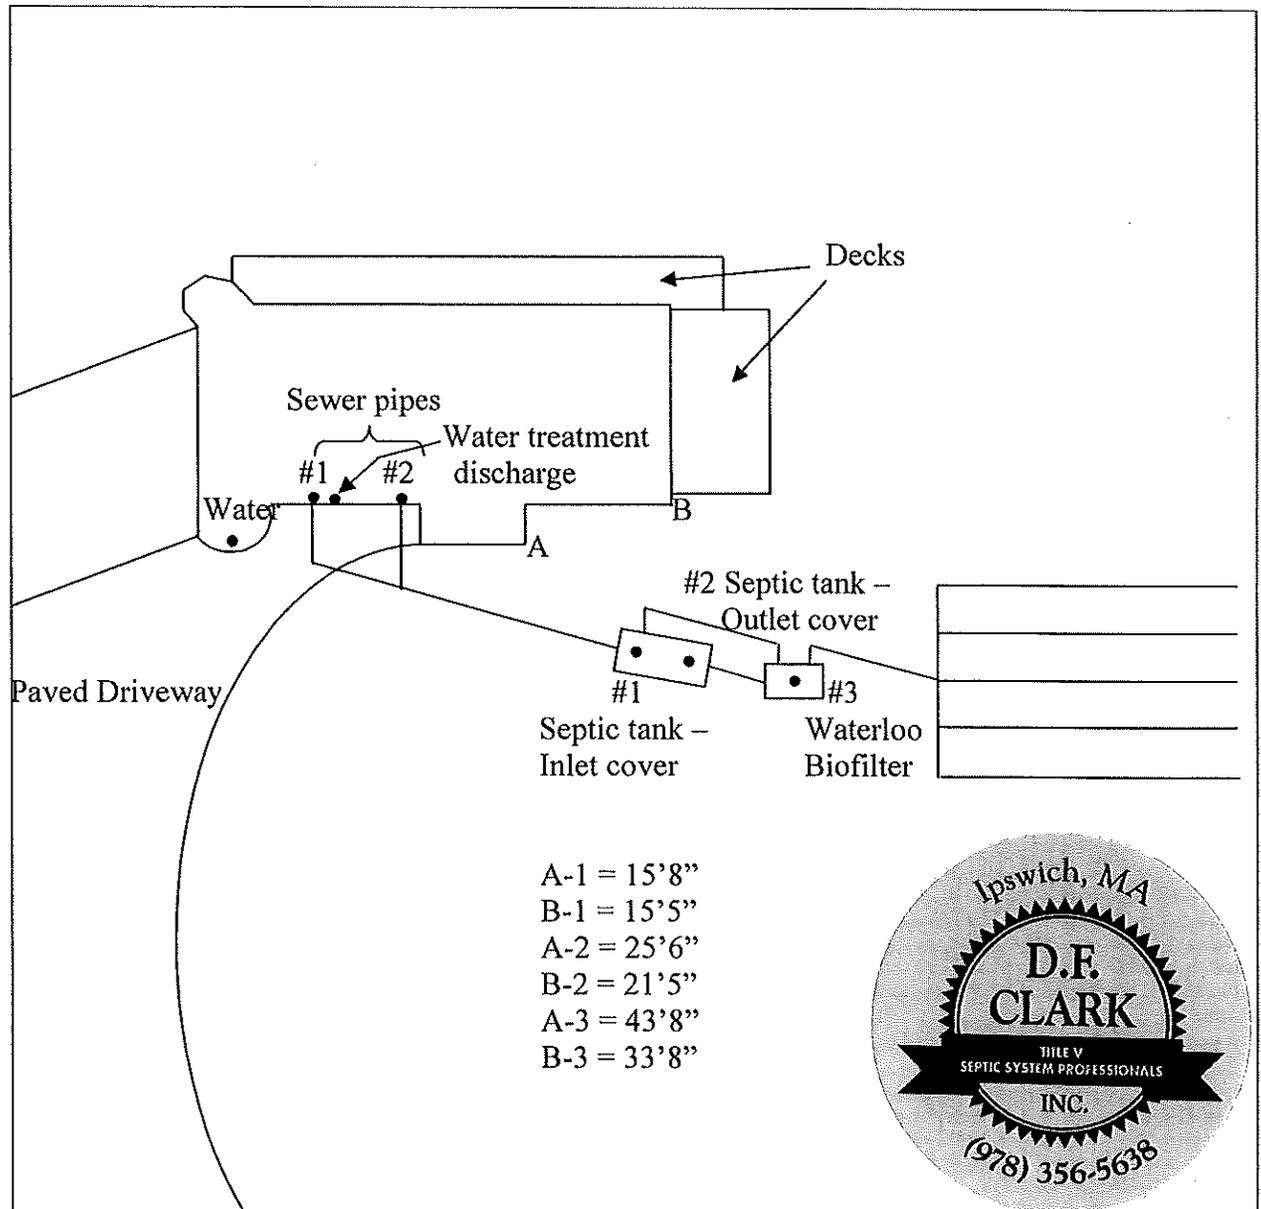
Provide a view of the sewage disposal system, including ties to at least two permanent reference landmarks or benchmarks. Locate all wells within 100 feet. Locate where public water supply enters the building. Check one of the boxes below:

When Jim Scanlan performed soil testing on June 3, 2004, ESHGW was observed in four (4) holes:

T-1B @ 44", T-2B @ 74", T-3B @ 46" and T-5B @ 0". According to design plan the bottom of the
SAS @ elevation 44.0 is 4' above the ESHGW in hole T-5B @ elevation 4.0. At time of inspection a
site exam was made, site is level, no surface water was observed, cellar was dry with no sump pump,
and no shallow wells were located.

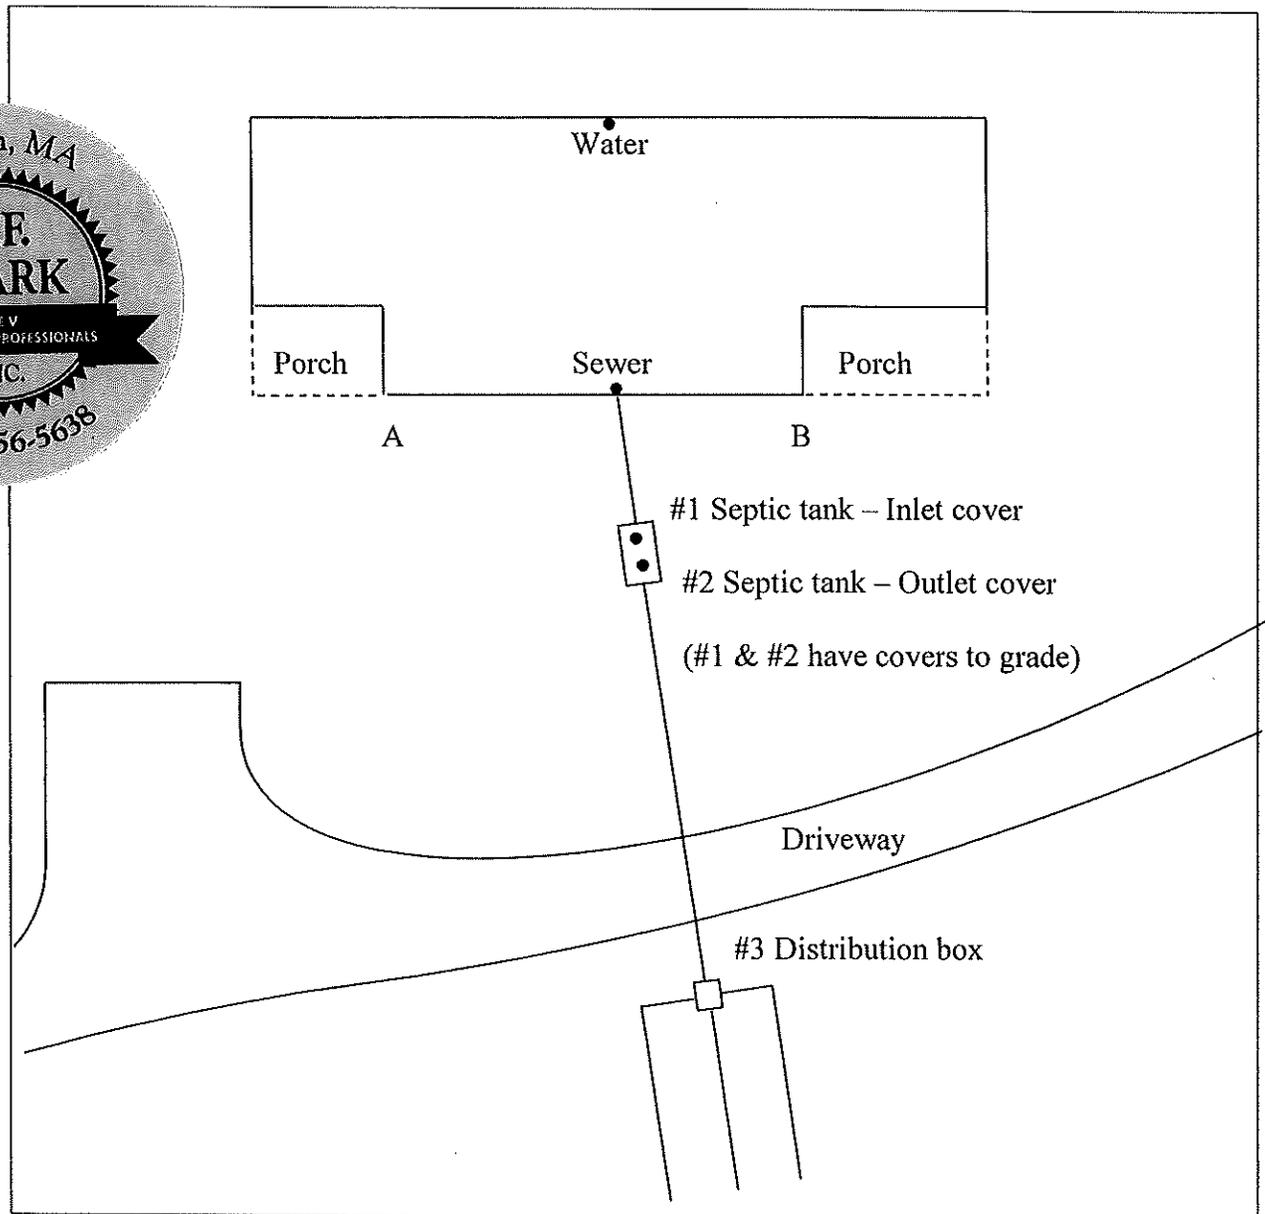
The as-built on file with the Board of Health is dated September 25, 2020. The septic tank and distribution box were replaced and the SAS was existing. Age of SAS is unknown.

Provide a view of the sewage disposal system, including ties to at least two permanent reference landmarks or benchmarks. Locate all wells within 100 feet. Locate where public water supply enters the building. Check one of the boxes below:
