### MANCHESTER-BY-THE-SEA

### NOTIFICATION TO OWNER ACTION REQUIRED

Property Address: 24 MAGNOLIA AVENUE, MANCHESTER-BY-THE-SEA

### Title 5 Official Inspection Form

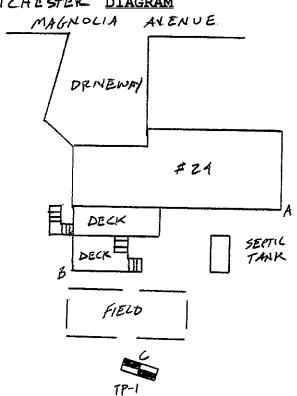
TEST PIT #1

0-60" A/FILL (LS)

60" - 63" O LOAM 104RZ/1

63"-67" E LS 2.546/3

67'-76" C, M-COS 10YR 416

63" ESHWT (2.546/2,7.5425/8)

70" OBS, GW (WEEPING) 76" OBS, GW (STANDING)
