## STRUCTURES INSPECTION FIELD REPORT

2-DIST <b>04</b>	B.I.N. <b>8AM</b>	<b>SPECIAL MEMBER INSPECTION</b>	BR. DEPT. NO. <b>M-02-001</b>
---------------------	----------------------	----------------------------------	----------------------------------

CITY/TOWN <b>MANCHESTER</b>	8-STRUCTURE NO. <b>M02001-8AM-MUN-BRI</b>	11-Kilo. POINT <b>000.000</b>	90-ROUTINE INSP. DATE <b>Nov 15, 2018</b>	93*-SPEC. MEMB. INSP. DATE <b>Nov 21, 2019</b>
07-FACILITY CARRIED <b>ST127 CENTRAL ST</b>	MEMORIAL NAME/LOCAL NAME		27-YR BUILT <b>1850</b>	106-YR REBUILT <b>1900</b>
06-FEATURES INTERSECTED <b>WATER SAW MILL BROOK</b>		26-FUNCTIONAL CLASS <b>Urban Minor Arterial</b>	DIST. BRIDGE INSPECTION ENGINEER <b>J. Dideo</b>	
43-STRUCTURE TYPE <b>811 : Masonry Arch - Deck</b>	22-OWNER <b>Town Agency</b>	21-MAINTAINER <b>Town Agency</b>	TEAM LEADER <b>J. Kelleher, P.E.</b>	PROJ MGR <b>Bayside Engineering Inc</b>
107-DECK TYPE <b>N : Not applicable</b>	WEATHER <b>SUNNY</b>	TEMP. (air) <b>9°C</b>	TEAM MEMBERS <b>R. TOMKINS</b>

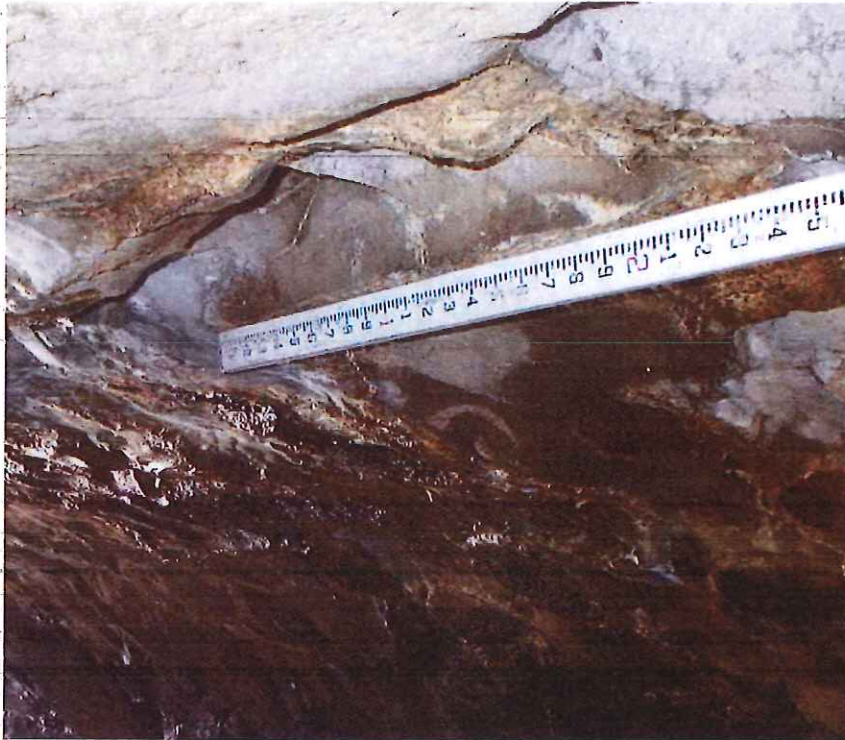
Keystones are missing throughout the arch barrel. The missing keystone areas are covered in shotcrete which appears unchanged since the previous inspection. Specific deficiencies relating to the missing keystones are as follows:

- 2'-6" From North Fascia (See Photo 1)
  - 24" long x 9" wide x 6" deep void
- 7'-0" From North Fascia (See Photo 2)
  - 24" long x 9" wide x 5" deep void
- 14'-0" From North Fascia (See Photo 3)
  - 12" long x 8" wide x 6" deep void
  - Stones surrounding void settled up to 6"
- 17'-0" From North Fascia (See Photo 4)
  - 6" long x 12" wide x 9" deep void
- 22'-0" From North Fascia (See Photo 5)
  - 5' long x 12" wide x 6" deep void

**Photo 1:** 2'-6" From North Fascia: 24" long x 9" wide x 6" deep void

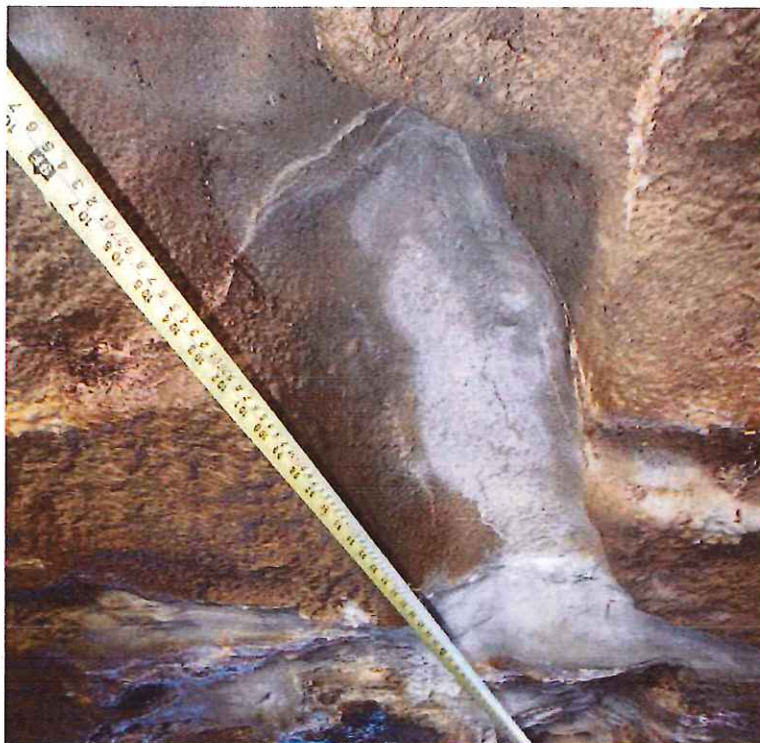
**Photo 2:** 7'-0" From North Fascia: 24" long x 9" wide x 5" deep void

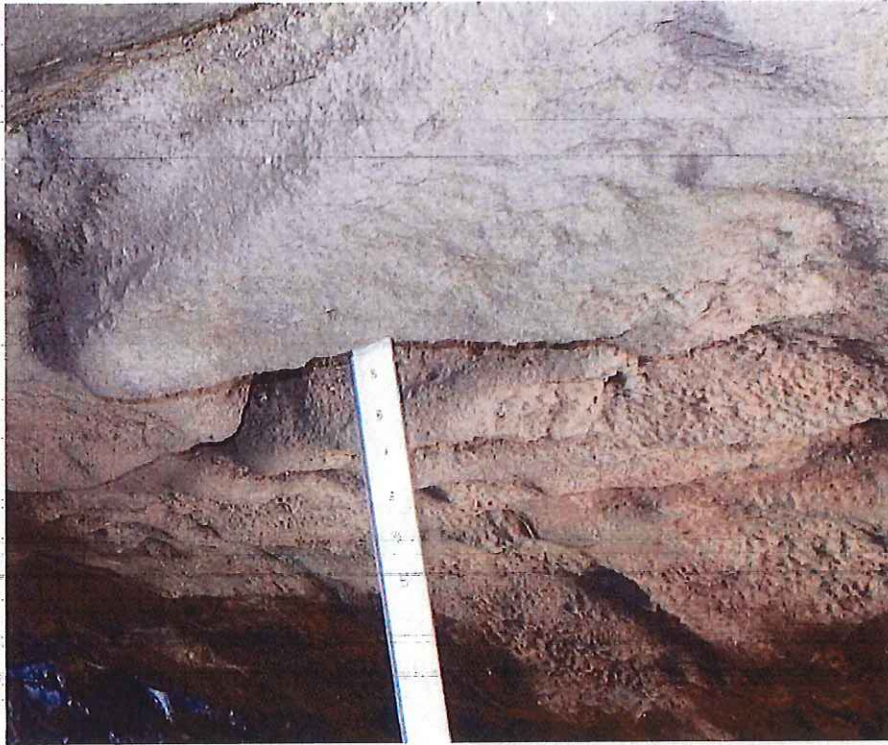
**Photo 3:** 14'-0" From North Fascia: 12" long x 8" wide x 6" deep void; stones surrounding void settled up to 6"

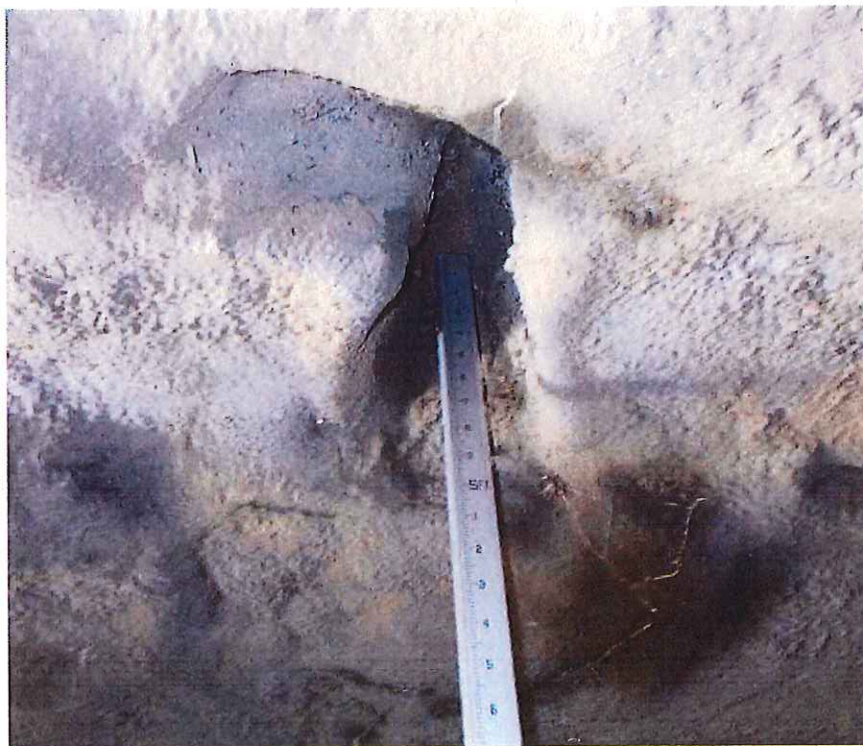
**Photo 4:** 17'-0" From North Fascia: 6" long x 12" wide x 9" deep void

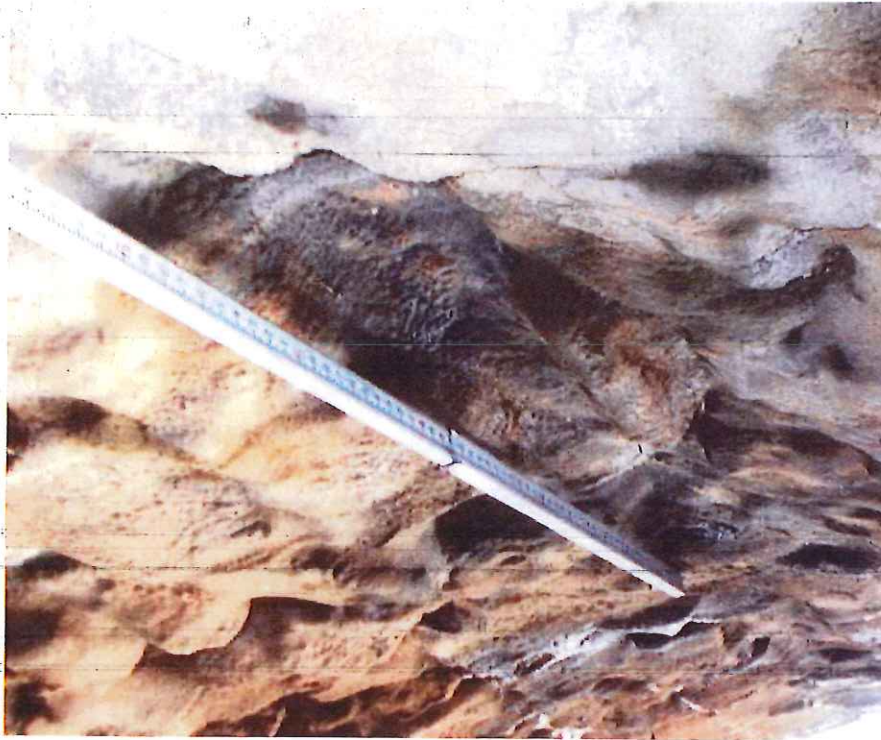
**Photo 5: 22'-0" From North Fascia: 5' long x 12" wide x 6" deep void**
