STRUCTURES INSPECTION FIELD REPORT

2-DIST 04 B.I.N. 8AM

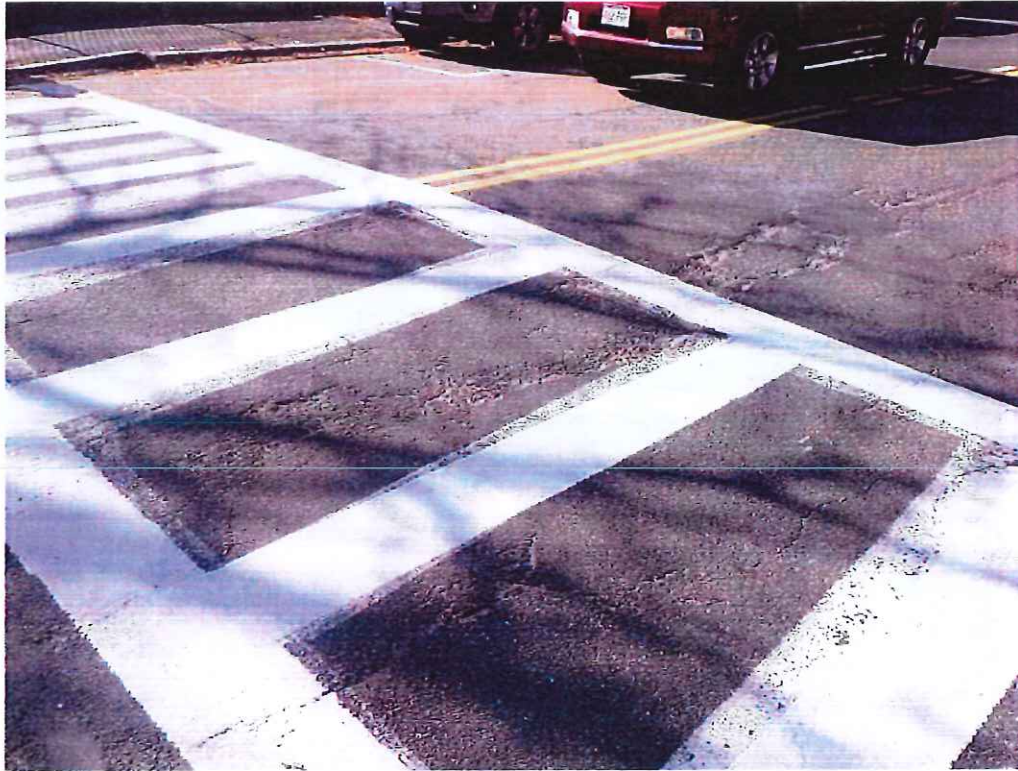
Photo 7: Wearing Surface- Westbound Lane: Heavy wear full length x 18" wide x 1/2" deep with scattered cracking.

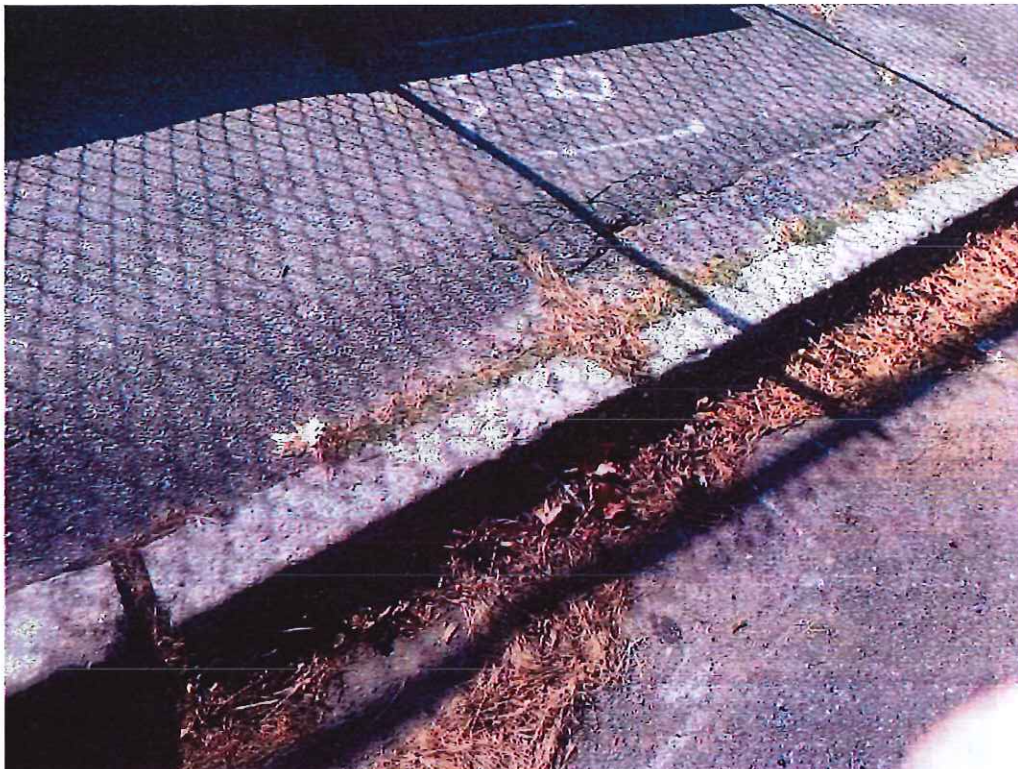
Photo 8: Sidewalks - South Sidewalk: Area of cracks up to 1-1/2" wide.

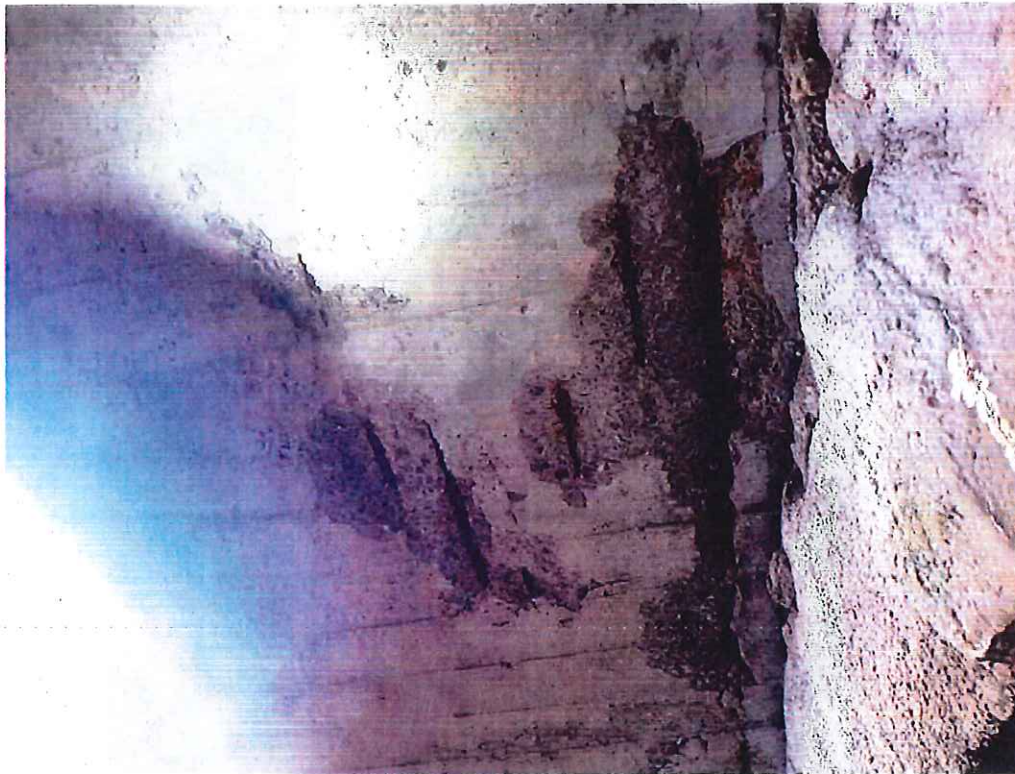
**Photo 9:** Sidewalks - Underside of South Sidewalk: Widespread deminalation, spalling, and exposed reinforcement. Spalling up to 8'-6" long x 15" wide x 1-1/2" deep adjacent to spandrel wall.

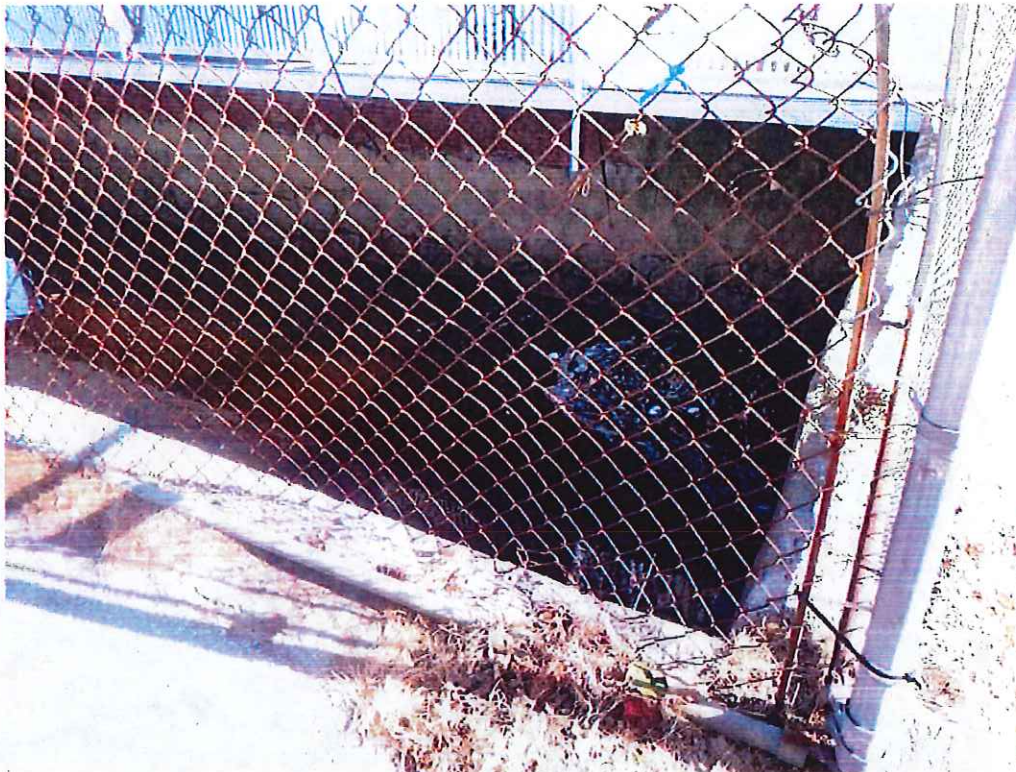
**Photo 10:** Railing - Northwest Corner: Chain link fabric is unsecured along bottom rail for 5'-0" length resulting in a potential gap and fall hazard.

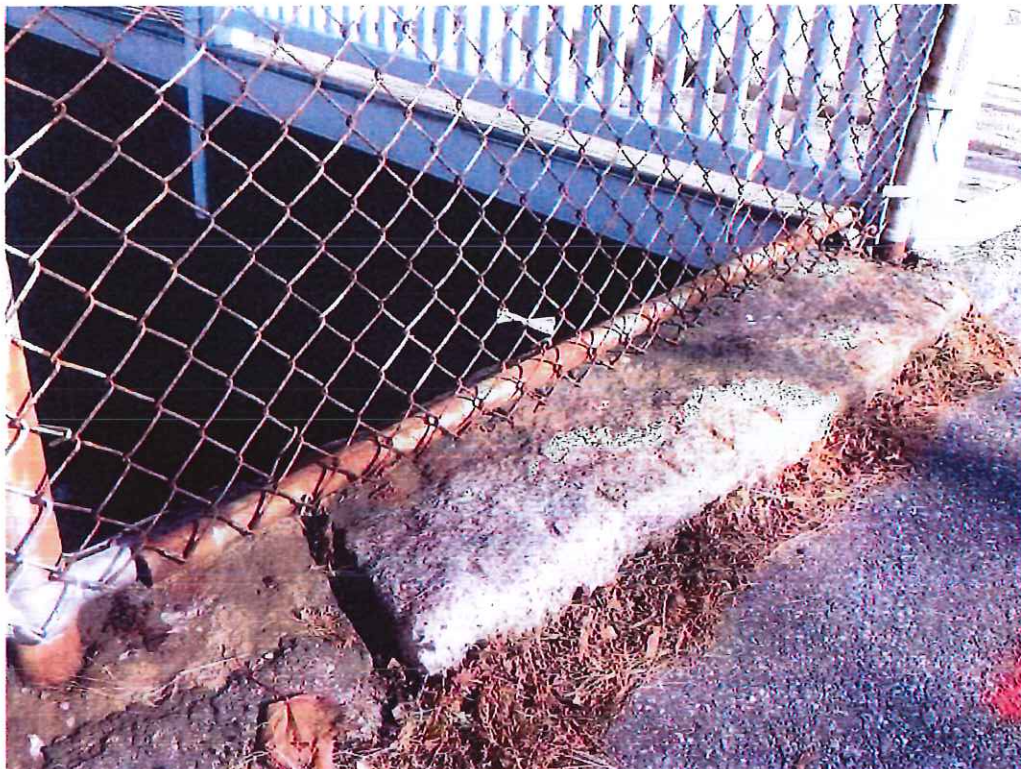
**Photo 12:** Railing - Northeast Panel: The bottom railing is detached from the receivers and hangs loosely.

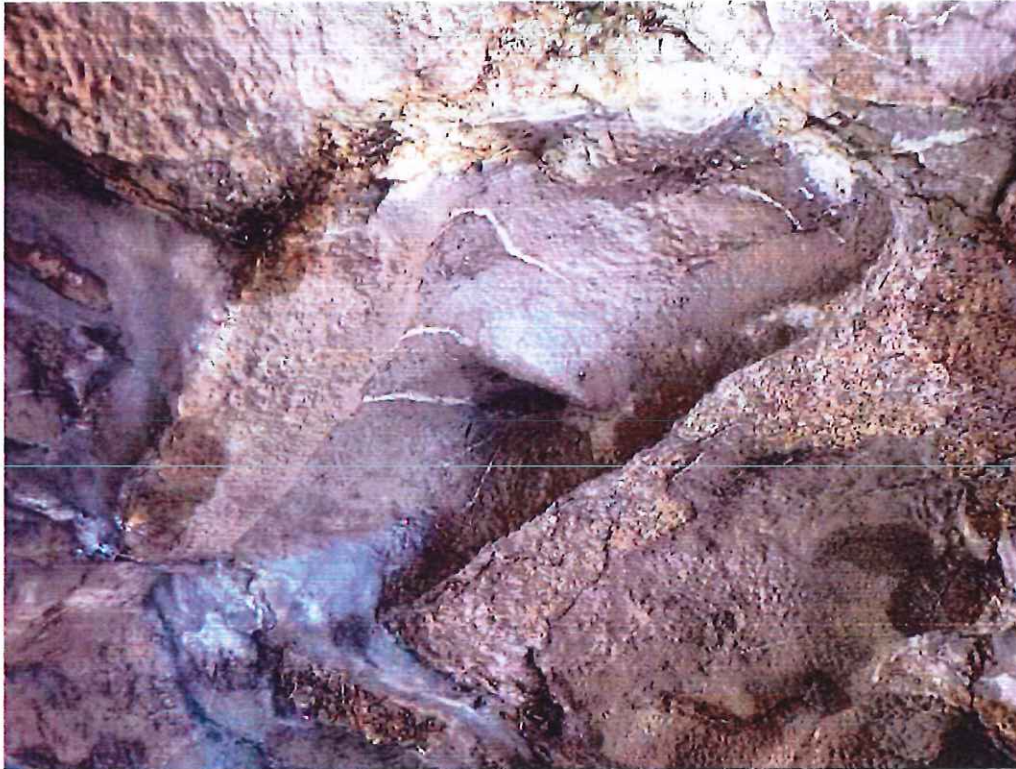
**Photo 15:** Keystone Area - 2'-6" from north fascia: Missing keystones resulting in a 2'-0" long x 9" wide x 6" deep void.

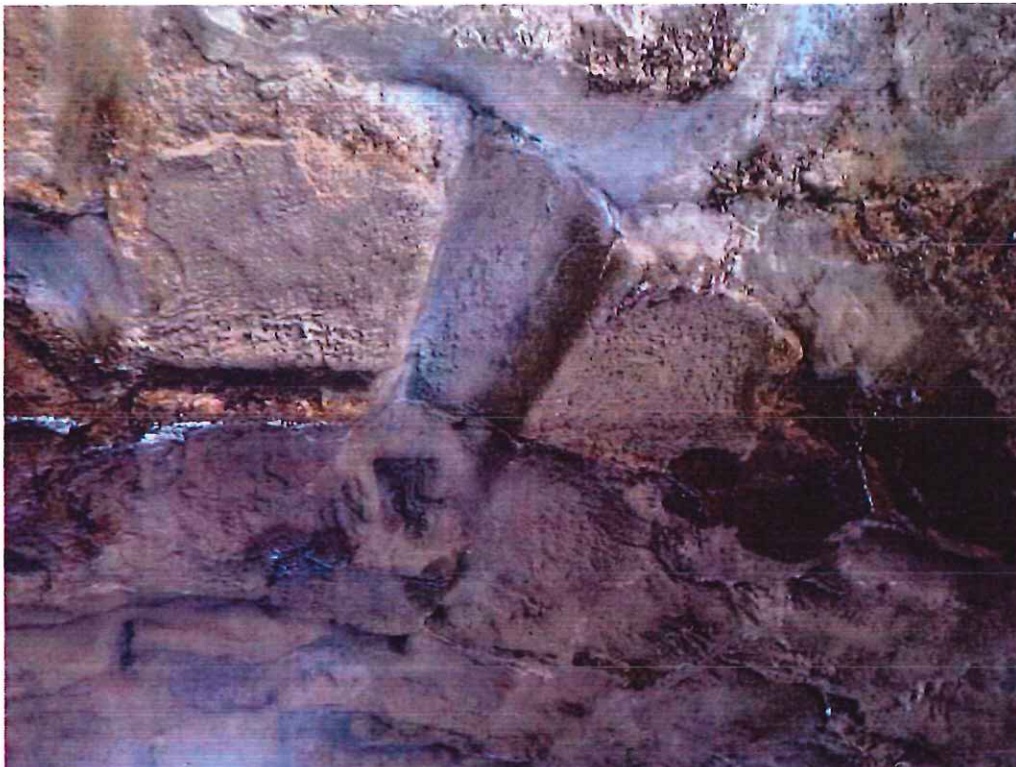
**Photo 16:** Keystone Area - 7'-0" from north fascia: Missing keystones resulting in a 3'-0" long x 9" wide x 6" deep void.

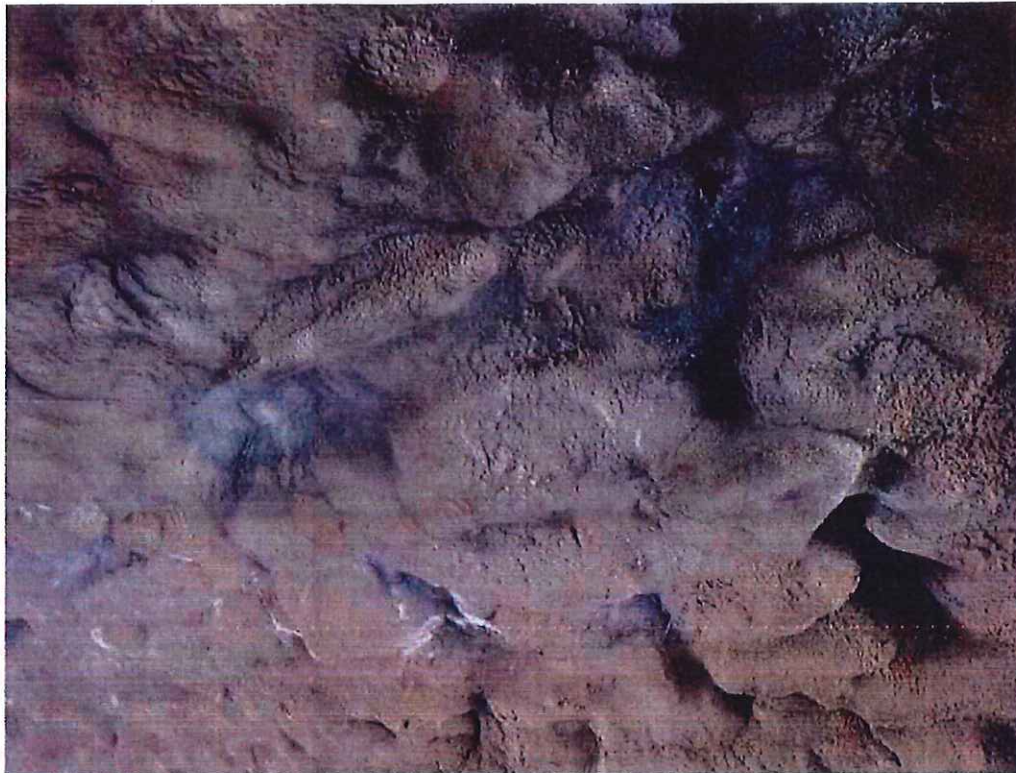
**Photo 17:** Keystone Area - 22'-0" from north fascia: Missing keystones resulting in a 5'-0" long 12" wide x 6" deep void.

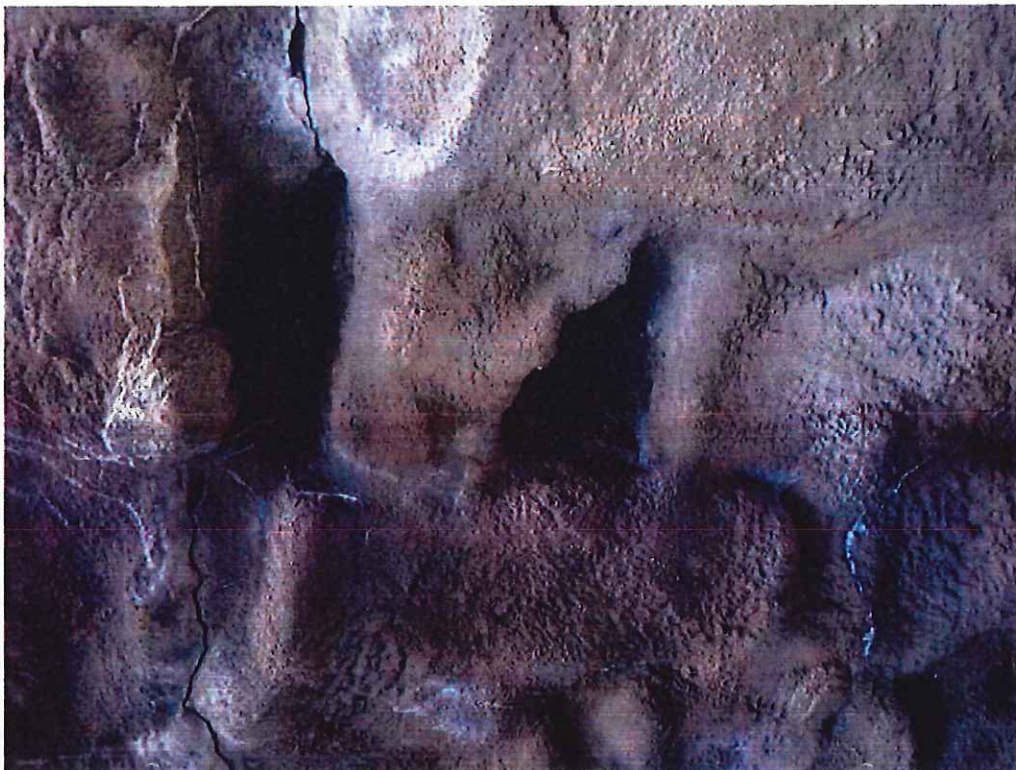
**Photo 18:** Keystone Area: 35'-0" from north fascia: Two missing keystones resulting in voids up to 7" long x 11" wide x 8" deep.

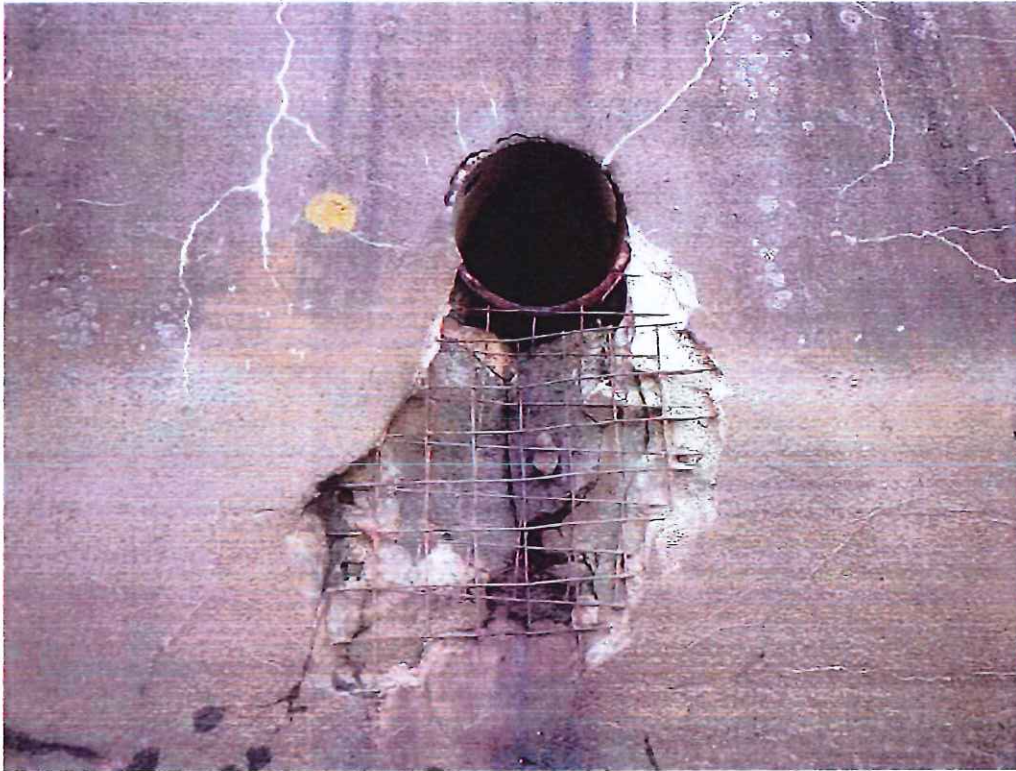
**Photo 19:** Spandrel Walls - West side of north wall: Spall in shotcrete under drain pipe, 2'-0" wide x 2'-0" high x 3-1/2" deep with exposed wire mesh.

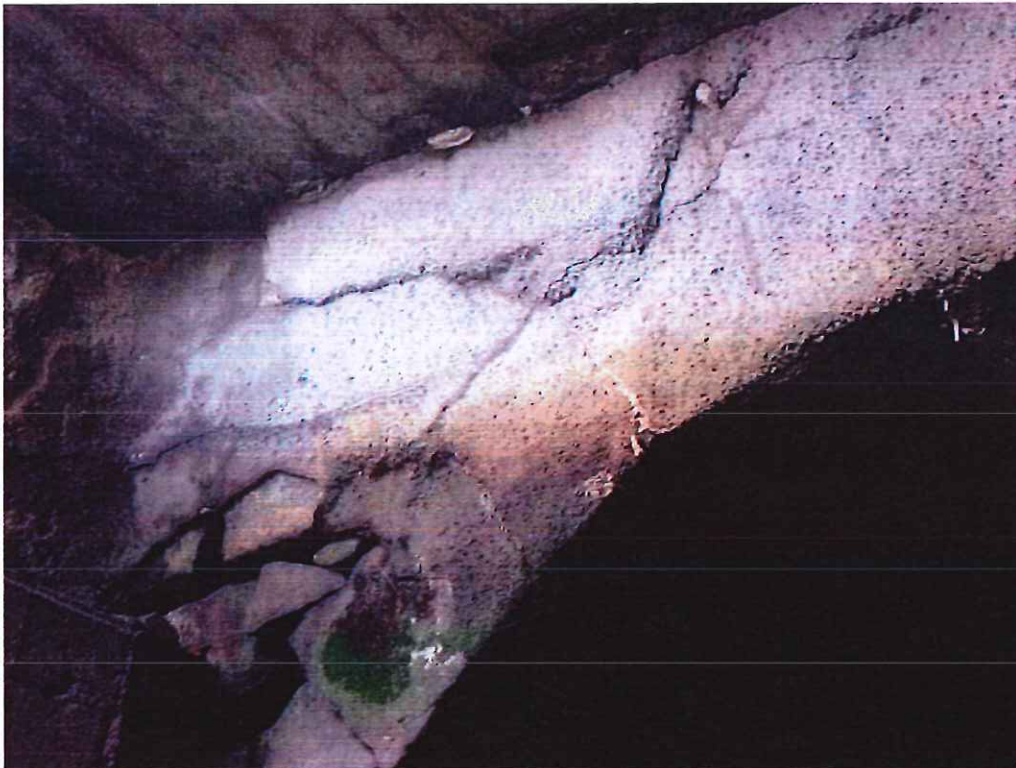
**Photo 20:** Spandrel Walls - East side of south wall: Missing shotcrete resulting in visible voids between masonry stones up to 21" deep. Surrounding shotcrete has areas of cracking and efflorescence.

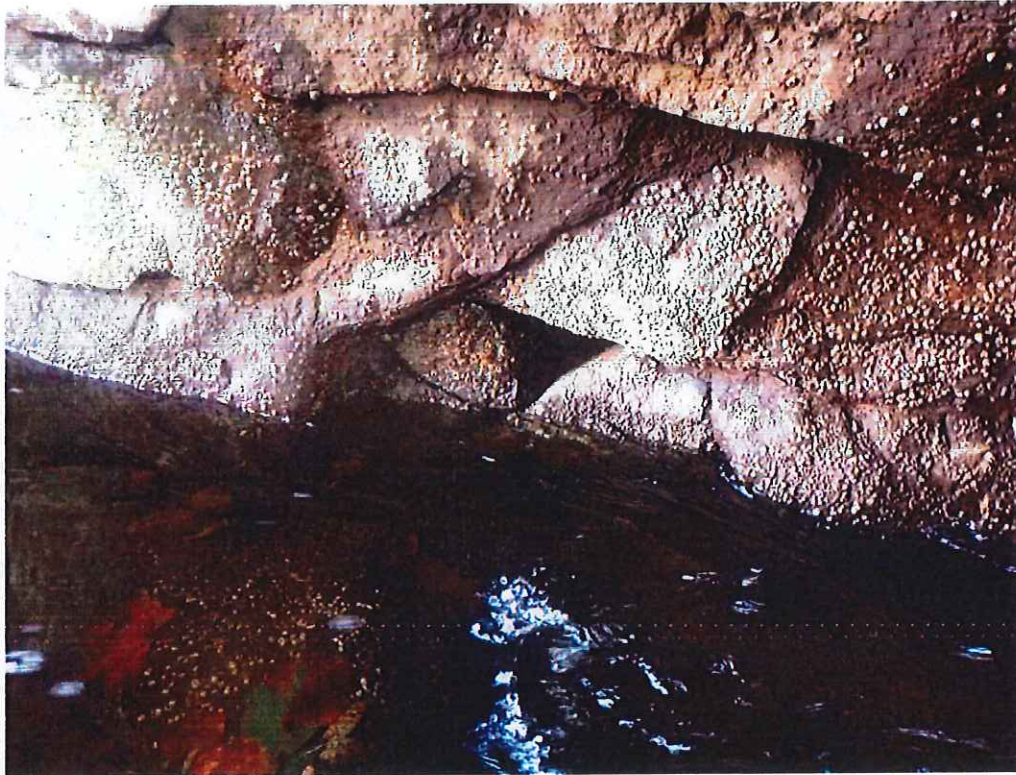
**Photo 21:** Spring Line - 9'-0" south of north fascia: East spring line with a void 24" wide x 10" high x 10" deep due to missing stone.

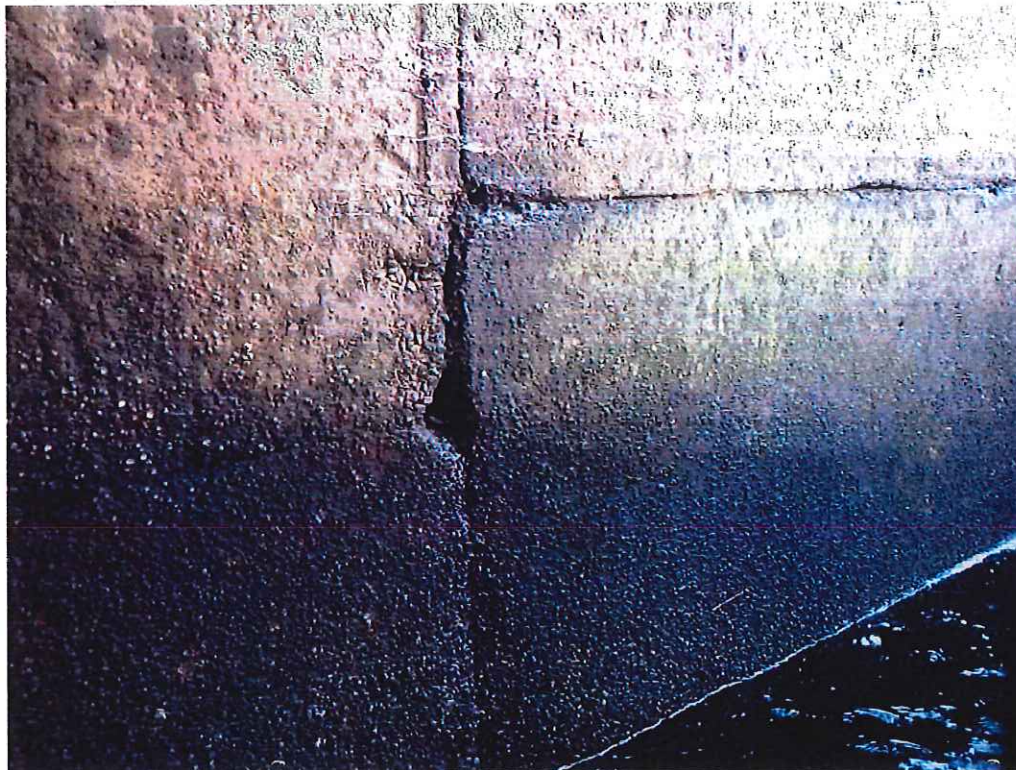
**Photo 22:** Wingwalls - Southeast Wingwall: Spalling at construction joints has resulted in a void 3" wide x 6" high x 6" deep. Typical scaling 1/16" deep covers walls.

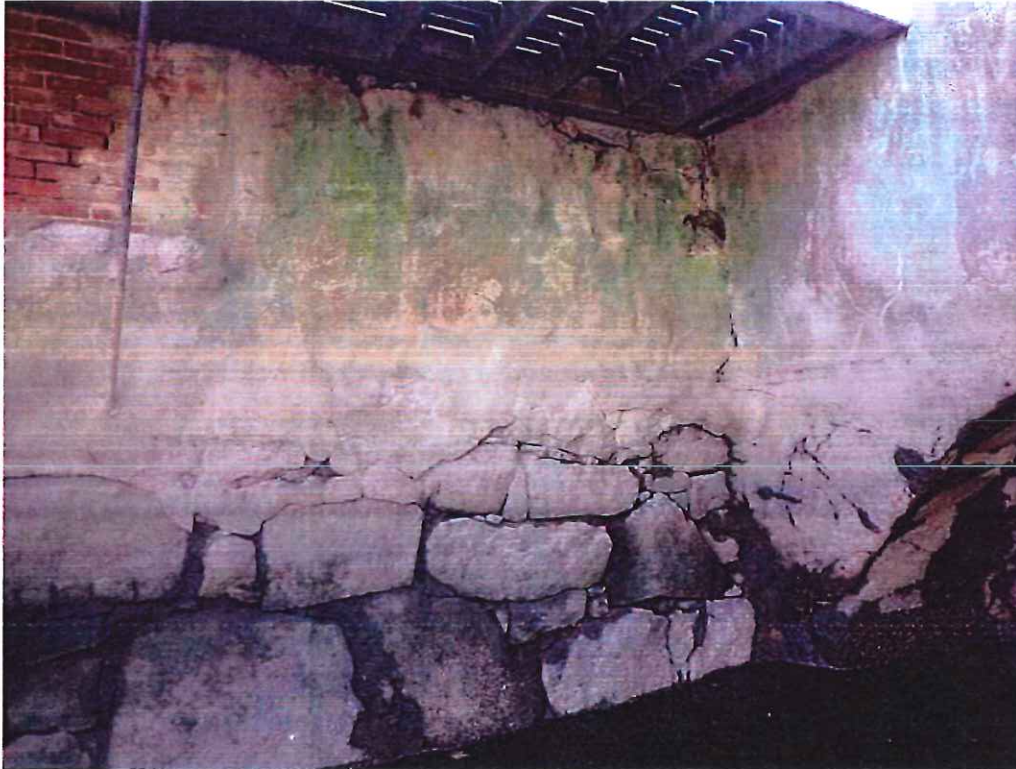
Photo 23: Wingwalls - Northeast Wingwall: Cracking and isolated hollow areas in shotcrete at the top of the stone masonry. Voids between stones up to 21" deep.
