B.I.N.
8AM

STRUCTURES INSPECTION FIELD REPORT
SPECIAL MEMBER INSPECTION

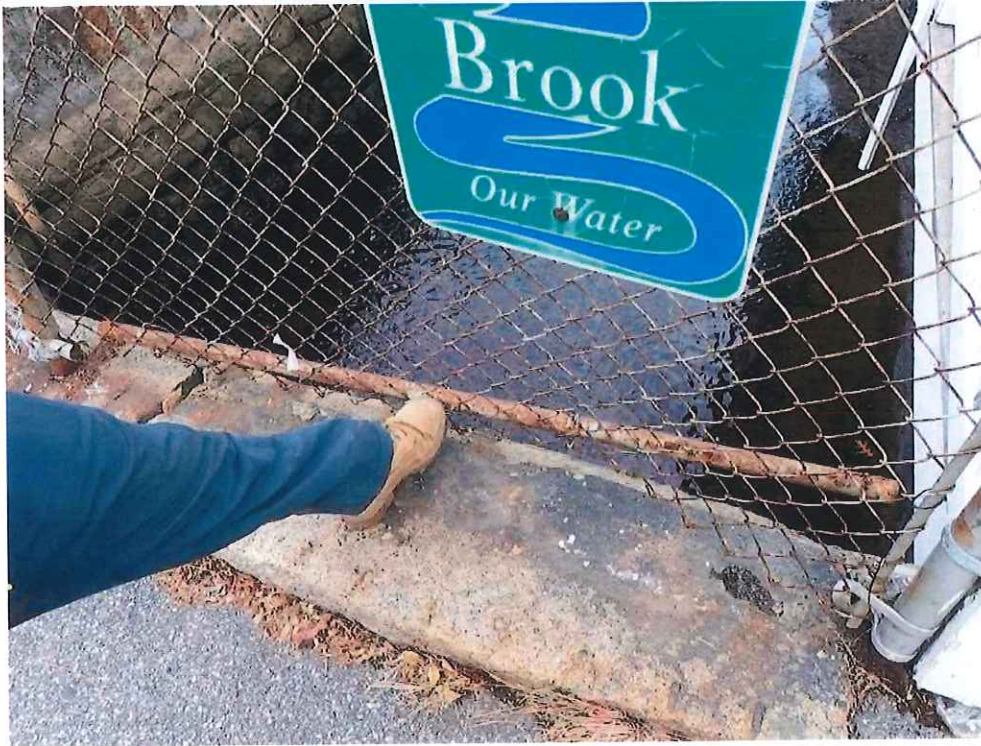
Photo 9: North Elevation Bridge Railing - Northeast Panel: The bottom railing is detached from the receivers and hangs loosely.

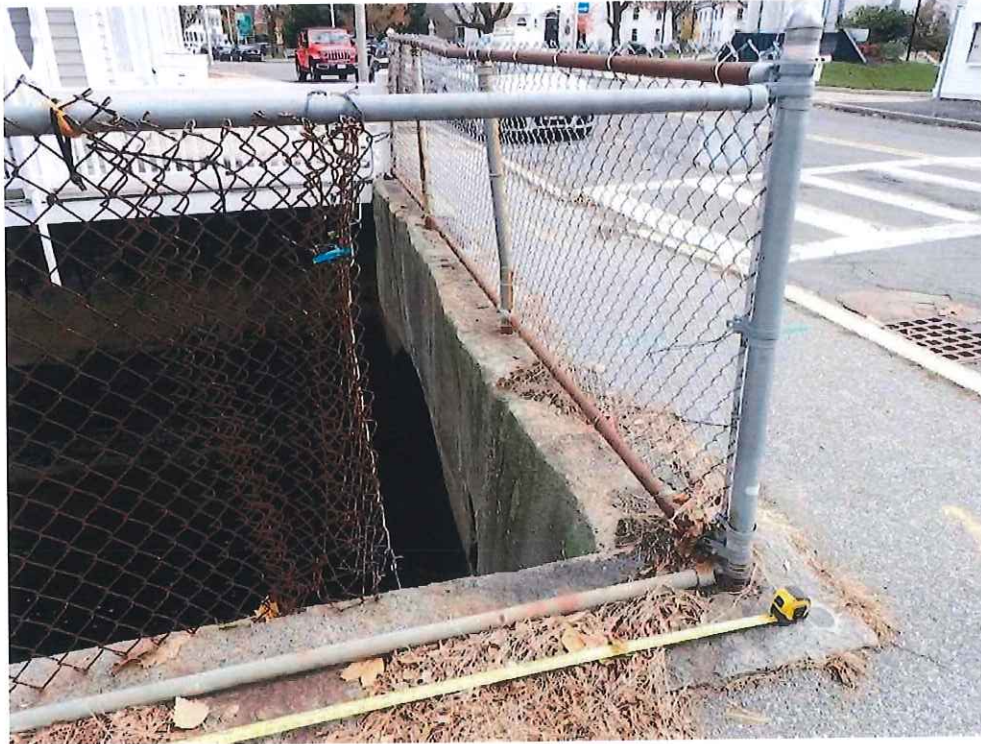
Photo 10: NW Retaining Wall Railing - South Corner: The chain link fabric was unsecured along bottom rail for 6'-0" and disconnected from top rail and corner post for 2'-8" L resulting in a fall hazard of approx. 9 feet.

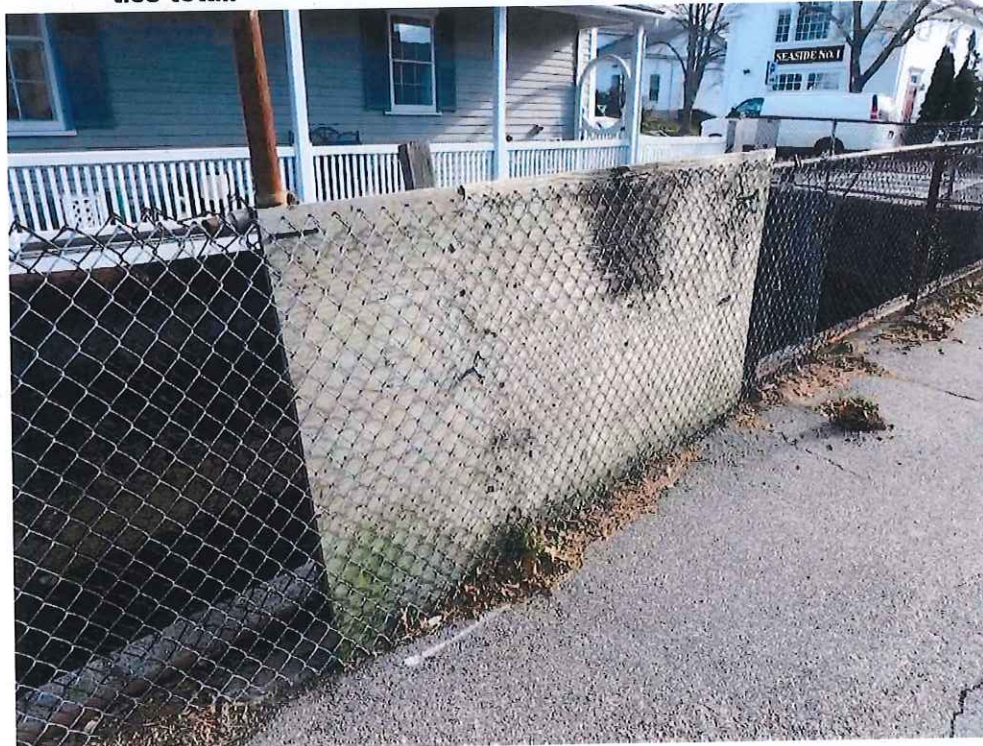
Photo 12: NW Retaining Wall Railing - 5th Panel from South Corner: The Posts and panel are very loose and movable by hand. The panels consists of a plywood board and supplemental chain link fabric.

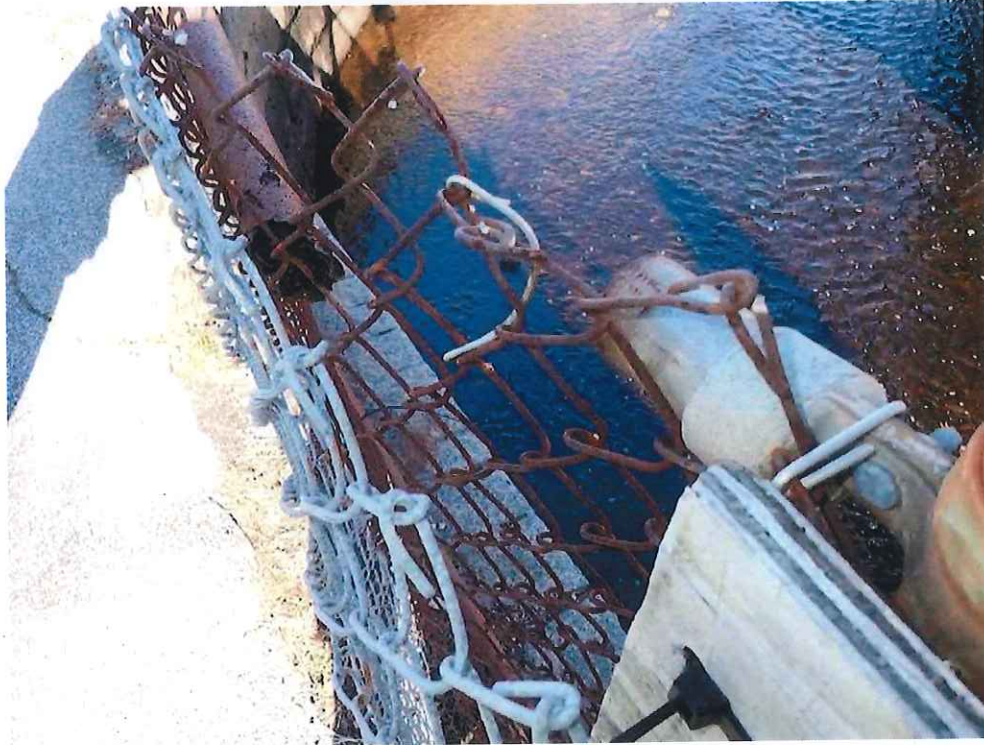
Photo 13: NW Retaining Wall Railing - 6th Panel from South Corner: At the 5th post from the south corner, the top rail has 100% section loss resulting in it being detached from the post and hanging loosely.

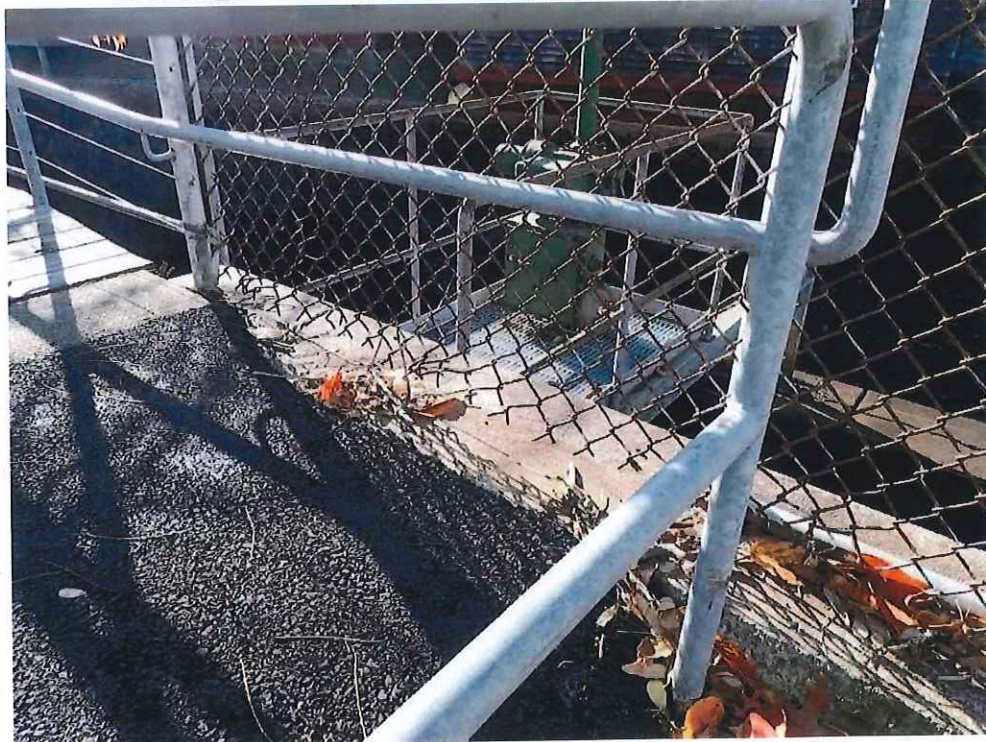
Photo 14: SE Wingwall Railing - 2nd Panel from North: The panel has no bottom rail and there is a gap between the chain link fabric and the top of the wingwall.

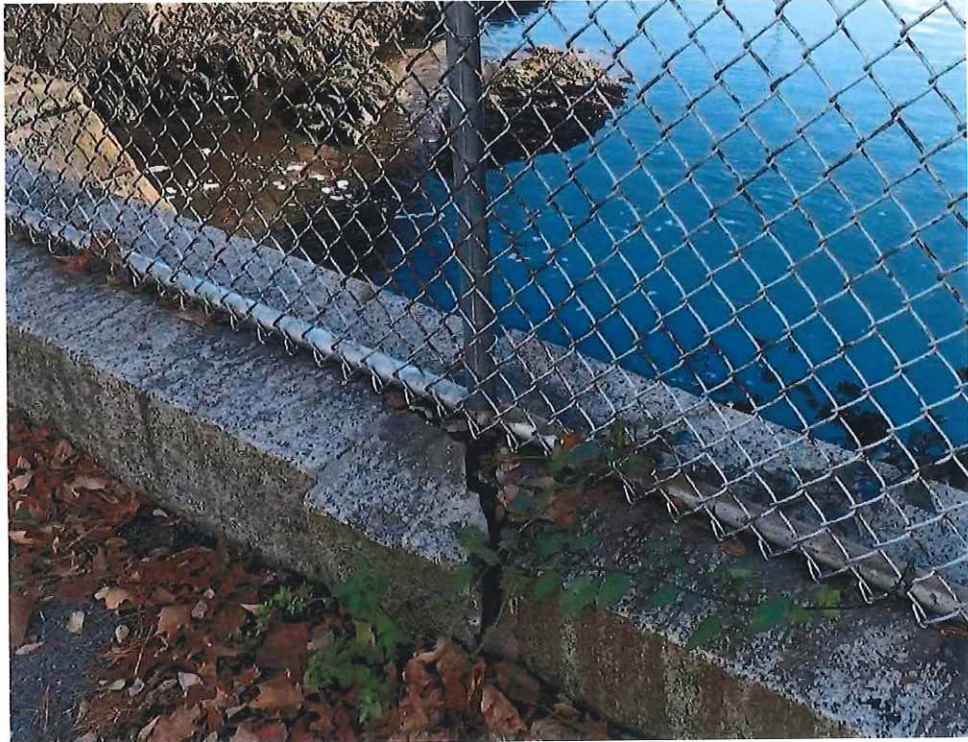
Photo 15: SW Wingwall Railing: The granite rail base is cracked at the 3rd post west of the bridge. Post is loose and appears detached within the base.

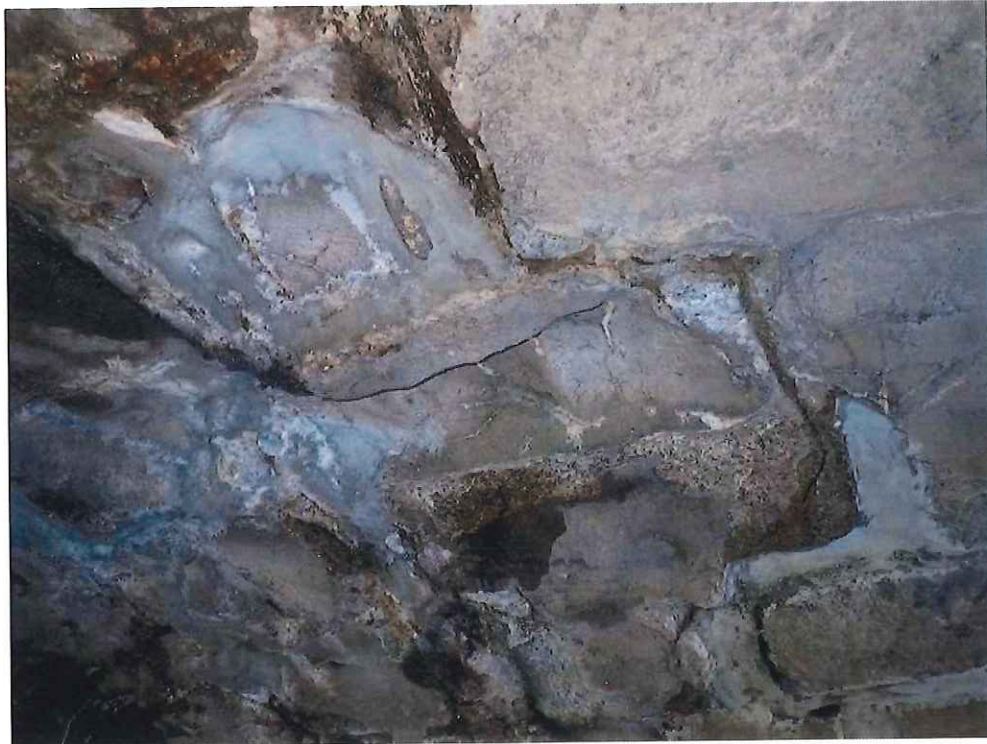
Photo 16: Keystone Area - 2'-6" from North Fascia: Missing keystones resulting in a 2'-0" long x 9" wide x 6" deep void.

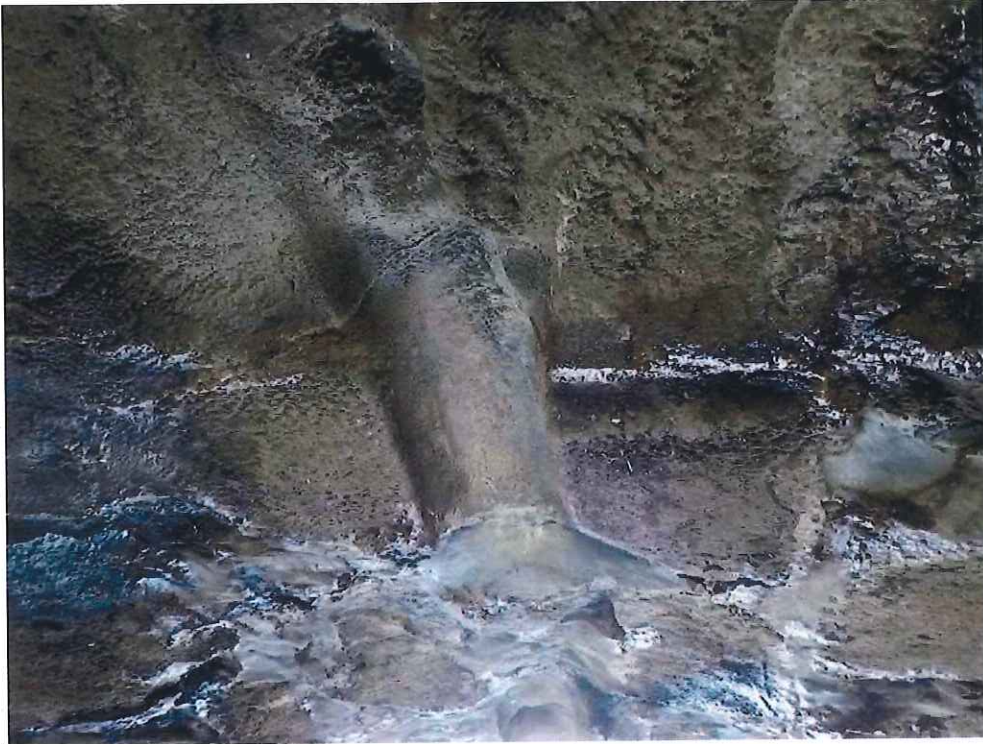
Photo 17: Keystone Area - 7'-0" from North Fascia: Missing keystones resulting in a 3'-0" long x 9" wide x 6" deep void.

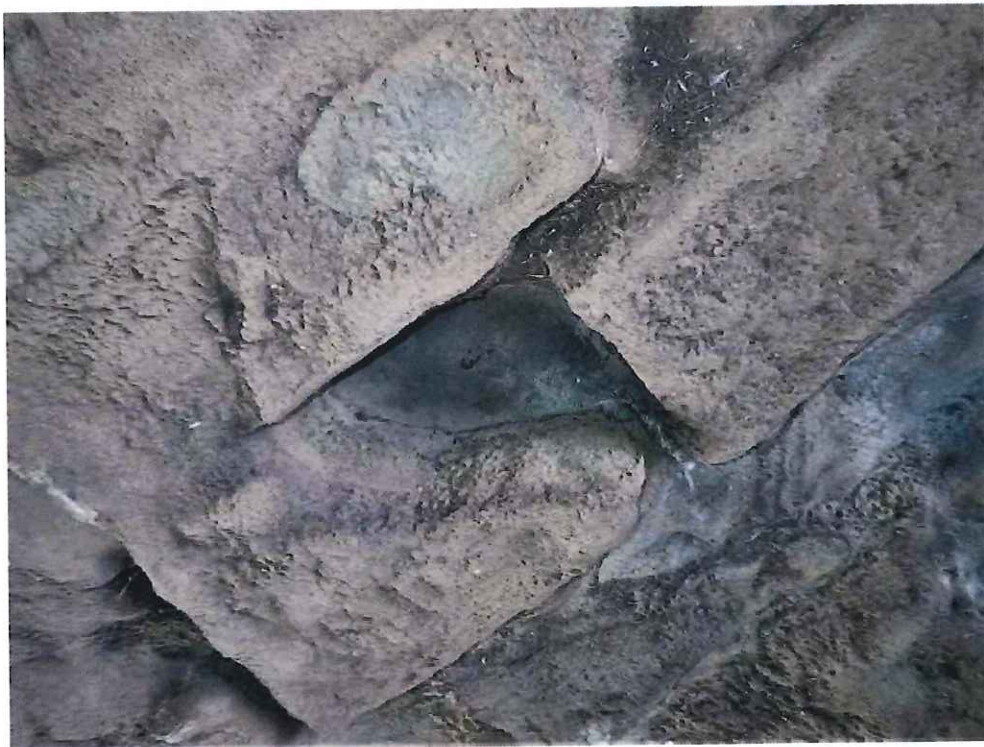
Photo 18: Keystone Area - 14'-0" from North Fascia: Missing keystones resulting in a 12" long x 9" wide x 6" deep void. Stones around void settled up to 6".

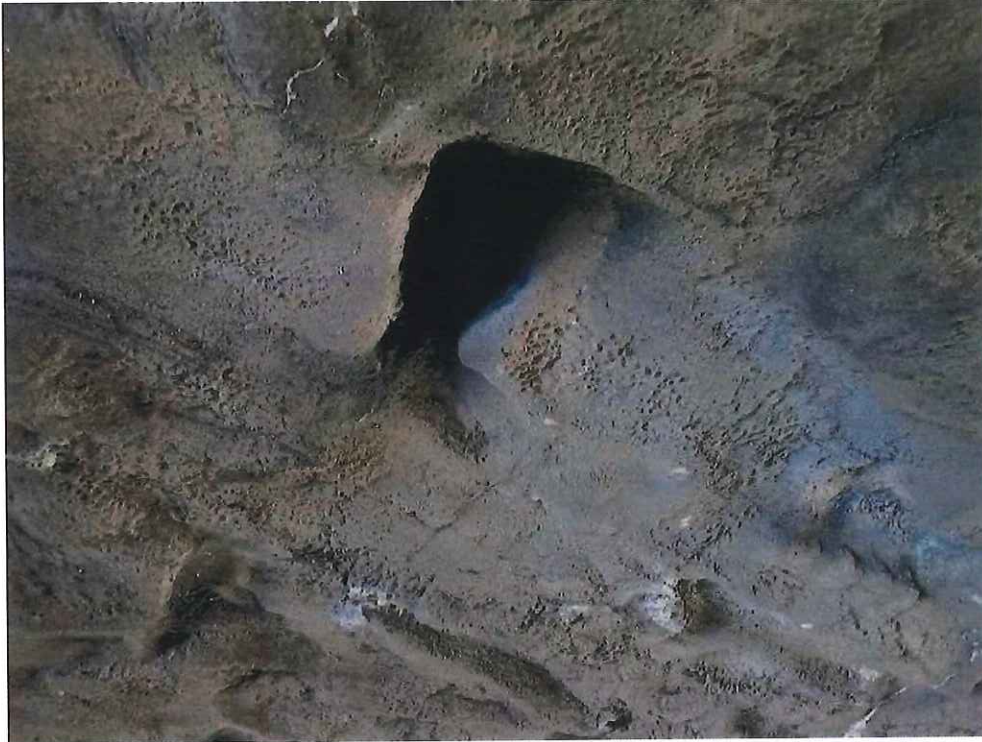
Photo 19: Keystone Area - 18'-0" from North Fascia: Missing keystones resulting in a 6" long x 12" wide x 9" deep void.

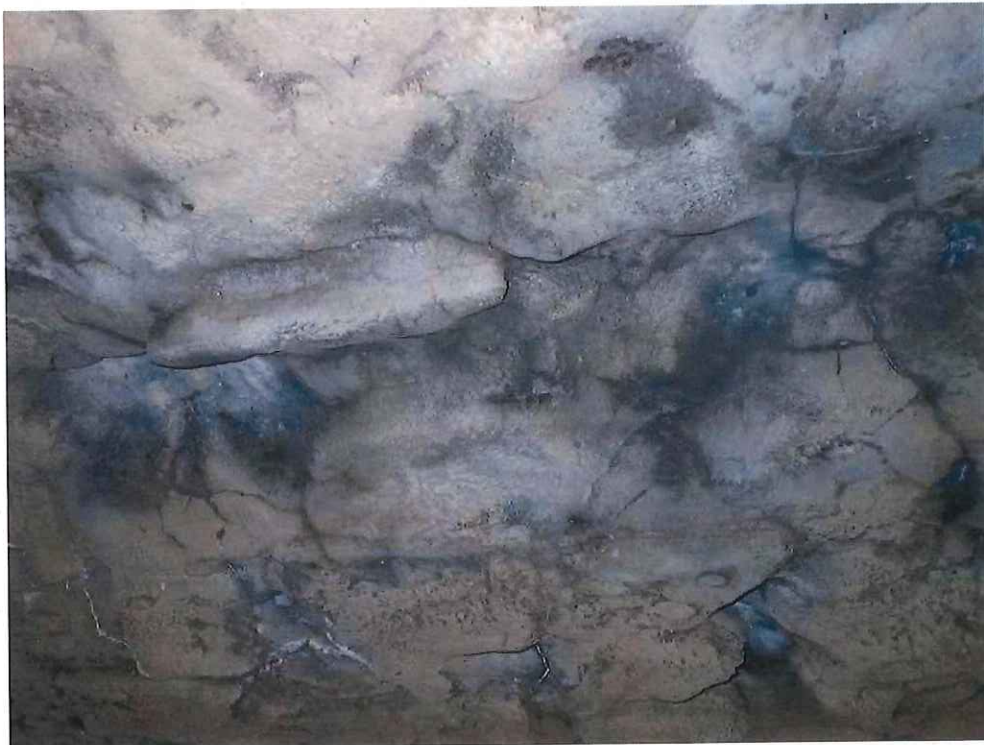
Photo 20: Keystone Area - 22'-0" from North Fascia: Missing keystones resulting in a 5'-0" long x 12" wide x 6" deep void.

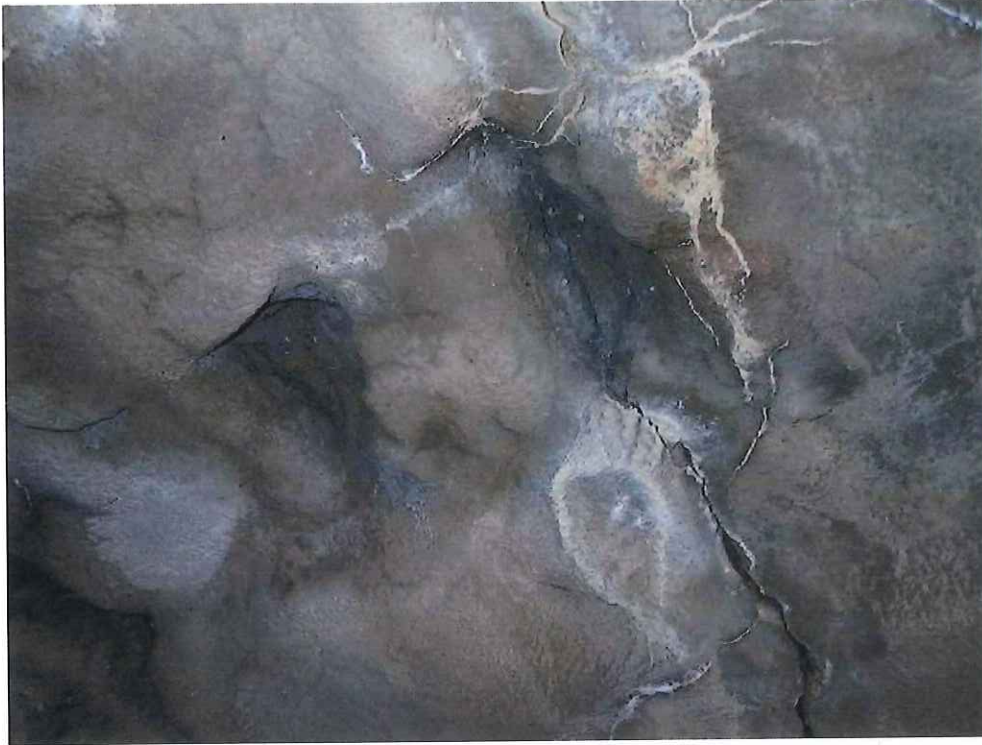
Photo 21: Keystone Area - 35'-0" from North Fascia: Two missing keystones resulting in an up to 7" long x 11" wide x 8" deep void.
