STRUCTURES INSPECTION FIELD REPORT

SPECIAL MEMBER INSPECTION

BR. DEPT. NO.
M-02-001

CITY/TOWN MANCHESTER	8-STRUCTURE NO. M02001-8AM-MUN-BRI	11-Kilo. POINT 000.000	90-ROUTINE INSP. DATE Nov 29, 2022	93*-SPEC. MEMB. INSP. DATE Nov 6, 2023
07-FACILITY CARRIED ST127 CENTRAL ST	MEMORIAL NAME/LOCAL NAME	27-YR BUILT 1850	106-YR REBUILT 1900	*YR REHAB'D (NON 106) 0000
06-FEATURES INTERSECTED WATER SAW MILL BROOK	26-FUNCTIONAL CLASS Urban Minor Arterial	DIST. BRIDGE INSPECTION ENGINEER J. Dideo		
43-STRUCTURE TYPE 811 : Masonry Arch - Deck	22-OWNER Town Agency	21-MAINTAINER Town Agency	TEAM LEADER R. Orlando	
107-DECK TYPE N : Not applicable	WEATHER Cloudy	TEMP. (air) 8°C	TEAM MEMBERS B. RAJBHANDARI

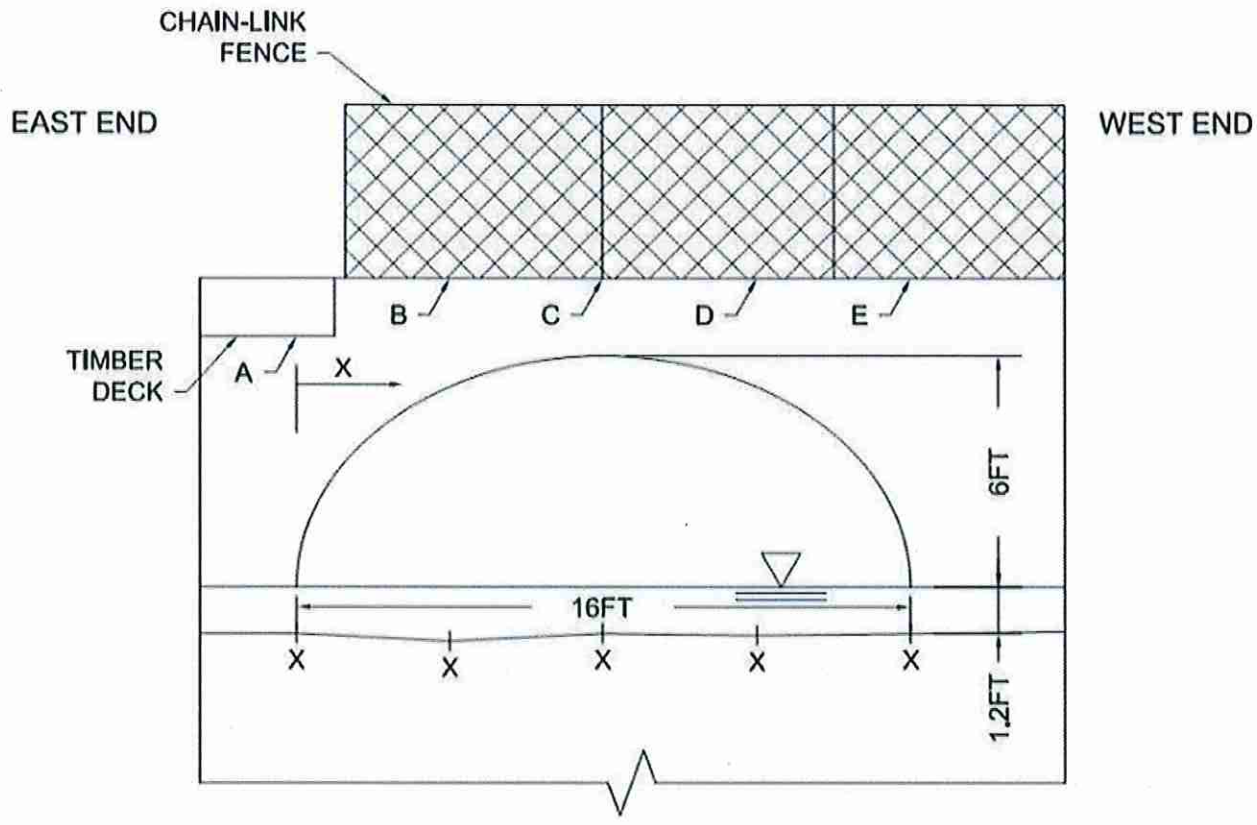
Sketch 2: Upstream Channel Profile.

UPSTREAM CHANNEL PROFILE		
LOCATION	DISTANCE X (% SPAN)	VERTICAL MEASUREMENT *
A	NE FACE (0%)	9.67FT
B	4FT-0IN (25%)	11.0FT
C	8FT-0IN (50%)	11.0FT
D	12FT-0IN (75%)	11.0FT
E	NW FACE (100%)	11.08FT

* ALL MEASUREMENTS ARE 0" to 6" LESS THAN PREVIOUS INSPECTION. THUS, NO SCOUR AND UP TO 6" OF AGGRADATION SINCE PREVIOUS INSPECTION.

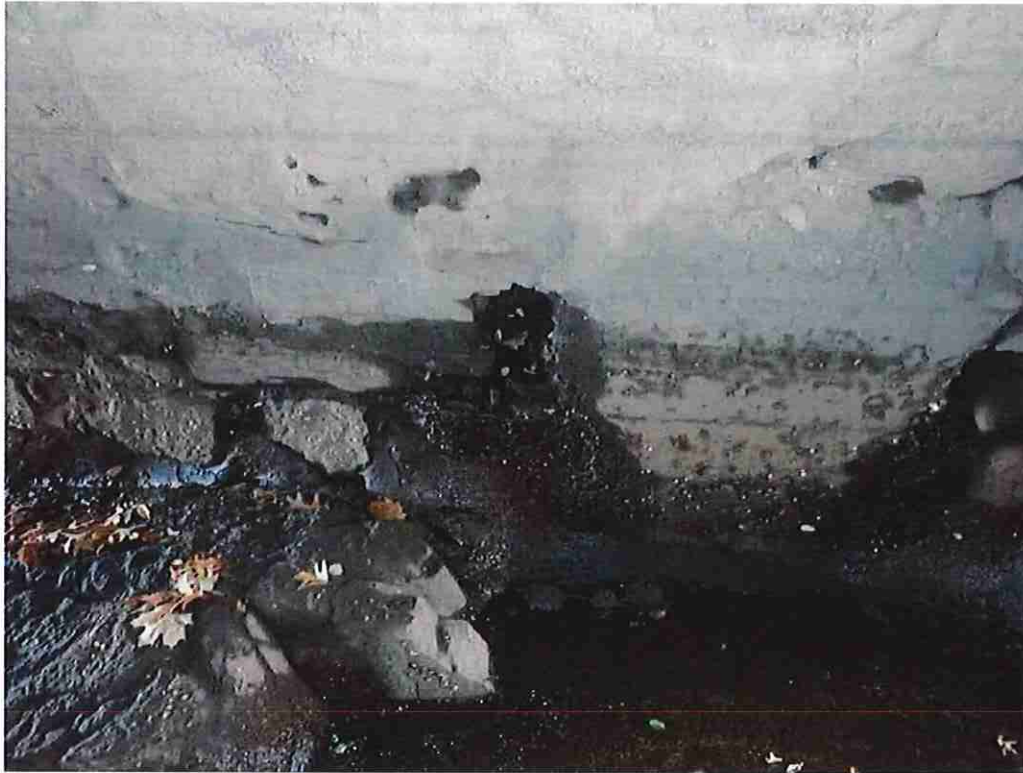
- 14' in from the north fascia: 6" wide x 12" high x 2'-8" deep void located 3' above the west spring line.
- 18' in from the north fascia: 10" diameter x 5' deep void located 3-1/2' above the west spring line (**See Photo 1**).
- 7' in from the south fascia: Full arch length x up to 1/2" wide crack in the shotcrete along arch section interface (**See Photo 2**). At the west spring line, the shotcrete ends resulting in exposed stone masonry with a void between the stones up to 4" wide x 2'-8" deep between the north and south arch section (**See Photo 3**).

Photo 1: Void in the arch at 18' in from the north fascia, 3-1/2' above the west spring line.

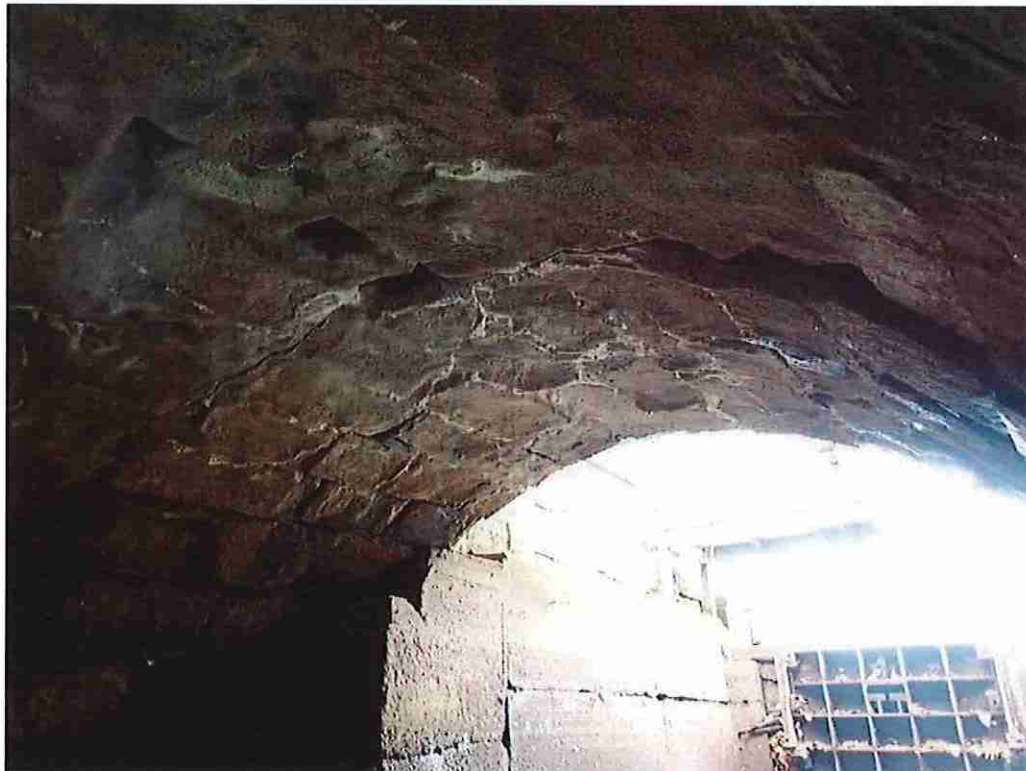
- 7' to 9' from south fascia: Two 7" long x 11" wide x 8" deep voids (See Photo 2).

Photo 2: Full length crack in the arch at 7' in from the south fascia and voids in the keystone area.

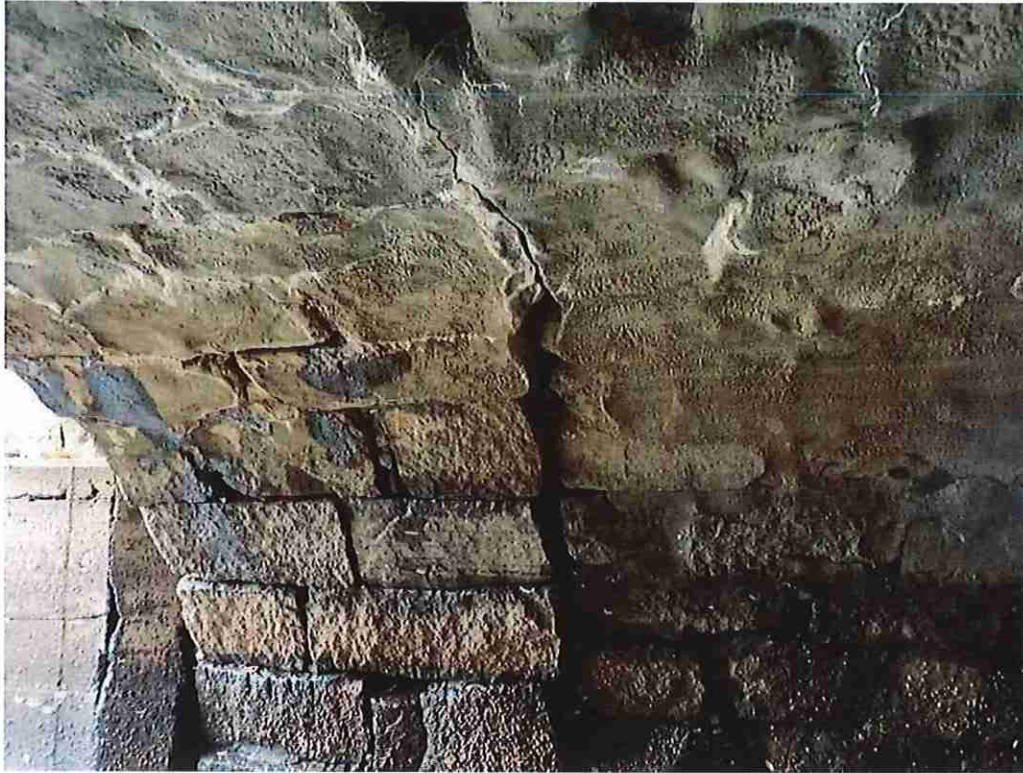
Photo 3: Void above the west spring line at 7' in from the south fascia.

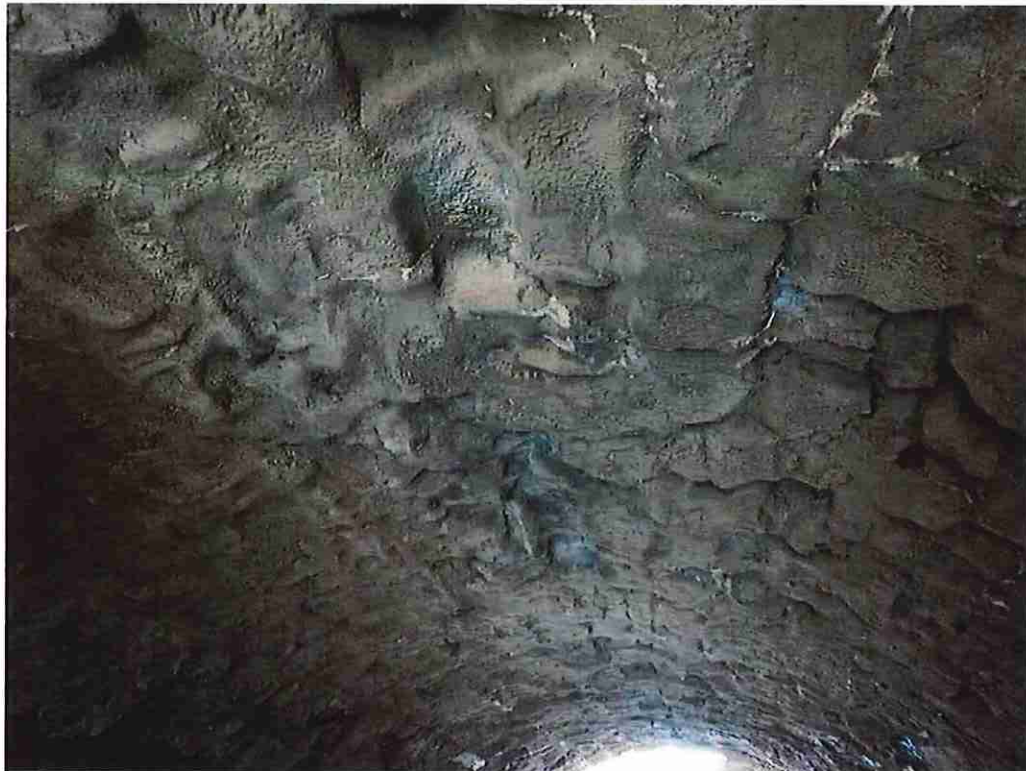
The keystone area, which is covered in shotcrete, has numerous random voids and areas that are uneven, apparently due to broken off and/or missing stones (**See Photo 4**). There has been no change in the appearance of the shotcrete since the previous inspection, indicating no shifting of the keystones. Specific deficiencies are as follows:

Photo 4: Typical voids and unevenness throughout the keystone area.

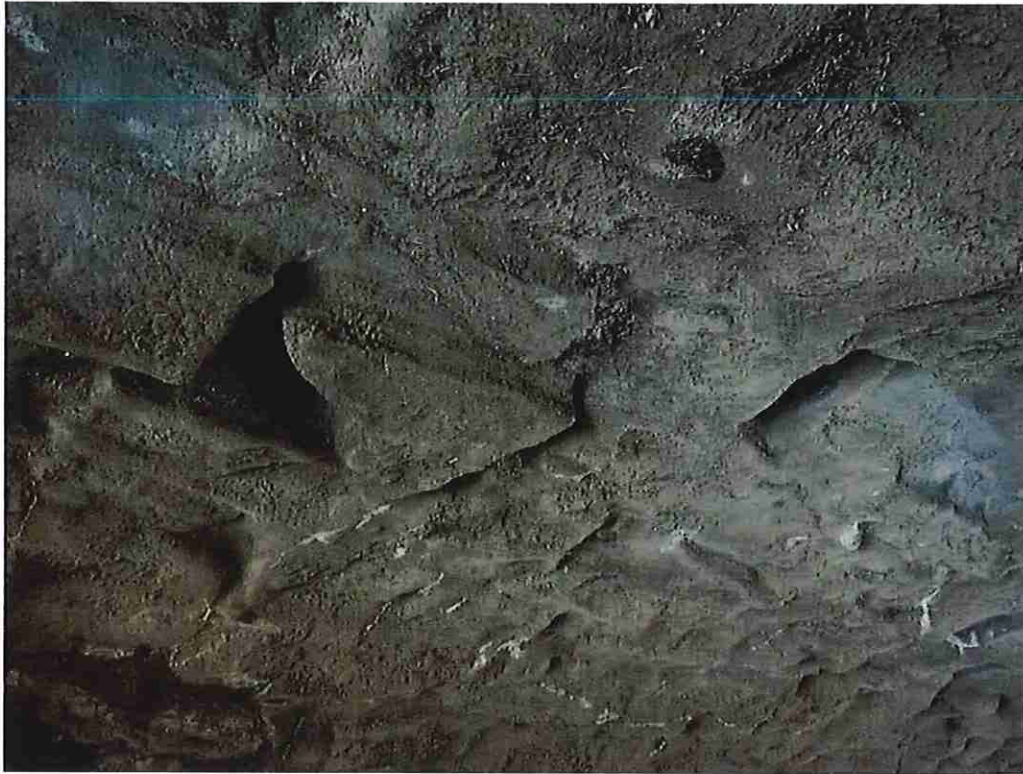
- 2'-6" from north fascia: 2' long x 9" wide x 6" deep void.
- 7' from north fascia: 3' long x 9" wide x 6" deep void.
- 14' from north fascia: 12" long x 9" wide x 6" deep triangular shaped void. Stones surrounding void settled up to 6" (**See Photo 5**).
- 18' from north fascia: 6" long x 12" wide x 9" deep void.
- 22' from north fascia: 5' long x 12" wide x 6" deep void.

Photo 5: Triangular shaped void in the keystone area at 14' in from the north fascia.
