Charles D. Baker, Governor
Karyn E. Polito, Lieutenant Governor
Stephanie Pollack, Secretary & CEO
Jonathan L. Gulliver, Highway Administrator

**The Board of Selectmen
Town Hall
10 Central Street
Manchester-by-the-Sea, MA 01944**

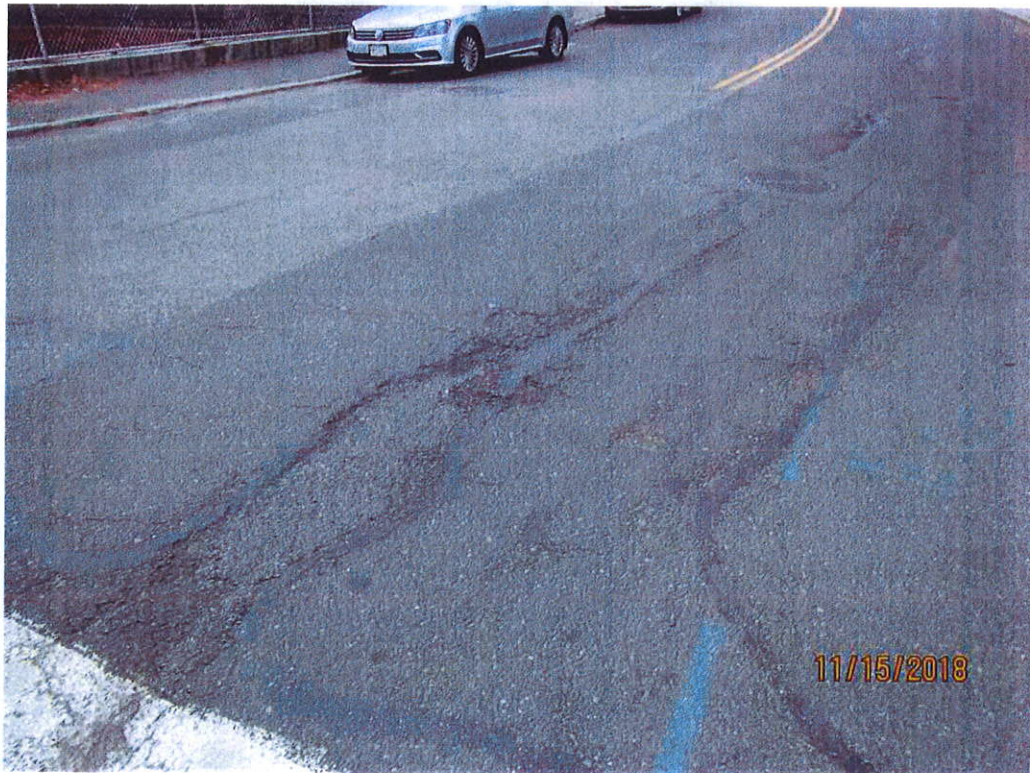
Photo 7: Wearing Surface - Eastbound lane: Heavy wear with typical scattered cracks, some sealed.

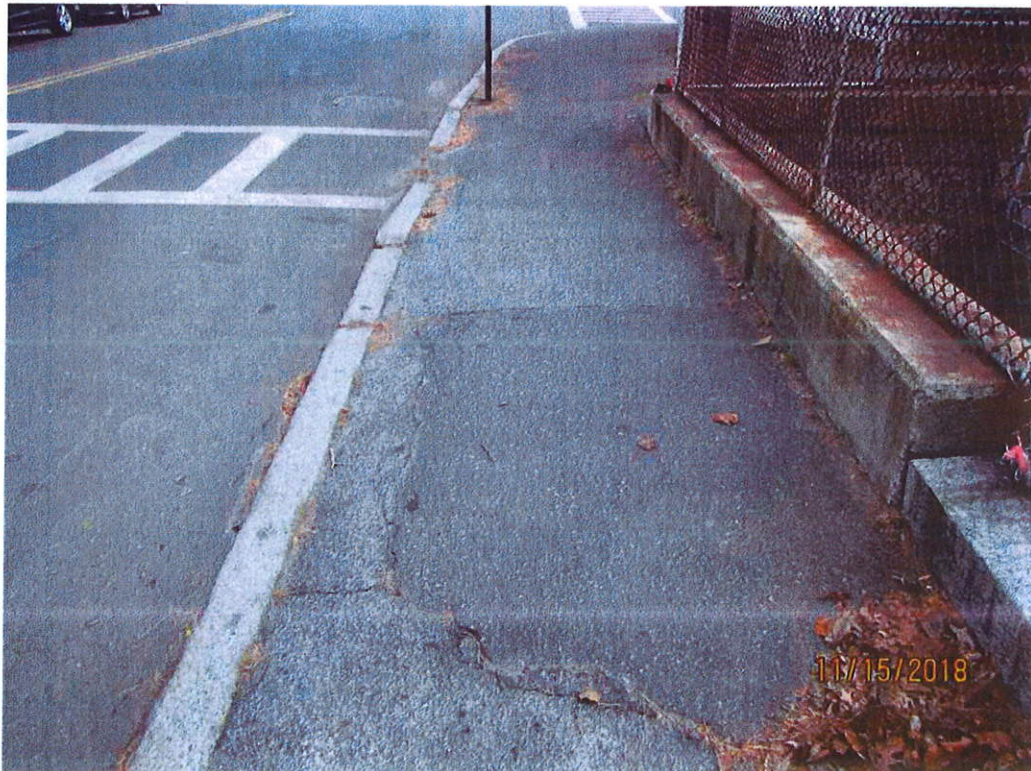
Photo 8: Sidewalks - South sidewalk: Scattered areas of delamination and cracking.

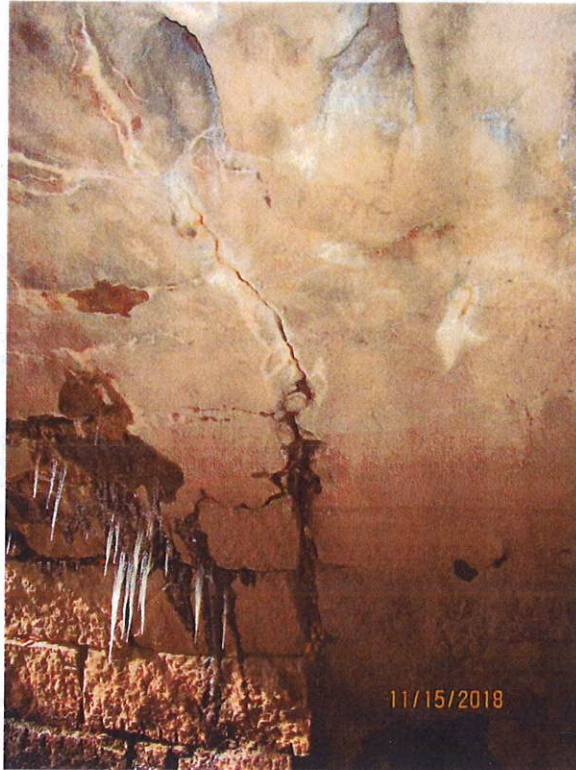
Photo 11: Arch/Arch Ring - 7ft north of south fascia from west spring line: Void between arch sections with the south edge lower than the north. Also note full arch crack in shotcrete with efflorescence and rust

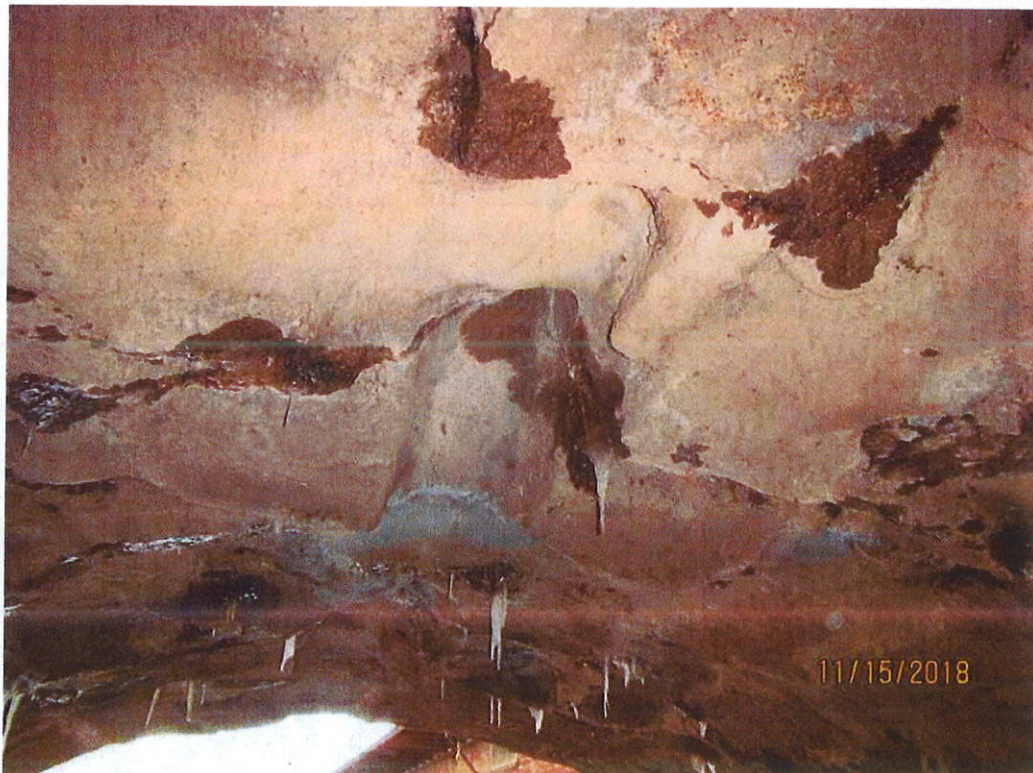
Photo 12: Keystone Area - 3ft south of north fascia: Area of missing keystones with shotcrete filling voids.

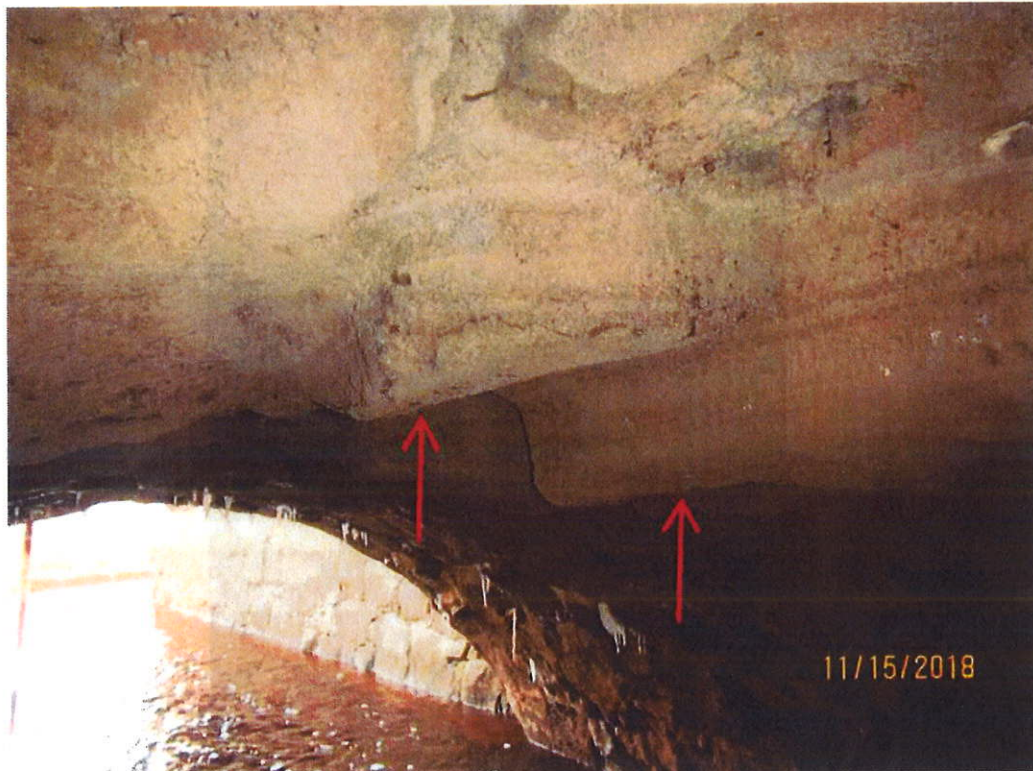
Photo 13: Keystone Area - 14ft south of north fascia: Settled stones surrounding void/missing keystone.

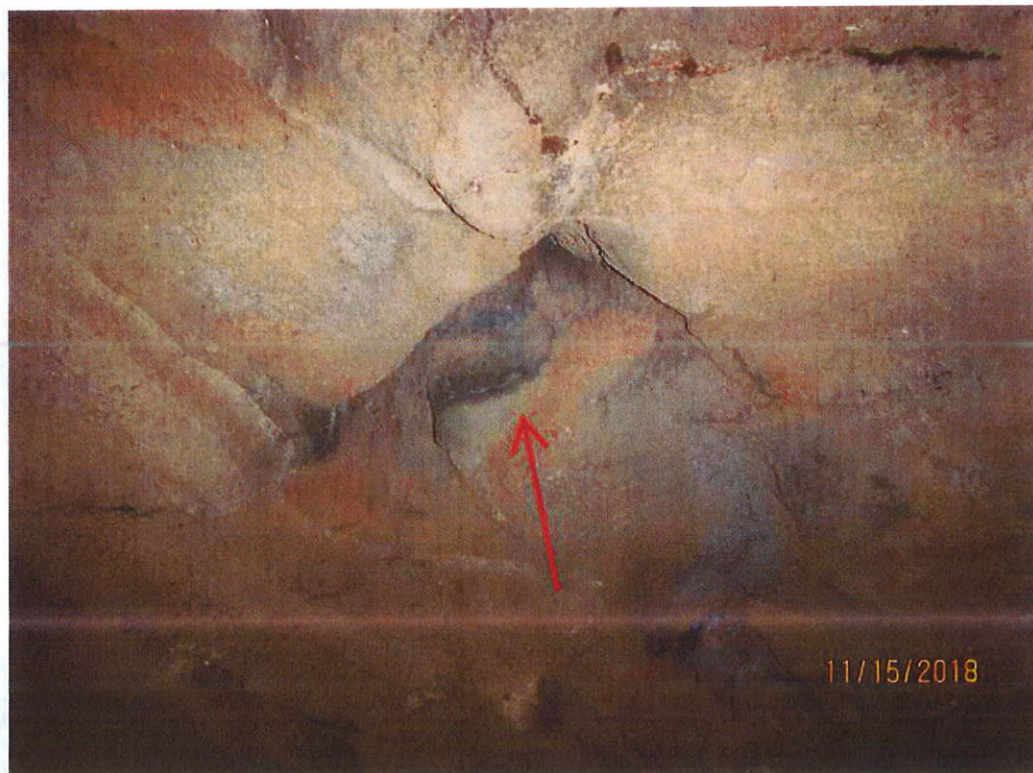
Photo 14: Keystone Area - 20ft south of north fascia: Void/missing keystone.

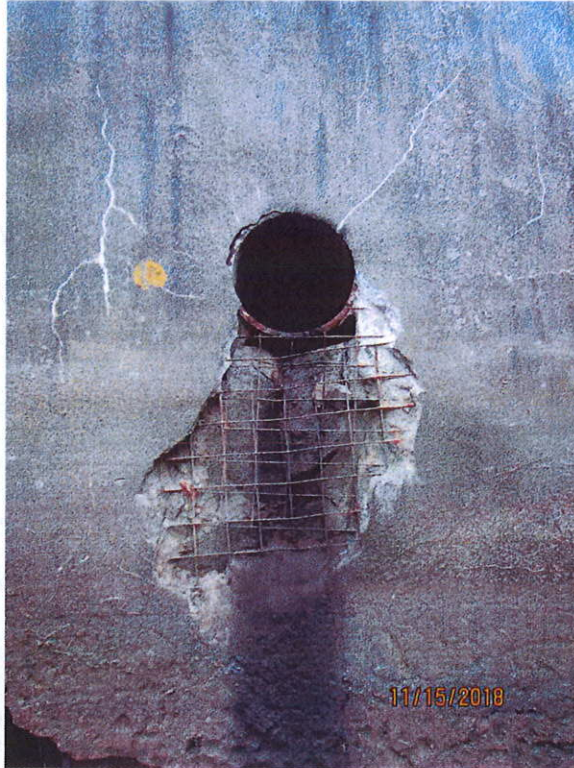
Photo 15: Spandrel Walls - West end of north wall: Spall in shotcrete with exposed wire mesh below drain pipe. Also note scattered cracks with efflorescence.

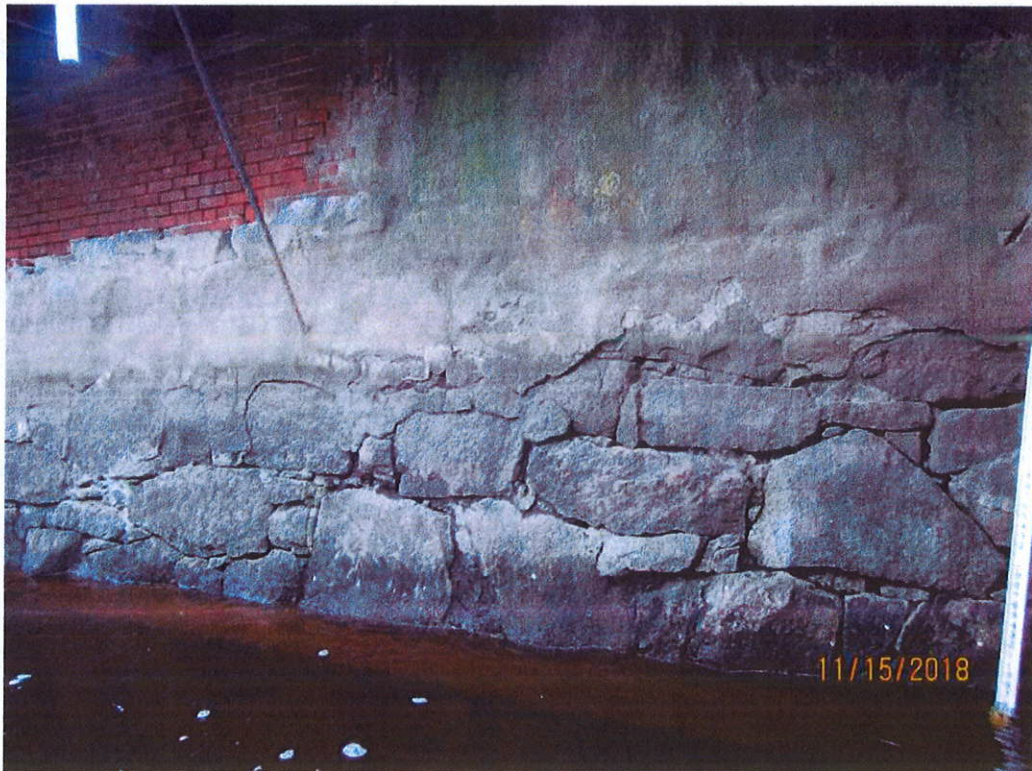
Photo 16: Wingwalls - Northeast wingwall: Typical scattered hollow areas of shotcrete.
