# Tighe&Bond

# SAWMILL BROOK / CENTRAL POND RESTORATION

**Manchester-by-the-Sea Town Hall – October 18, 2018**

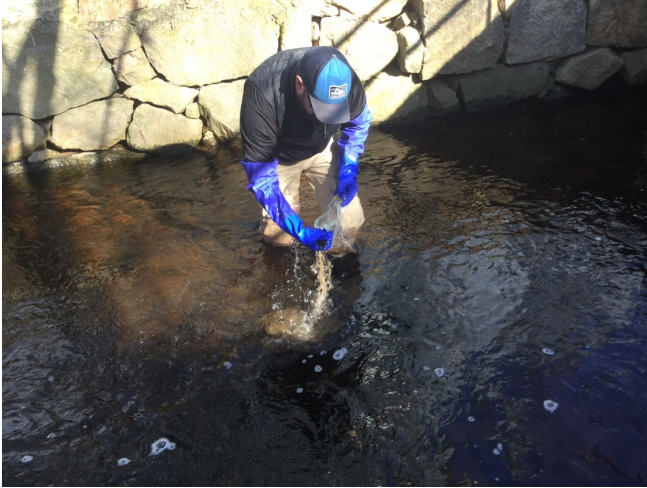
## Central Pond

- 5,000 CY of soft sandy sediment
- Sources include bank erosion, stormwater runoff and natural debris
- Pond mudflats are highly saline
- Allowing sediment to naturally flush may be preferred approach to dredging- subject to permitting with state and ACOE

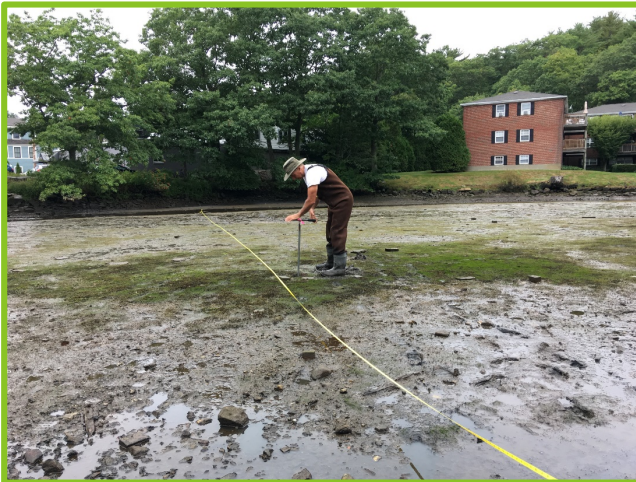
## Upstream Channel

- Gravel and sand substrate ideal for fish spawning

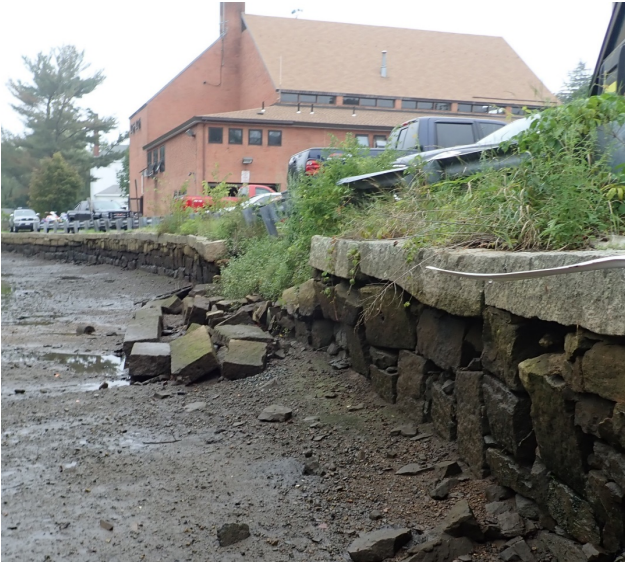
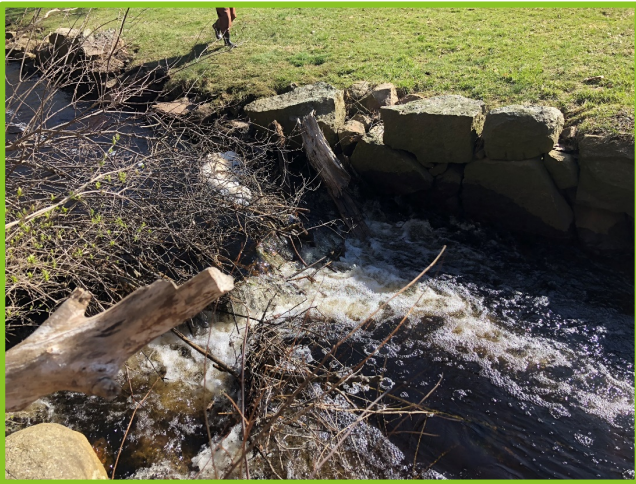
# FINDINGS FROM WALL SURVEY

- Granite block, poured concrete, brick, field stone and shale revetment and combinations of the above are the dominant structures found around Central Pond.
- Granite block, field stone and combinations of the above are the dominant structures found along Sawmill Brook.
- 
- Almost 50% of the walls arounds Central Pond are in need of maintenance. Over 60% of the shoreline of Central Pond is privately owned.
- Many locations can benefit from some type of bioengineering to stabilize banks using stone and plantings

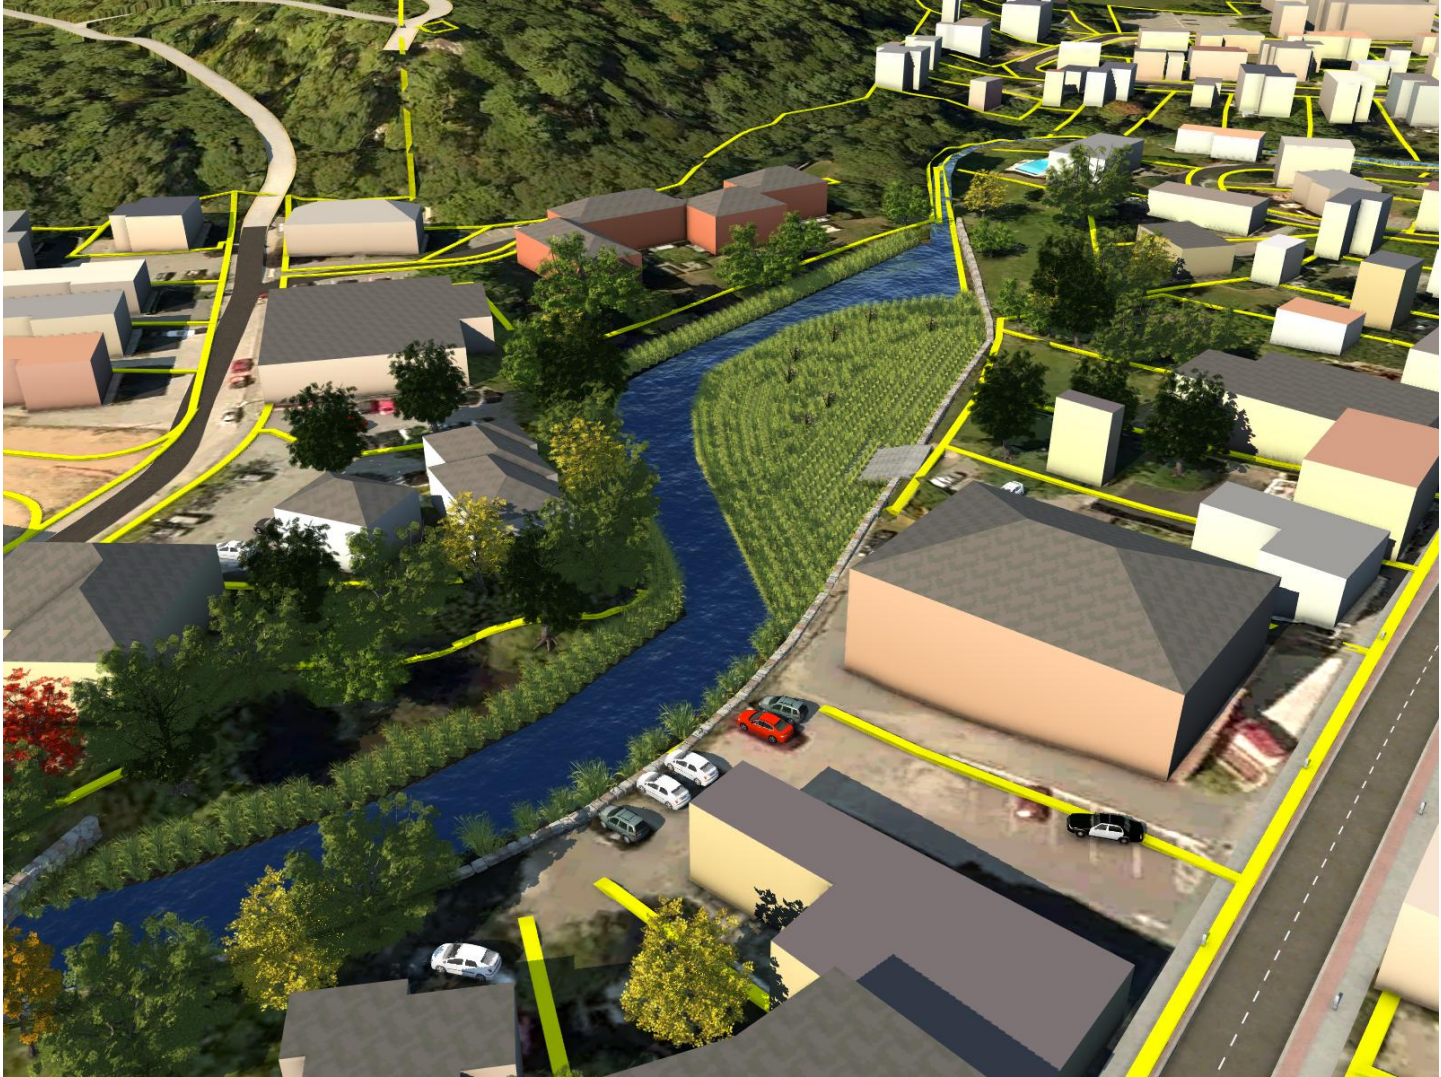
# STREAM RESTORATION

## 3. Stream Restoration

- unrestricted free flow water
- Provides continuous low level stream

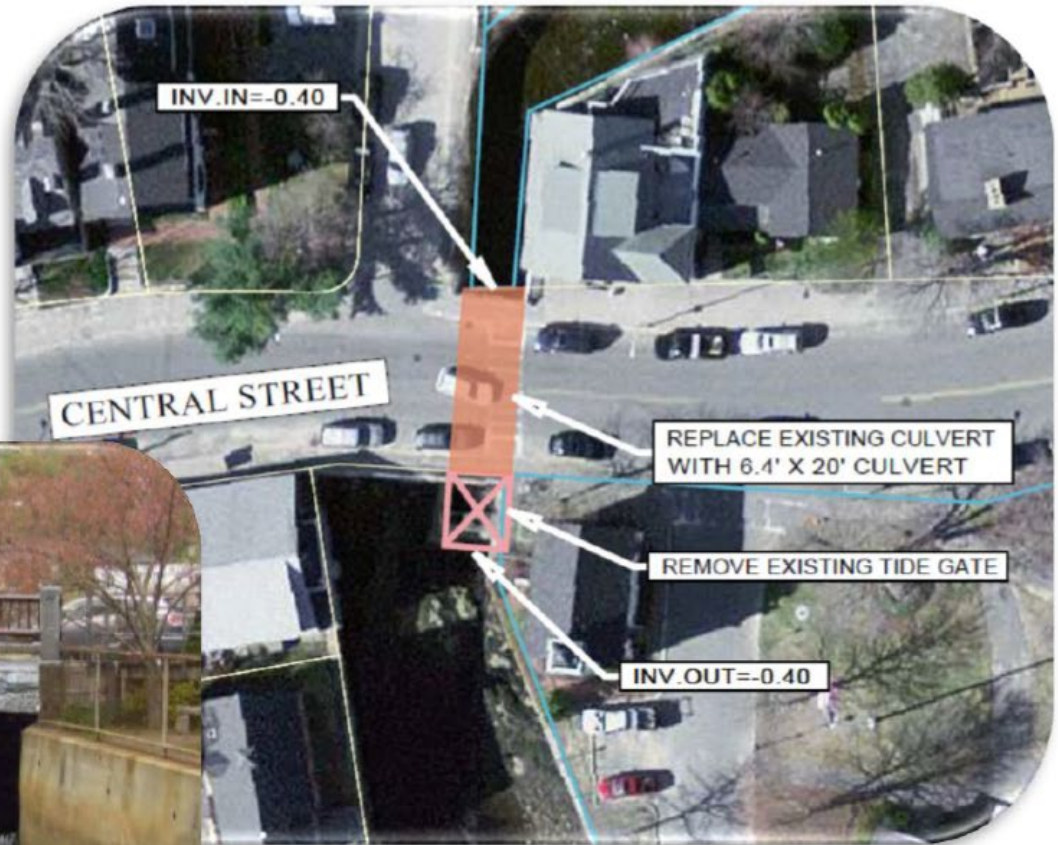
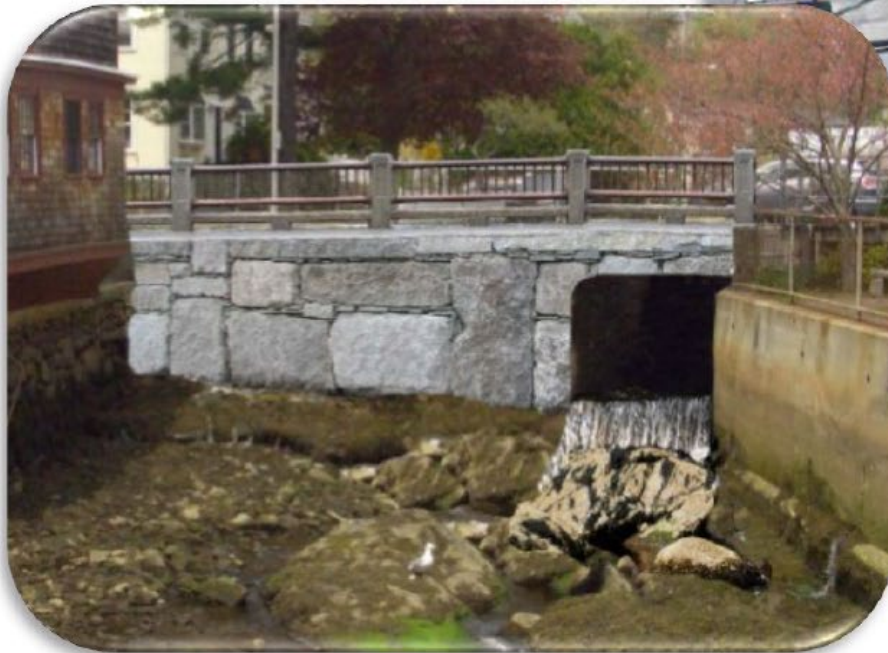
# BRIDGE RESTORATION PROJECT

Photo rendering of tide gate removed, new culvert, new granite wall and guard rail
