Sawmill Brook Restoration Project – Review of Technical Feasibility of Tide Gate Removal

TO: Susan Beckmann, Chair, Manchester-by-the-Sea Board of Selectmen
FROM: Gabrielle Belfit, CFM, Dan Buttrick, PE, and Duncan C. Mellor, PE
COPY: Greg Federspiel, Town Administrator, Sue Brown, AICP, Town Planner, Mary Reilly, Grants Administrator, David Loring, PE, ENV SP, LEED AP
DATE: January 28, 2019

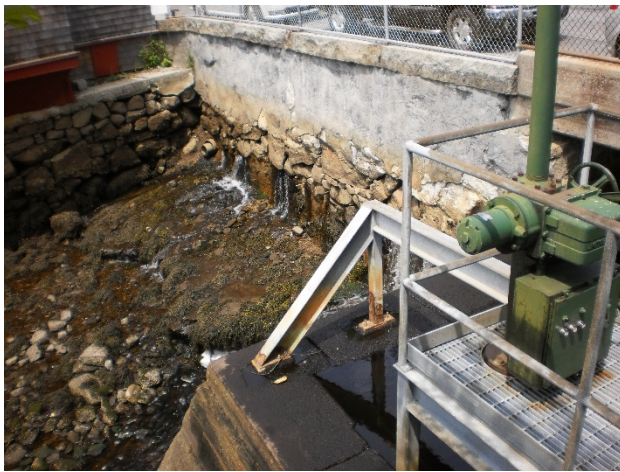
Photo 1: View of tide gate motor on the right and wall seepage on the left.

The tide gate structure is comprised of two orthogonal concrete walls approximately 9 feet high, a bottom opening gate of cast iron or cast steel (gate and tracks), and an overhead

actuator motor/controller supported by a galvanized steel platform (Photo 1). The tide gate opening is 5.9 feet and the open height of the gate is 2.75 feet, with the invert 10 to 18 inches above the stream bed. The elevation of the top of the tide gate is 4.6 feet Mean Sea Level (MSL) NAVD 88 and regularly overtops during average to high tide events. When the tide gate is closed, the hydrostatic pressure from impounded water causes water to seep through the stone culvert wing wall (Photo 1 and Photo 2). This seepage flow can cause loss of soils under the street through the wall. Attempts to repair the stone surface and culvert have failed, particularly in the tidal zone area.

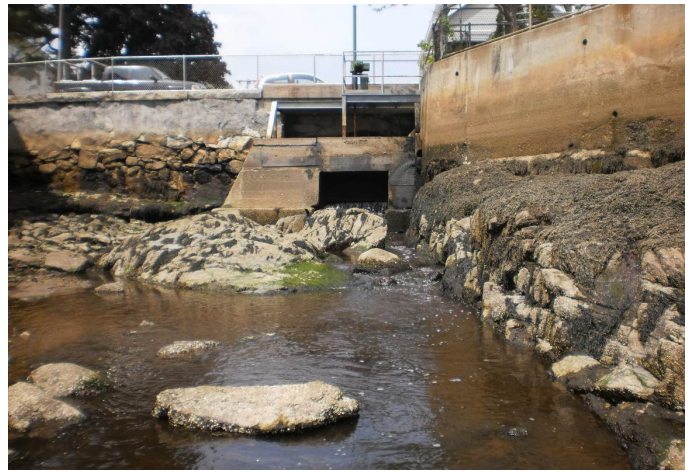
Photo 2: Looking upstream at the tide gate and Central St. culvert at low tide.

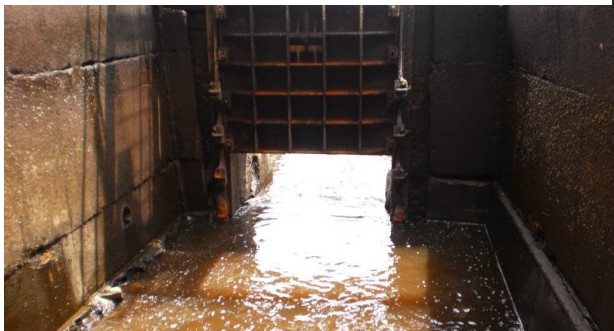
Photo 3: View of the tide gate from inside culvert

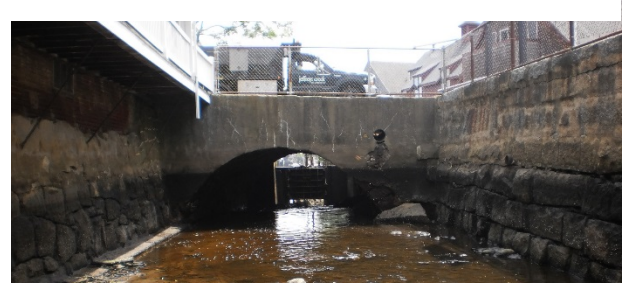
Photo 4: View of stream channel upstream from culvert looking south with dark staining on walls indicating normal high-water level when the gate is closed.

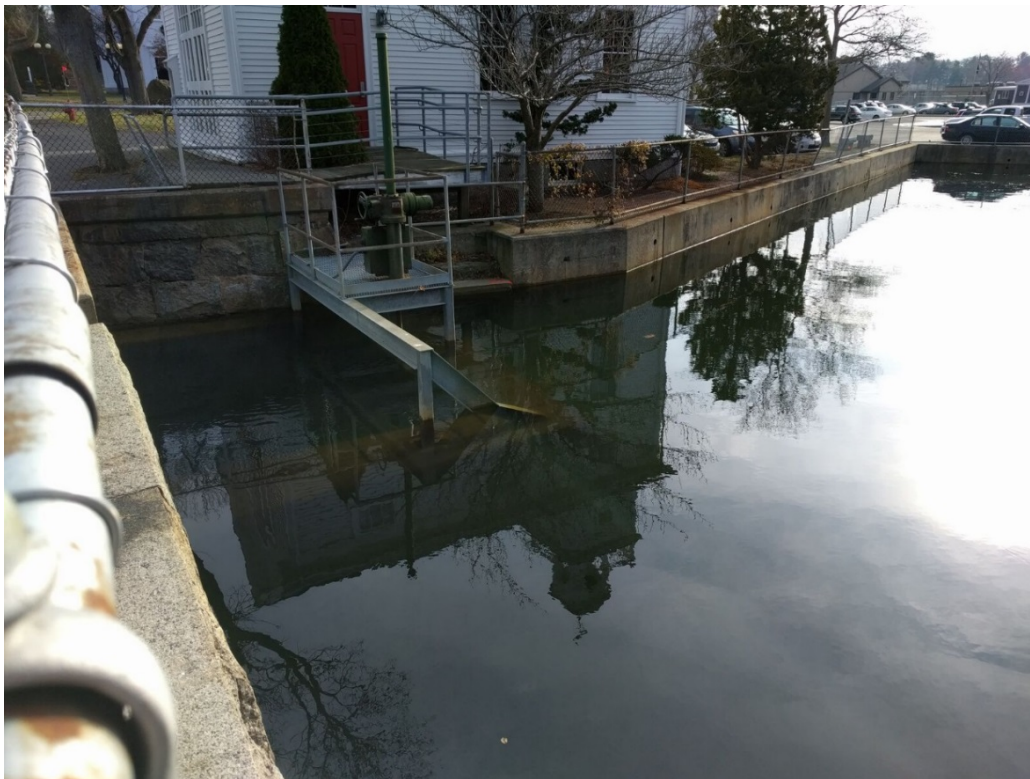
Photo 5: High Tide on December 3, 2017 the tide is well above the top of the tide gate

The tide gate wall regularly overtops on monthly high tides and storm surge tides indicating that **the tide gate is not effective in preventing coastal flooding**.

As part of the MET grant, water level data was collected from pressure transducers above and below the Central Street Bridge from November 2017 to April 2018 to evaluate how high tide periods impacted upstream water levels. This period captured a wide range of conditions, including the record high tides set in January 4, 2018 (see photo 5 for December 3, 2017 high tide). Over the five-month monitoring period 290 high tides were recorded, and 194 (or 67%) of the readings were higher than the tide gate crest wall elevation of 4.6 feet MSL NAVD88.

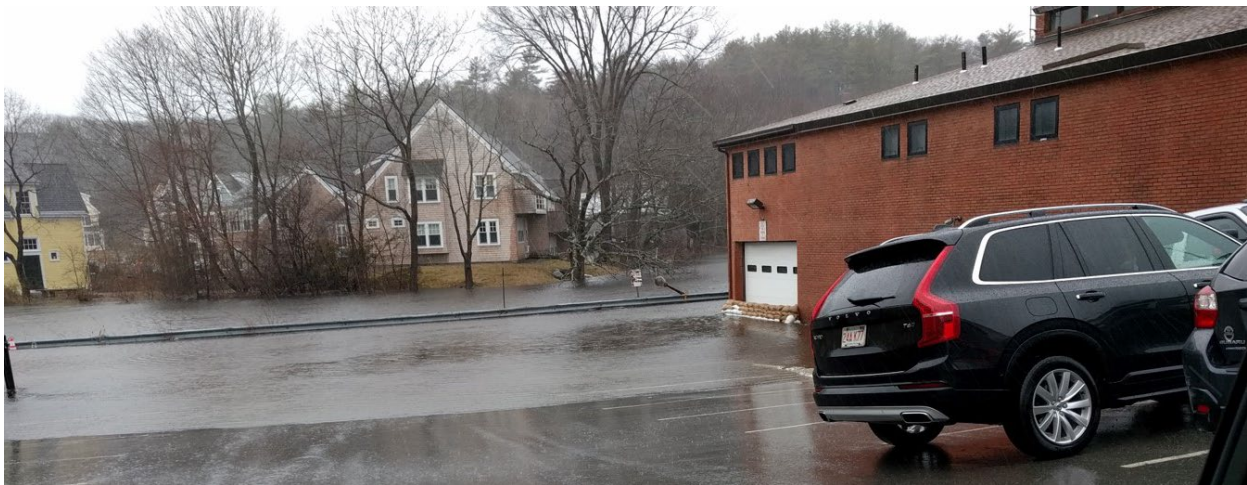
Photo 6: Central Pond adjacent to the Manchester Fire Department shown on 1/4/2018. Rising water levels eventually overtopped the wall (elevation 5.4 ft. NAVD88) flooding the parking area and Fire Department basement and garage area despite preventive sand bags across the door.

Photo 6 below shows an example of the Central Pond flooding overtopping the retaining walls along the pond and flooding adjacent properties. The tide gate was closed when this photo was taken. The extent of inland flooding is more widespread with larger storm events. During the May 2016 "Mother's Day Flood" 12 inches of rain was recorded, flooding properties adjacent to Sawmill Brook with up to 6 feet of water and damaging 150 homes. A 2015 local survey of areas prone to flooding, cites extreme precipitation events, stream bank overflow, and culvert backup as the most prevalent causes of flooding in Manchester-by-the-Sea.

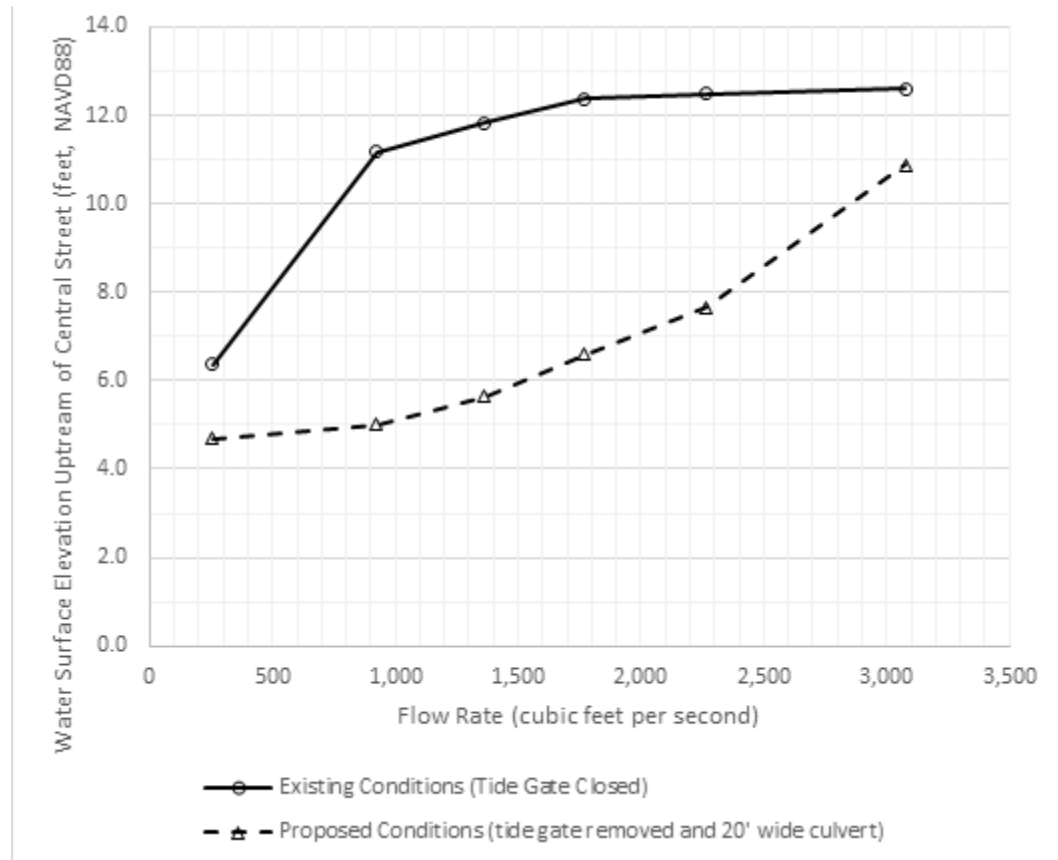
Figure 3. Stream Discharge Rating Curve for Existing and Proposed Conditions

The modeling shows that increasing the size of the Central Street culvert and removing the tide gate would result in a significant increase in discharge flow capacity (oceanward), that would be anticipated to reduce pond overbank flooding. The proposed improvements (removing the tide gate and replacing the existing culvert with a 20-foot wide arch culvert) would be anticipated to reduce the water surface elevation upstream of Central Street during a 24-hour duration 25-year frequency storm event occurring with mean higher high-water tidal conditions from 11.8 feet to 5.6 feet. Similarly, the water surface elevation upstream of Central Street would be anticipated to decrease from 12.5 feet to 7.7 feet if a 24-hour duration 50-year frequency storm event occurred during mean higher high-water tidal conditions. See Figure 3 and Tables 1 and 2 for the stream discharge and surface water elevations. To further

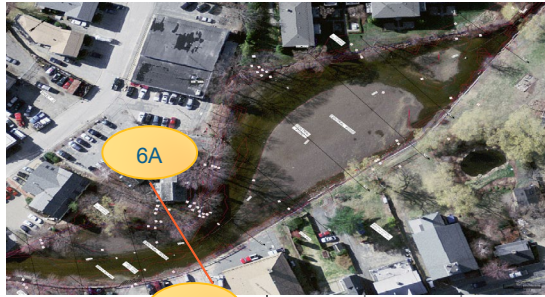
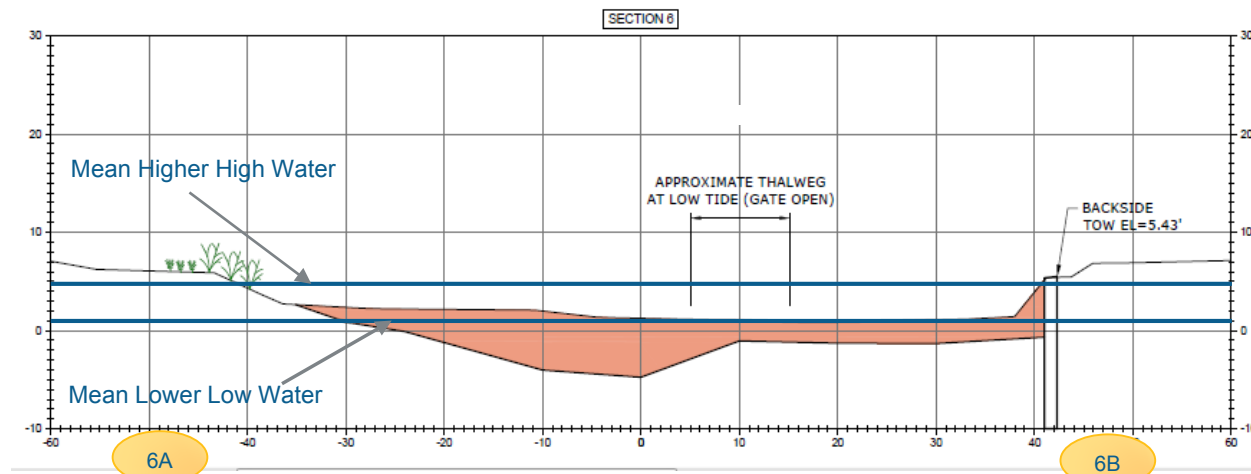
FIGURE 5 CENTRAL POND BEFORE AND AFTER TIDE GATE REMOVAL

Pond Level with
Gate Closed

Pond Levels with
Gate Removed

demonstrate the differences, Figure 4 and Figure 5 provide cross sections at the Central Street Bridge and Central Pond before and after the improvements are made during mean higher high water and mean lower low water tide conditions.
