FEMA Hazard Mitigation Plan Enhancement: Task 3 Vulnerability and Risk Assessment Manchester-by-the-Sea

Town of Manchester-by-the-Sea
Massachusetts

August 2016

Vulnerability and Risk Assessment

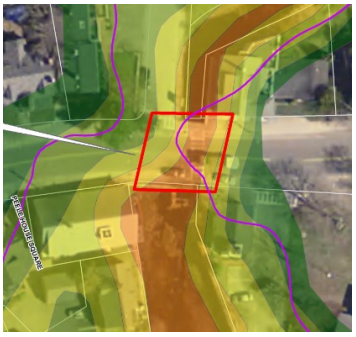
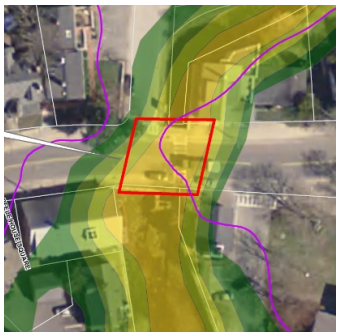
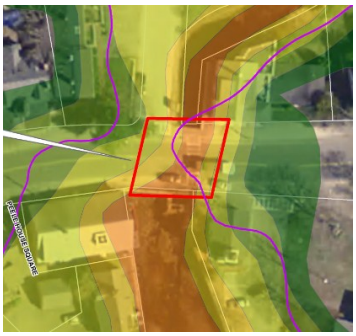
Vulnerability and Risk Assessment
Central Street Dam

These figures depict the extent of currently defined flood hazard area, including the 100-year base flood elevation shown in purple and the future flooding hazards for storm surge and sea level rise. Exposure vulnerability for near, mid and long term climate change planning periods is represented based on probability of occurrence from 1% (very unlikely) to 99%, (extremely likely). The figures show that there is a 66% probability that the dam will be impacted by sea level rise and 90% probability that it will be impacted by storm surge across the 3 time periods. This location is also subject to inland flooding from extreme precipitation events.

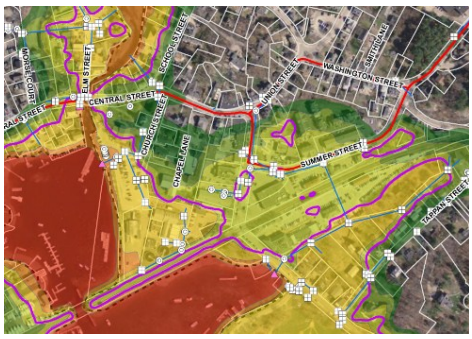
Vulnerability and Risk Assessment
Downtown Stormwater System

This figure depicts locations of stormwater catchbasins and outfalls and the extent of flood exposure due to storm surge for existing conditions, shown in purple and the future flooding hazards for storm surge and sea level rise. Exposure vulnerability for near, mid and long term climate change planning periods is represented based on probability of occurrence from 1% (very unlikely) to 99%, (extremely likely). Although not shown, it is important to note that the stormwater system is also subject to flooding from Upland Flooding sources. As shown, there is a chance of storm surge impacting the stormwater system as early as 2025. Sea level rise is less likely to impact the system until 2100. However, the low-lying catch basins can become surcharged from the ocean outfalls from extraordinary events.

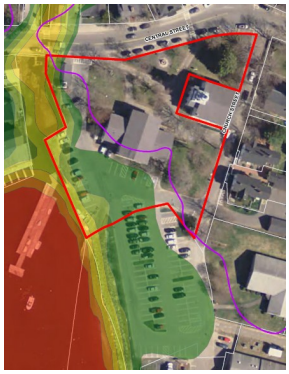
Vulnerability and Risk Assessment
Town Hall, Police and Emergency Operations

This figure depicts the extent of currently defined flood hazard area, including the 100-year base flood elevation shown in purple and the future flooding hazards for storm surge and sea level rise. Exposure vulnerability for near, mid and long term climate change planning periods is represented based on probability of occurrence from 1% (very unlikely) to 99%, (extremely likely). The figures show that sea level rise will not significantly impact the site until 2100, but there is a much stronger possibility that the building will be impacted by storm surge in the near and mid-term.

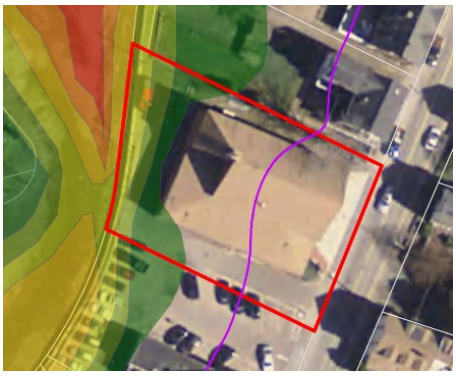
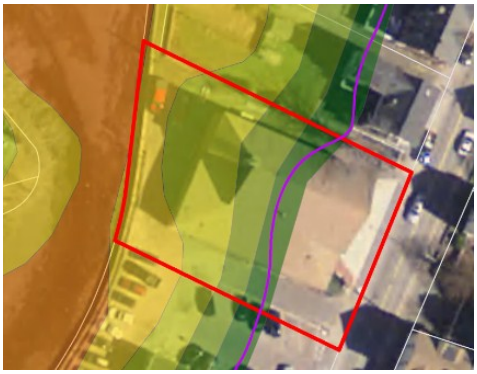
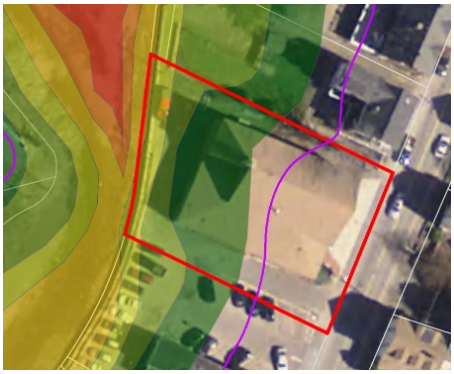
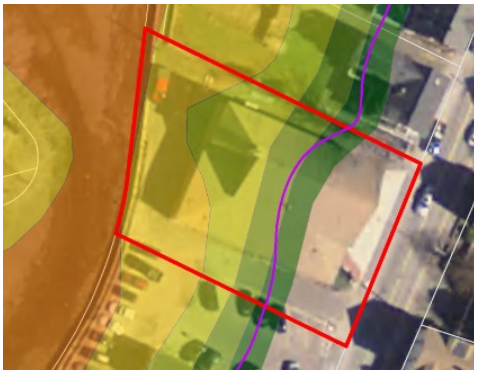
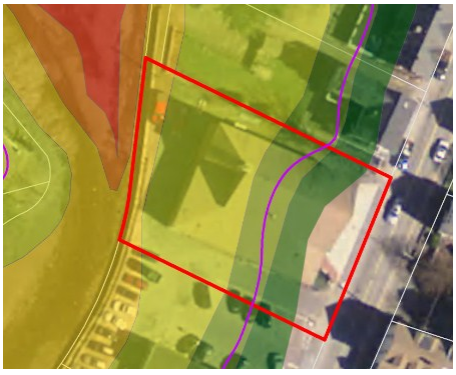
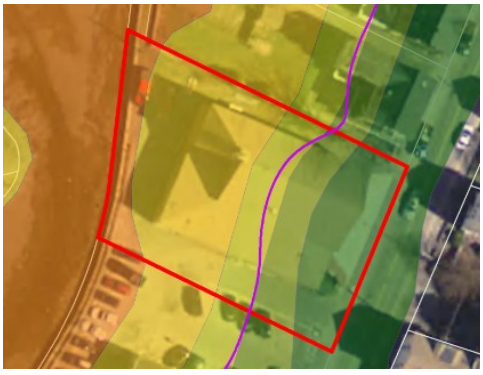
Vulnerability and Risk Assessment
Fire Station

The figures above depict the extent of flood hazard areas, including the current 100-year base flood elevation shown in purple and the future flooding hazards for storm surge and sea level rise. Exposure vulnerability for near, mid and long term climate change planning periods is represented based on probability of occurrence from 1% (very unlikely) to 99%, (extremely likely). As shown, there is a significant risk of flooding due to Storm Surge by 2050. Sea Level Rise will likely not impact the building until later in the century.

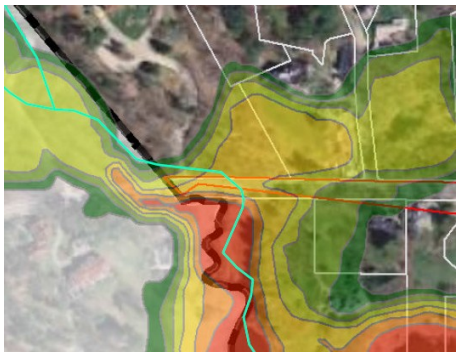
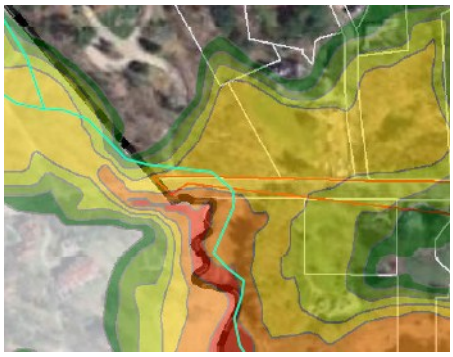
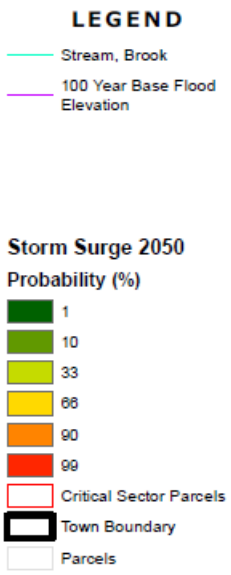
Vulnerability and Risk Assessment
Flood Risk Locations Along Route 127

The figures above depict the extent of flood hazard areas, including the current 100-year base flood elevation shown in purple and the future flooding hazards for storm surge. Exposure vulnerability for near, mid and long term climate change planning periods is represented based on probability of occurrence from 1% (very unlikely) to 99% (extremely likely). Storm surge is likely to impact Route 127 at both the Chubb Creek and Bennett Brook crossings in 2025. The area of impact at the Chubb Creek location will expand as time progresses.

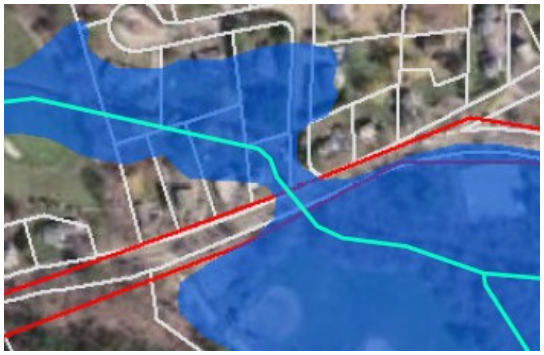
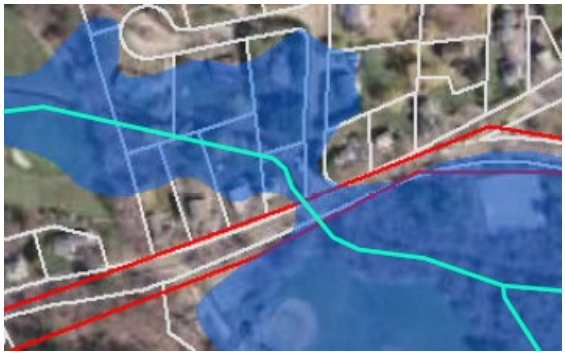
Vulnerability and Risk Assessment
Flood Risk Locations Along Route 127

The figures above depict the extent of Upland Flooding impacts at the Causeway Brook and Causeway Brook Branch crossings on Route 127. As shown, the areas of impact change only slightly over the course of time. Both locations have a history of minor localized flooding.

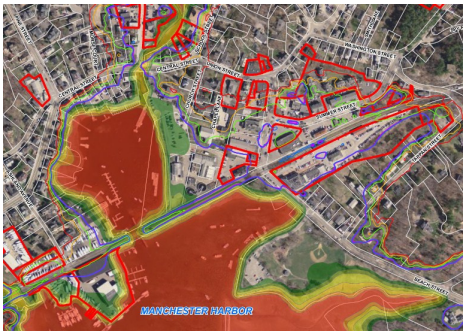
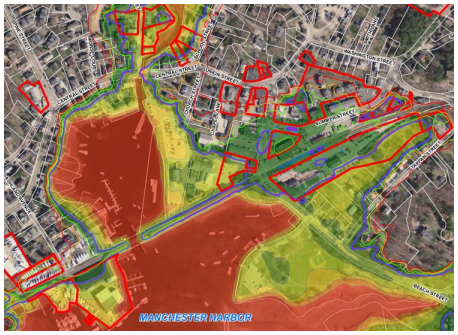
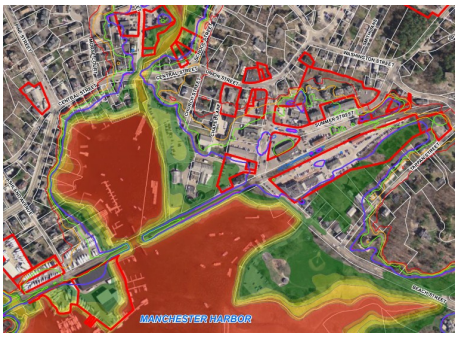
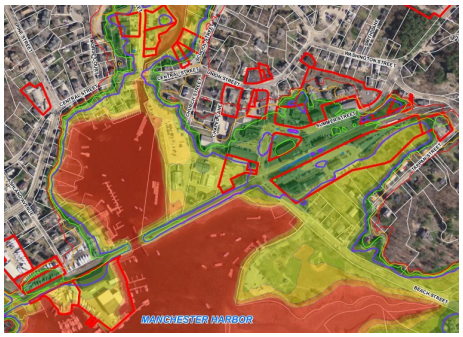
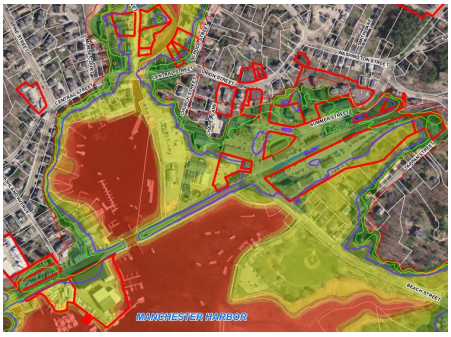
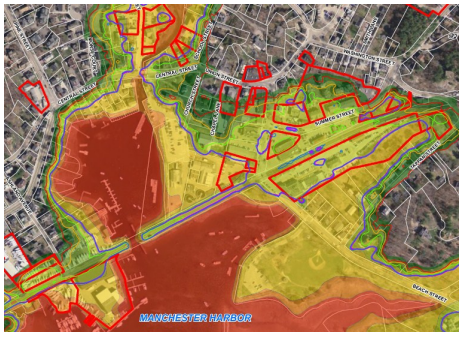
Vulnerability and Risk Assessment
Downtown Businesses

The figures above depict the extent of flood hazard areas, including the current 100-year base flood elevation shown in purple and the future flooding hazards for storm surge and sea level rise. Exposure vulnerability for near, mid and long term climate change planning periods is represented based on probability of occurrence from 1% (very unlikely) to 99%, (extremely likely). The figures show that many of the businesses will likely not be impacted by sea level rise until 2100. However, many sites are at risk of flooding due to storm surge; probabilities greatly increase by 2100.

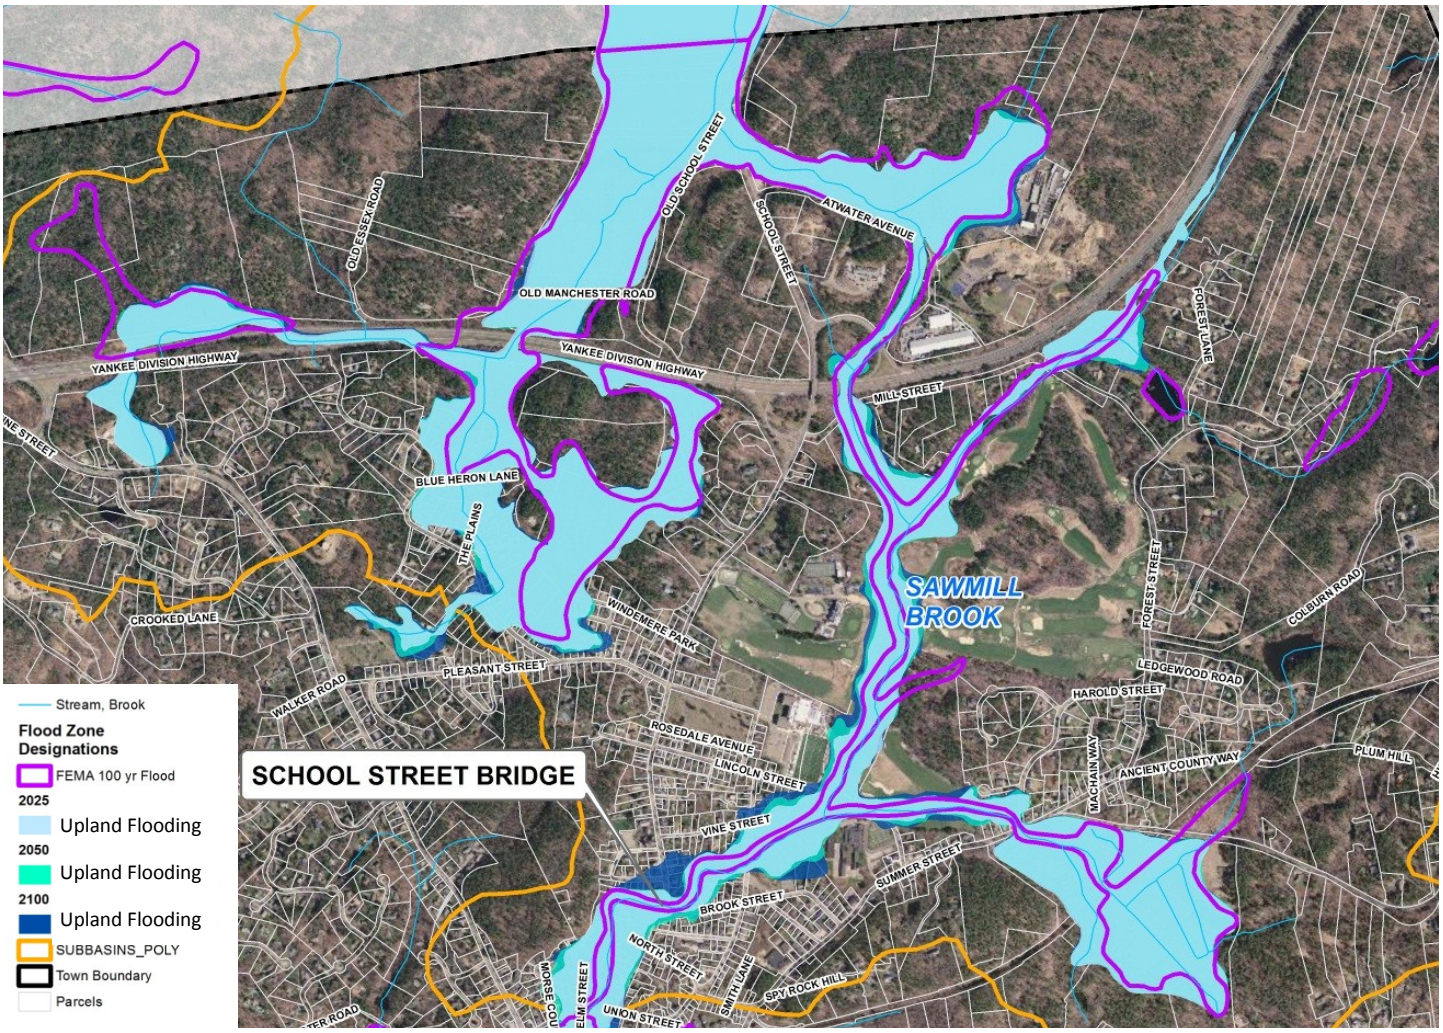
Sawmill Brook Upland Flooding Impacts 2025, 2050, 2100

This figure above depicts the extent of flood hazard areas, including the current 100-year FEMA flood elevation shown in purple and the future flooding hazards area for Upland Flooding based on the Sawmill Brook Watershed Model. The modeled area of inundation due to upland flooding is based on precipitation amounts generated under a balanced fossil fuel energy emission scenario and tail water conditions created with sea level rise at the Harbor. The modeled area of flooding is subject to change as culvert restrictions are addressed throughout the watershed.

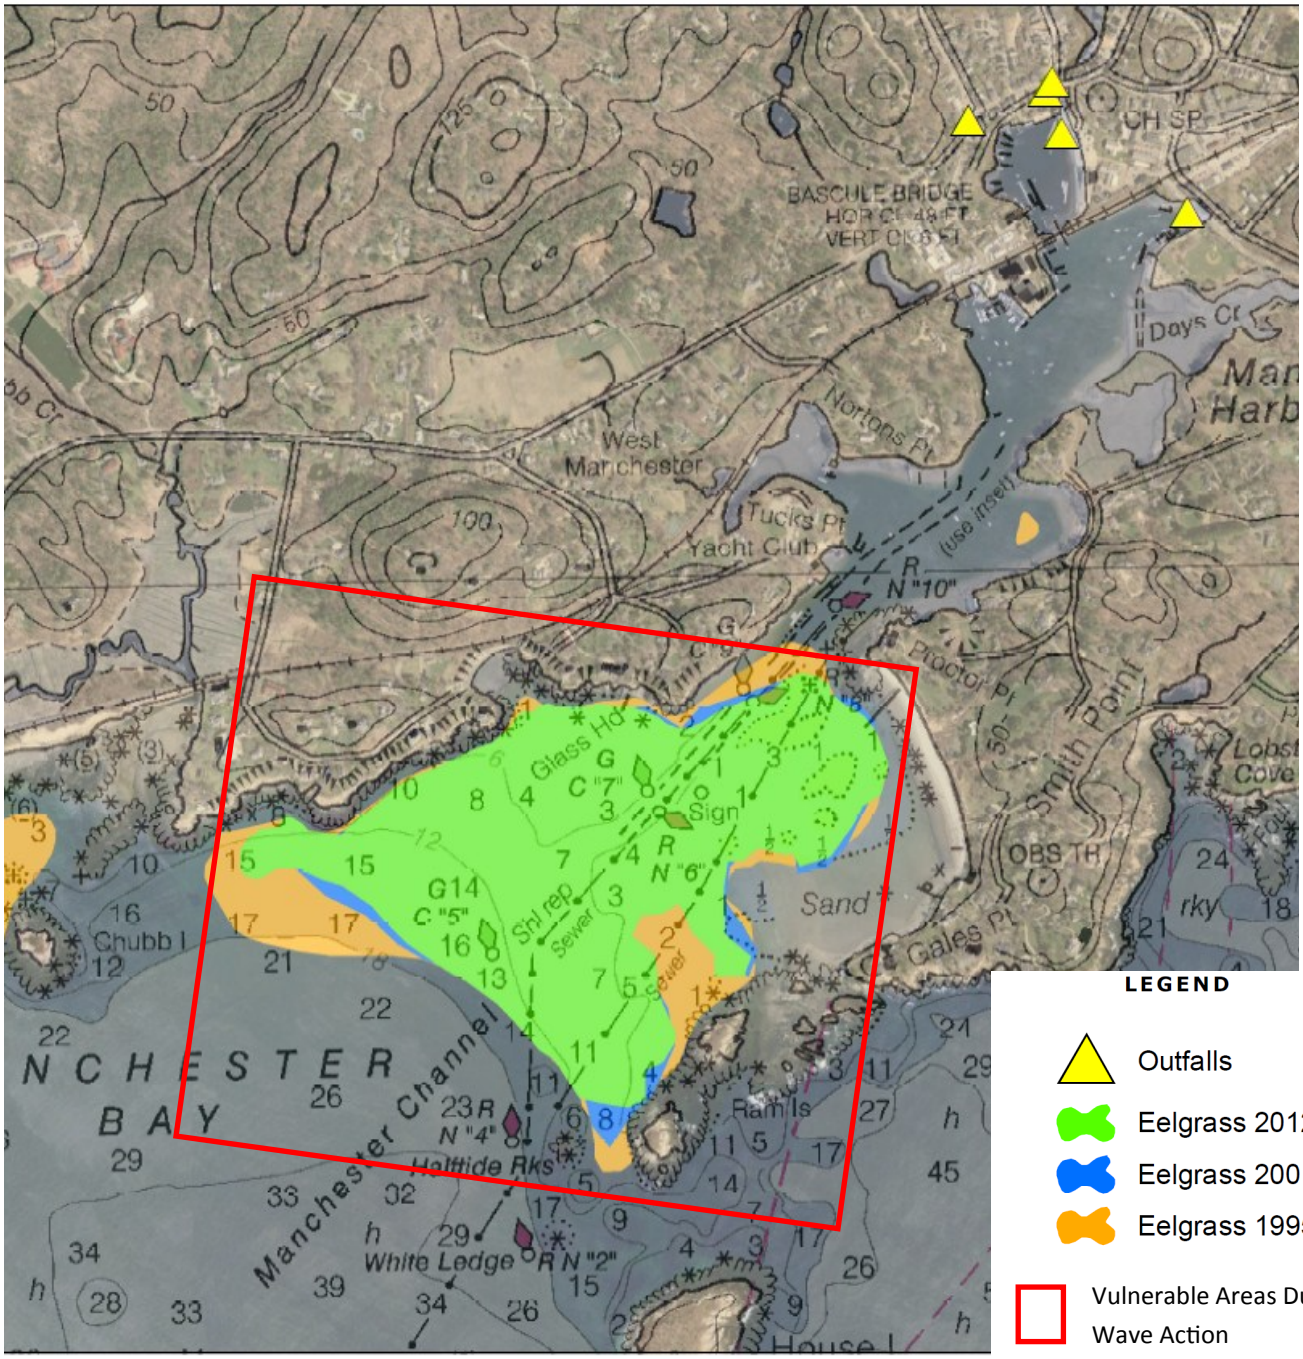
Vulnerability and Risk Assessment
Manchester Harbor

The image above shows an NOAA nautical chart of Manchester Harbor and the extent of eel grass beds which have gotten smaller over time. Beds are vulnerable to wave action associated with storm surge that may increase with climate change. Areas most vulnerable are west of Rams Island where beds are more exposed to wave refraction. The stormwater outfalls in Manchester Inner Harbor are also located on the map.

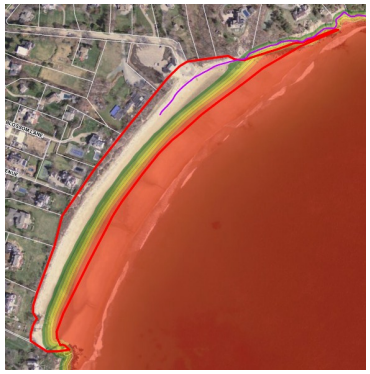
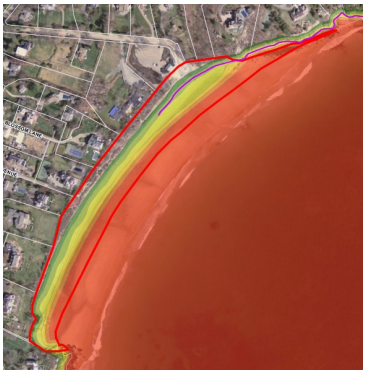
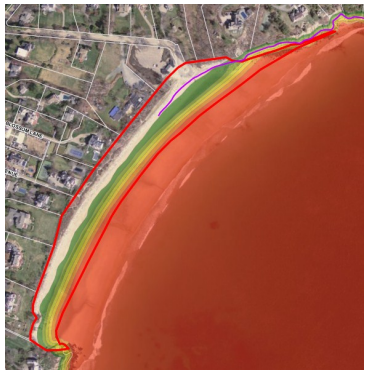
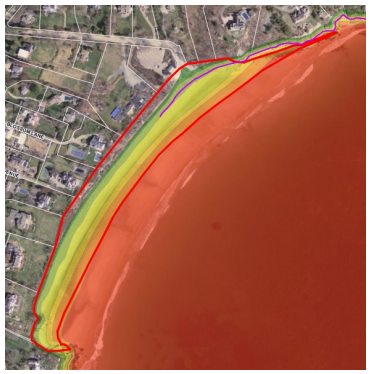
Vulnerability and Risk Assessment
Singing Beach

This figures above depict the extent of flood hazard areas, including the current 100-year base flood elevation shown in purple and the future flooding hazards for storm surge and sea level rise. Exposure vulnerability for near, mid and long term climate change planning periods is represented based on probability of occurrence from 1% (very unlikely) to 99%, (extremely likely). The figures show that sea level rise will not significantly impact the site until 2100. Storm surge is likely to impact the site and may even breach the Singing Beach, impacting the homes behind it.
