Sidewalk Inventory

DRAFT REPORT

Town of Manchester BTS, Massachusetts

Date: January 24, 2019

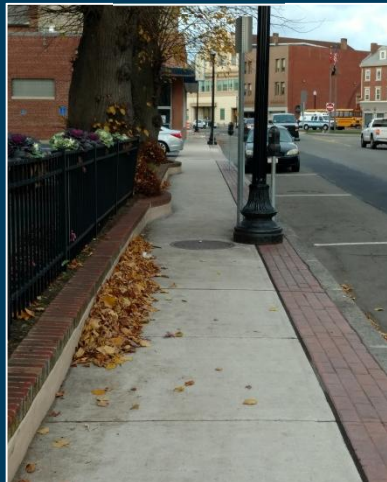
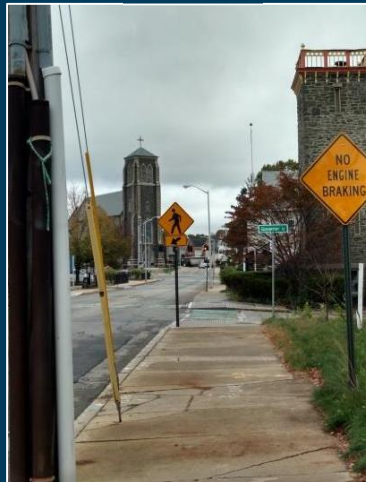
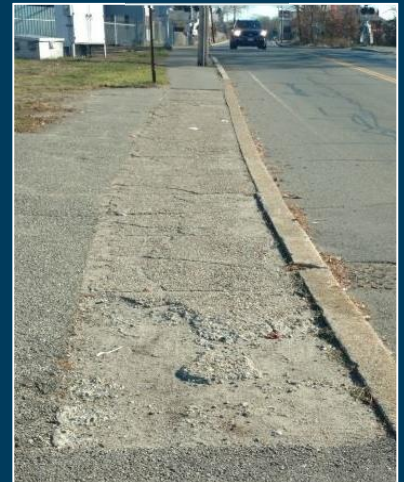
POOR

- Distresses are actively found in a section of sidewalk which may require resurfacing.
- Between 25% and 50% of the sidewalk section needs major repairs or resurfacing.
