## Manchester-by-the-Sea, Massachusetts

## Outdoor Areas

## Black Beach

## Town of Manchester-by-the-Sea ADA Transition Plan

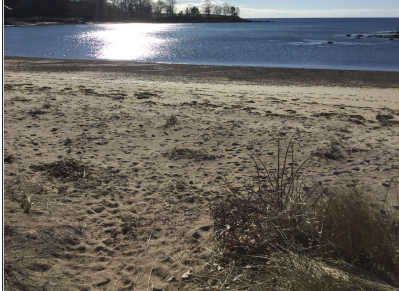
Beach route not provided	50'	Provide an accessible route that is firm and stable. Ensure the accessible route extends from a beach mat at the top of the dune to the high tide level.  (Cost based on 78" wide x 50' long beach mat.)	1	2492	\$2492

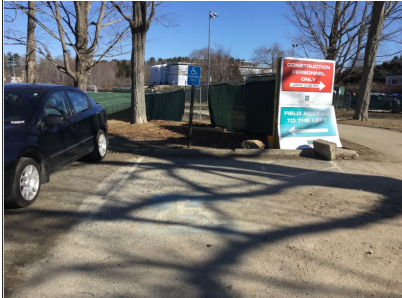
Total # of parking Total # of designated accessible parking spaces Total # of designated van accessible spaces Vehicle space < 132" wide at van space Access aisle < 60" wide at car/van space Sign does not have the designation "Van Accessible"	25 1 - 89" 55"	Provide a van accessible space that is at least 96" wide. Provide a marked access aisle that is at least 96" wide. Add the designation "Van Accessible" to the sign located at the van accessible space. Position sign 60" min. and 96" max. above the ground. (Cost based on re-striping space and aisle and a sign with "Van Accessible".)	1	1100	\$1100

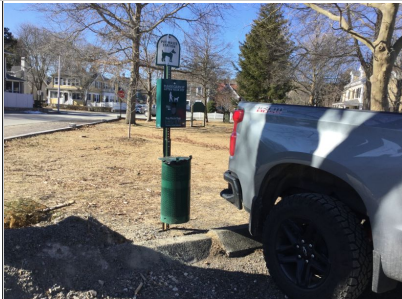
<b>Access to Goods and Services</b>												
<b>Operable Parts</b>												
3	By East End Parking Lot	Ext.		Operable Parts	N/A

Element not on an accessible route	6"	Ensure dog waste bag dispenser is located on an accessible route. (Relocate dispenser or relocate cement blocking route.)	1	Labor	\$0
<b>Benches</b>												
4	Near East End Parking Lot	Ext.		Benches	N/A

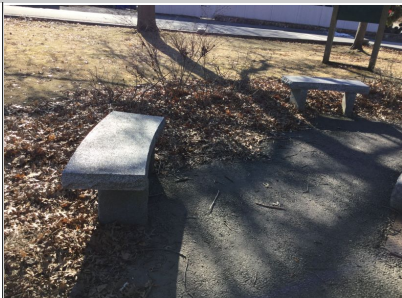
Seating spaces < 36" x 48" (single space)		Provide a 36" by 48" clear floor space that is stable, firm and slip resistant at end of 5% (at least one) bench. Position clear floor space to allow for shoulder alignment with someone seated at the end of the bench for wheeled mobility device users.  (Cost based on s 36"x48" asphalt space.)	1	90	\$90
<b>Additional Access</b>

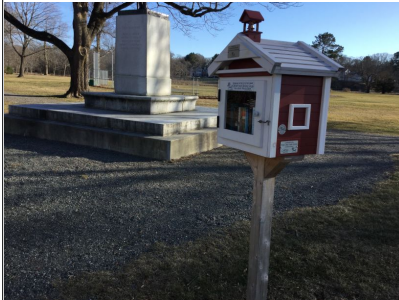
Accessible route not provided	-	Ensure an accessible route is provided.  (Cost base on 6'x48" of stone dust connecting book exchange to stable, firm and slip resistant surface at monument.)	1	192	\$192
<b>Off-Street Parking Lot or Garage</b>												
3	Parking for Masconomo Park and Reed Park and Docks	Ext.		Off-Street Parking Lot or Garage	N/A

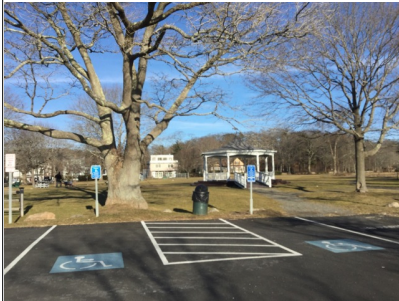
Total # of parking Total # of designated accessible parking spaces Total # of designated van accessible spaces Sign does not have the designation "Van Accessible"	55 1 1 -	Add the designation "Van Accessible" to the sign located at the van accessible space.	1	500	\$500

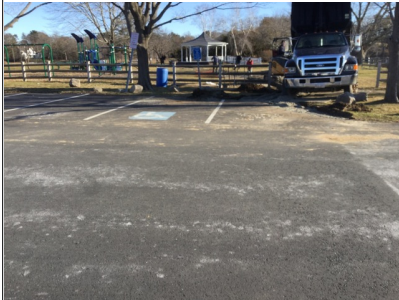
4	Parking for Masconomo Park and Reed Park and Docks	Ext.		Off-Street Parking Lot or Garage	N/A

Access aisle not provided	-	Provide a marked access aisle that is at least 60" wide.	1	300	\$300
<b>Access to Goods and Services</b>

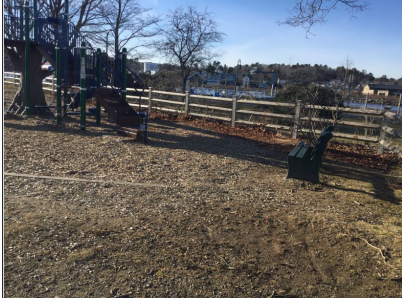
No accessible route to one bench in this area	-	Provide an accessible route to at least one bench in this area.  (Cost based on 18'x48" stone dust path to bench.)	1	576	\$576
<b>Bike Racks</b>												
7	Bike Rack	Ext.		Bike Racks	N/A

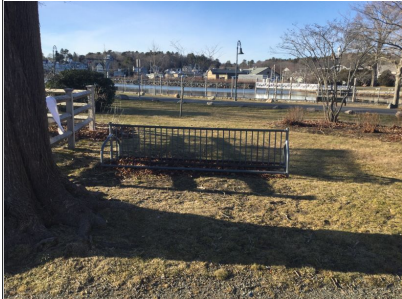
Not connected to an accessible route	-	Ensure bike rack is connected to an accessible route.  (Cost based on a 12'x48" stone dust path to bike rack.)	1	384	\$384

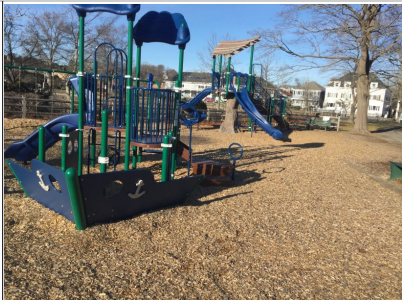
<b>Play and Sport Areas</b>												
<b>Play Areas</b>												
8	Playground	Ext.		Play Areas	N/A

Accessible route not provided at play components Surface not stable, firm, and slip-resistant	- -	Provide a compliant impact-attenuating surface under and around the play components and a stable, firm and slip resistant route around the playground.  (Cost estimate for 150 sq. ft. of poured in place rubber surface and 180' x 48" min. of stone dust completing a path around the playground.)	1	7860	\$7860

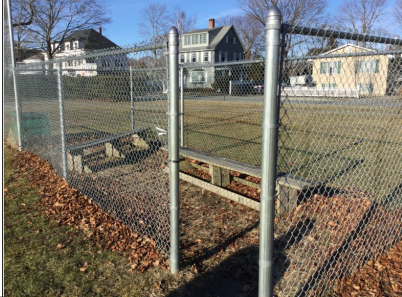
Not connected to an accessible-route	-	Ensure player seating is connected to an accessible route.  (Cost based on a 48" wide min. x 60' stone dust path to team seating on third base side of baseball field.)	1	1920	\$1920
<b>Best Practice</b>												
<b>Bench</b>												
11	Near Entry	Ext.		Bench	N/A

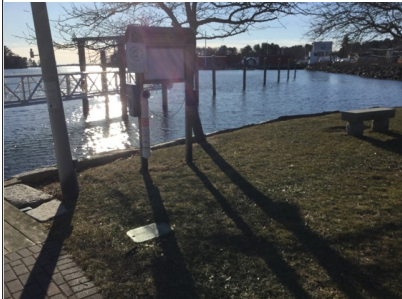
Not connected to an accessible route		Locate information on an accessible route.	1	Labor	\$0
<b>Benches</b>												
3	Beach Street - East Side	Ext.		Benches	N/A

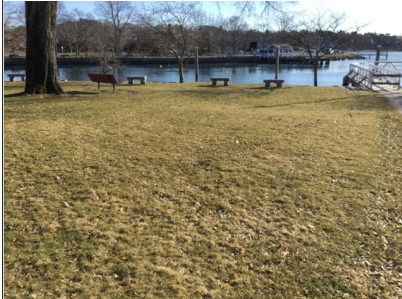
No accessible route to one bench in this area	-	Provide an accessible route to at least one bench in this area.  (Cost based on 60 ft. long by 48 inches wide stone path.)	1	1920	\$1920
<b>Bike Racks</b>												
4	Beach Street - West Side	Ext.		Bike Racks	N/A

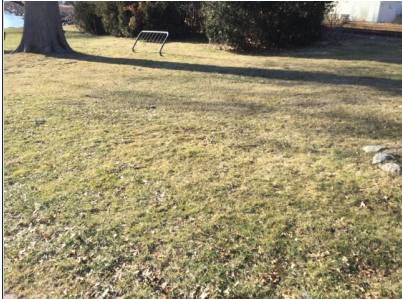
Not connected to an accessible route		Ensure bike racks are connected to an accessible route.  (Cost based on 30 ft. long by 48 inches wide stone path.)	1	960	\$960

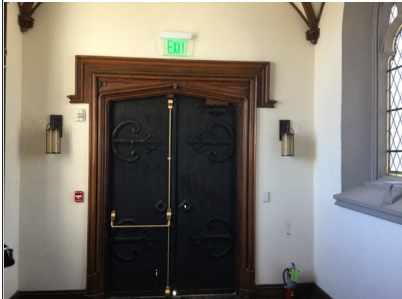
Illuminated ISA symbol not provided (MAAB)	-	Provide an illuminated sign with the International Symbol of Accessibility (ISA).	1	200	\$200
<b>Assembly Area</b>												
3	Chapel	1		Assembly Area	N/A

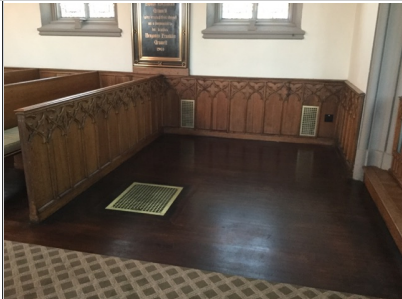
Minimum # wheelchair spaces not provided	-	Provide comparable accessible seating as needed.	1	Labor	\$0
4	Alter	1		Assembly Area	N/A

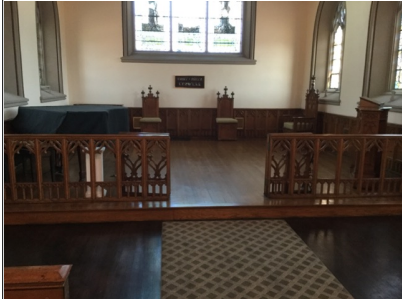
Accessible route to stage not provided	-	Provide a portable ramp as needed to ensure an accessible route to the stage.	1	500	\$500

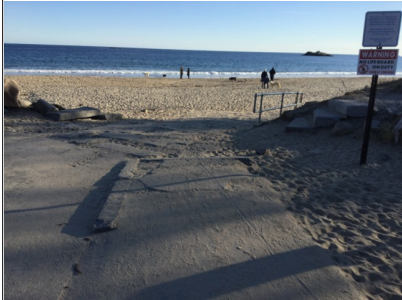
Beach route not provided	-	Provide an accessible route that is firm and stable. Ensure the accessible route extends to the high tide level.  (Cost based on 78" wide 100' and 33' beach mats combined to reach high tide level.)	1	6484	\$6484
3	Walkway From Parking to Beach	Ext.		Beach Access Routes	Removable

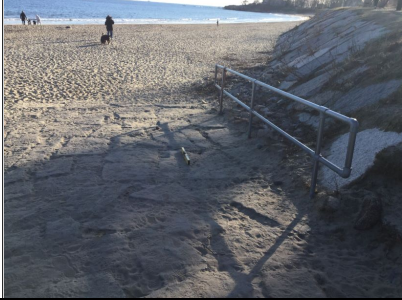
Beach route not provided Surface is not firm and stable	- -	Ensure surface at the accessible route is firm and stable. (Remove uneven stones, provide beach mat joining beach mat to high tide level.)  (Cost for 78" wide 6.5' long beach mat. Cost to remove stones not provided.)	1	980	\$980

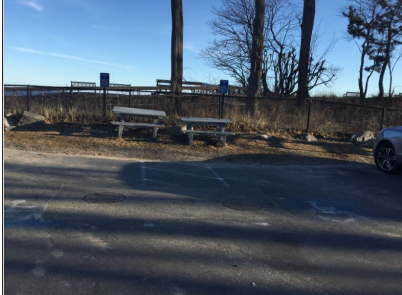
<b>Off-Street Parking Lot or Garage</b>												
4	Accessible Parking Spaces Near Viewing Platform	Ext.		Off-Street Parking Lot or Garage	Visitor

Access aisle not compliant	-	Restripe both car accessible parking spaces.	2	300	\$600

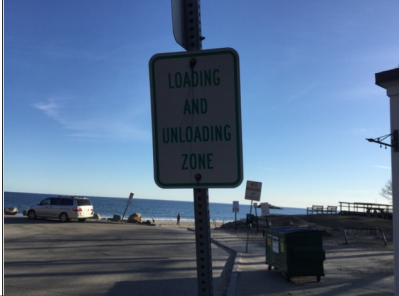
ISA not provided	-	Add the International Symbol of Accessibility (ISA) to the sign.	1	500	\$500
<b>Entrance</b>												
7	Toilet Rooms	Ext.		Entrance	Secondary Entrance

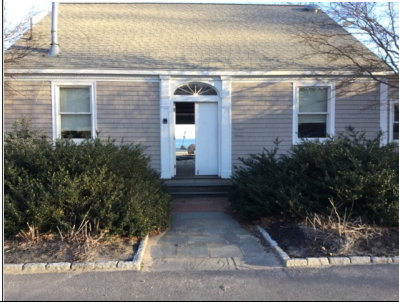
Entrance not on an accessible route Directional sign to accessible entrance not provided	- -	Provide a directional sign indicating the location of the nearest accessible entrance.	1	346	\$346

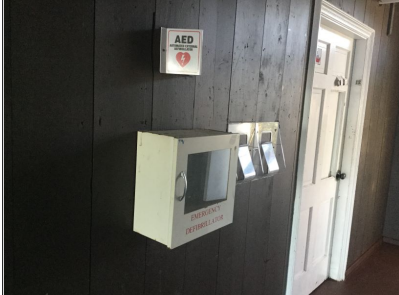
<b>Access to Goods and Services</b>												
<b>Interior Access Route</b>												
8	Toilet and Bathing Room Area	1		Interior Access Route	Interior

Obstructed by protruding objects	-	Relocate object./Provide a cane-detectable barrier.	1	306	\$306

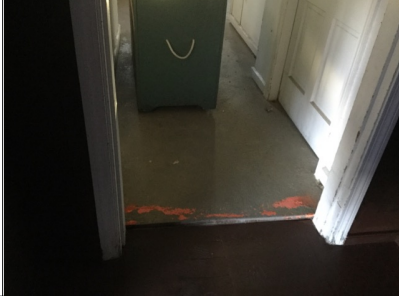
Threshold not beveled	-	Bevel threshold.	1	150	\$150
<b>Signage</b>												
11	Women's Changing Area	1		Signage	Egress

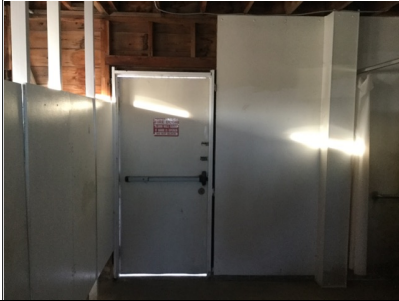
Not provided Directional sign to accessible emergency exit not provided Raised characters not provided	- -	Provide a directional sign indicating the location of the nearest accessible emergency exit. Provide text with raised characters duplicated in braille located on the latch side of the door.	1	232	\$232
12	Men's Toilet Room	1		Signage	Egress

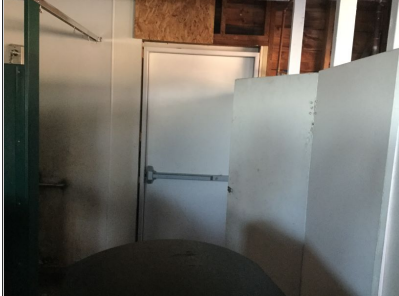
Not provided Raised characters not provided	- -	Provide a directional sign indicating the location of the nearest accessible emergency exit. Provide text with raised characters duplicated in braille located on the latch side of the door.	1	232	\$232

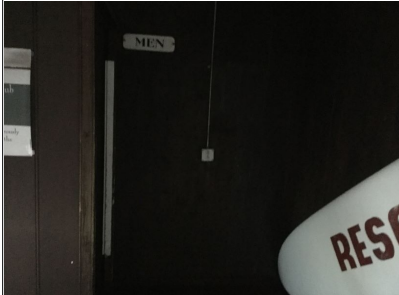
13	Men's Toilet Room	1		Signage	Designation

Raised characters not provided	-	Provide text with raised characters duplicated in braille.	1	232	\$232

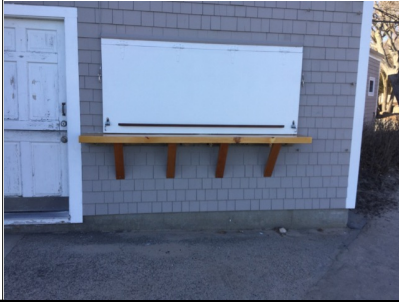
Counter > 36" high	40.5"	Provide a counter that is 36" max. above the ground.	1	880	\$880
<b>Operable Parts</b>												
16	Near Beach	Ext.		Operable Parts	N/A

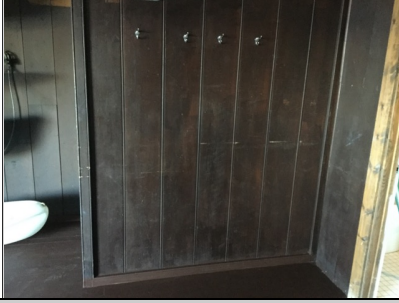
Reach < 15" or > 48"(forward/side approach)	68"	Mount at least one coat hook 48" above the finished floor.	1	256	\$256

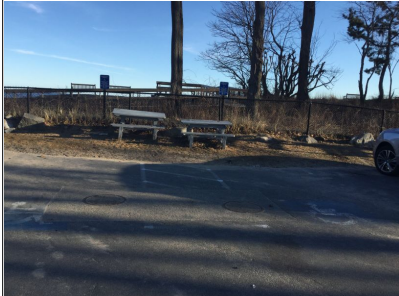
<b>Picnic Tables</b>												
18	Accessible Parking Spaces Near Viewing Platform	Ext.		Picnic Tables	N/A

Toe or knee clearance at table not provided Picnic table not on an accessible route	- -	Provide at least one picnic table with toe and knee clearance. Locate picnic table on an accessible route.	1	1400	\$1400

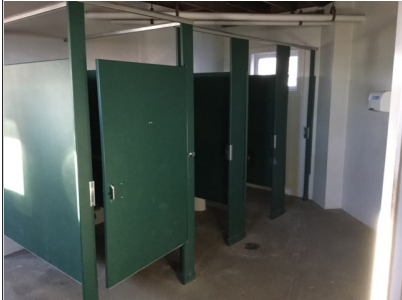
Turning space not provided Accessible plumbing fixtures or stalls not provided	- -	Provide one accessible wheelchair compartment in both the women's and men's toilet room.	2	6182	\$12364
<b>Lavatory</b>												
21	Single-User Toilet Room	1		Lavatory	N/A

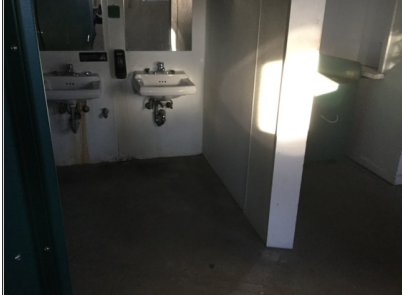
Exposed plumbing underneath Mirror above lavatory w/reflective surface > 40"	- 41"	Insulate or otherwise configure pipes to prevent contact, for at least one lavatory. Lower mirror so that the bottom surface is at 40" max. above finished floor.	1	348	\$348

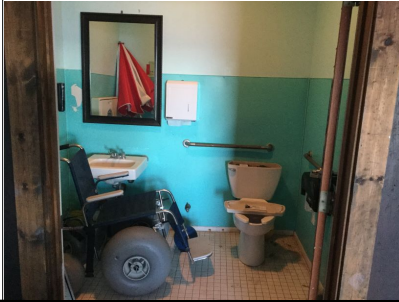
Rear grab bar < 42" long (MAAB)	36"	Provide a rear wall grab bar that is 42" long min. and extends from the toilet 12" min. on one side and 24" min. on the other side (open side).	1	898	\$898
<b>Changing Area</b>												
25	Men's Changing Area	1		Changing Area	N/A

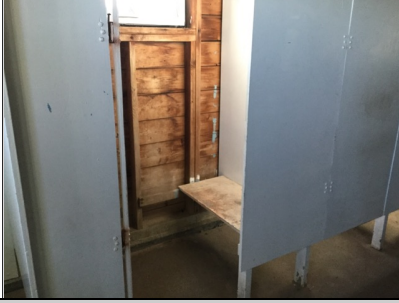
26	Women's Changing Area	1		Changing Area	N/A

5% Accessible not provided		Provide at least one accessible changing area with a turning space. Provide a bench that is between 17" - 19" above the finished floor, 48" long and between 20" - 24" wide. Ensure a 30" by 48" is provided adjacent to the bench. Ensure the bench has back support or is affixed to a wall.	1	5866	\$5866
<b>Shower Compartment</b>												
27	Men's Shower	1		Shower Compartment	Transfer Type

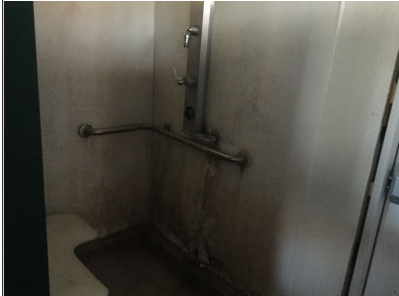
Size of shower compartment non compliant	43"x43"	Provide a transfer shower that is 36" by 36"	1	9832	\$9832

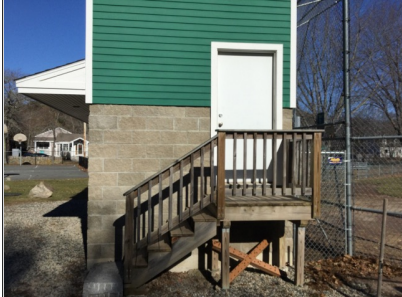
Hardware not operable with a closed fist	-	Provide hardware that can be operable with one hand and not require tight grasping, pinching, or twisting of the wrist.	1	484	\$484
3	Bill Burgess Canteen	Ext.		Doors, Doorways, & Gates	N/A

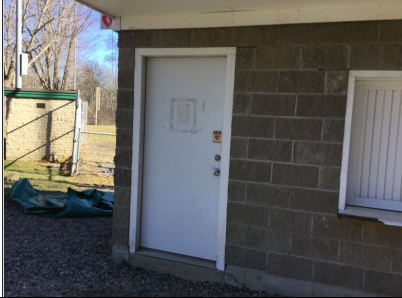
Hardware not operable with a closed fist	-	Provide hardware that can be operable with one hand and not require tight grasping, pinching, or twisting of the wrist.	1	484	\$484

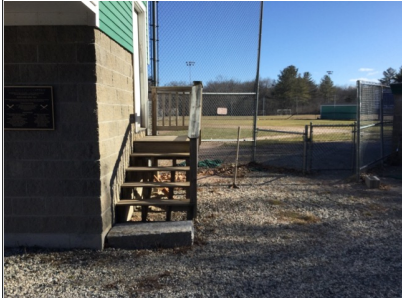
<b>Stairways</b>												
4	Press Box	Ext.		Stairways	Exterior

Stair has open risers	-	Ensure stairs have closed risers.  (Cost based on closing four (4) wood risers.)	1	64	\$64

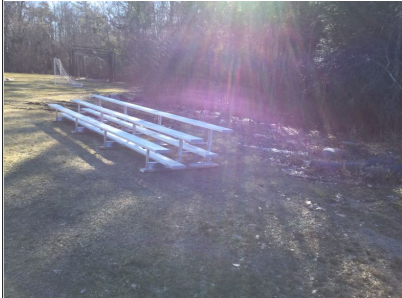
8	Fan Seating Softball	Ext.		Field	Softball

Accessible spaces are not provided at team seating Not connected to an accessible-route	- -	Provide a 36" x 48" clear floor space at bleacher seating. Ensure bleacher is connected to an accessible route.  (Cost based on a 60'x48" min. stone dust path to bleachers and a 36'x48' asphalt patch at bleachers.)	1	2160	\$2160

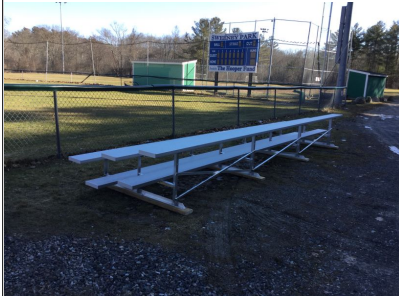
Accessible spaces not provided at sidelines seating	-	Provide a 36" x 48" clear floor space at sidelines seating.  (Cost based on a 36'x48' asphalt patch.)	1	240	\$240
11	Team Seating Softball	Ext.		Field	Softball

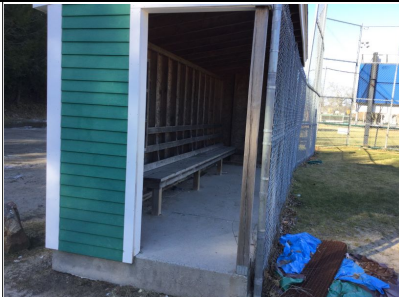
Not connected to an accessible-route	-	Ensure softball team seating is connected to an accessible route. (Provide a concrete walkway 48" wide min. with a running slope of 1:20 (5.00%) max. and a cross slope of 1:50 (2.00%) max.  (Cost based on two (2) 6'x4' of concrete walkways, one at each softball field dugout.)	2	384	\$768

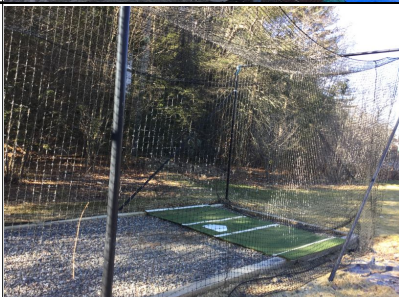
12	Softball Bullpen	Ext.		Field	Softball

Practice areas are not on an accessible route	-	Provide an accessible route to practice areas (softball bullpen).  (Cost based on a 180'x48" min. stone dust path to edge of bullpen.)	1	5760	\$5760
13	Soccer Field	Ext.		Field	Soccer

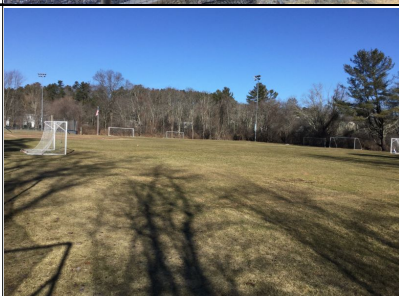
No accessible route to all areas of sports activity	-	Provide an accessible route to the soccer field. (Cost based on a 60'x48" min. stone dust path to the edge of sport activity at the soccer field.)	1	1920	\$1920

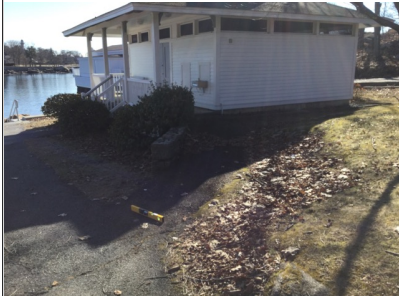
Cross slope > 1:50 (2.00%) (MAAB) Running slope > 1:20 (5.00%)	4.6% 5.5%	Reduce cross slope to be no steeper than 1:50 (2.00%). Reduce the running slope to be no steeper than 1:20 (5.00%).  (Cost to reduce excessive running slope not provided.)	1	-	\$0
3	Gazebo Towards Toilets	Ext.		Exterior Access Route	Exterior

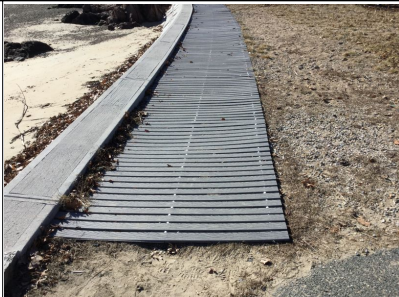
Level changes > 1/4"	2"	Alter change in level to be 1/4" high max.  (Cost based on 4'x3' of asphalt to reduce change in level and provide a stable, firm and slip resistant surface between asphalt and mat walkway.)	1	120	\$120

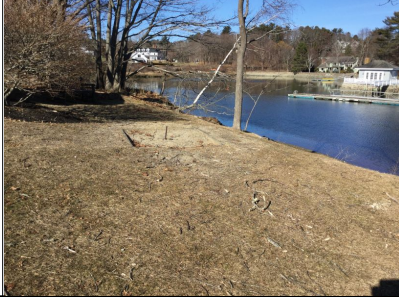
Accessible route not provided	-	Ensure an accessible route is provided to at least one of the horseshoe pits.  (Cost based on a 30'x48" wide min. 30' asphalt path to at least one of the horseshoe pits in this area. Ensure walkway has a running slope of 1:20 (5.00%) max. and a cross slope of 1:50 (2.00%) max.)	1	1200	\$1200

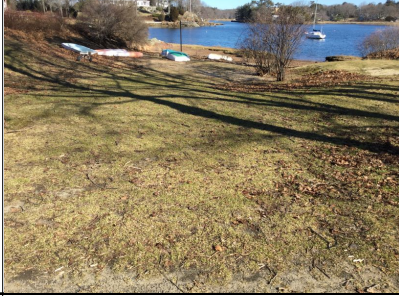
9	Path to Boats	Ext.		Exterior Access Route	Exterior

Accessible route not provided	-	Ensure an accessible route is provided to the area where the boats are stored.  (Cost based on a 36'x48" wide min. 60' asphalt path to the accessible picnic table in this area. Ensure walkway has a running slope of 1:20 (5.00%) max. and a cross slope of 1:50 (2.00%) max.)	1	2400	\$2400
10	Life Vest Loaner Station	Ext.		Exterior Access Route	Exterior

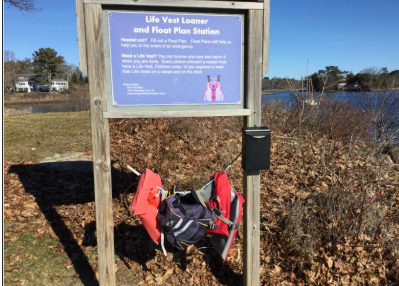
Accessible route not provided	-	Ensure an accessible route is provided to the life vest loaner station.  (Cost based on a 30'x48" wide min. 30' asphalt path to at least one of the horseshoe pits in this area. Ensure walkway has a running slope of 1:20 (5.00%) max. and a cross slope of 1:50 (2.00%) max.)	1	1200	\$1200

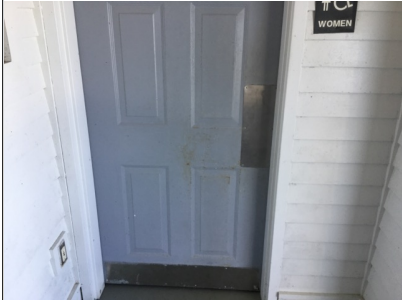
Door requires > 5 lbs of force to open	14 lbs	Adjust closers so doors do not require more than 5 pounds of force to open.	1	Labor	\$0

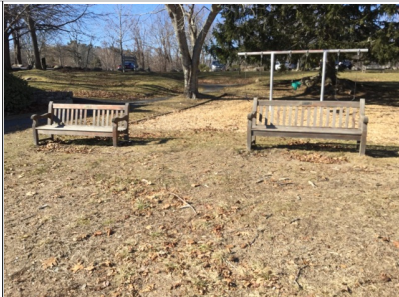
<b>Benches</b>												
18	Near Playground	Ext.		Benches	N/A

No accessible route to one bench in this area	-	Provide an accessible route to at least one bench in this area.  Cost based on an 10 ft. long by 4 ft. wide asphalt route.	1	400	\$400
19	Chowder House Exterior by Ocean	Ext.		Benches	N/A	 	No accessible route to one bench in this area		Provide an accessible route to at least one bench in this area.  (Cost based on a 30'x48" wide min. 30' asphalt path to at least one of the benches in this area. Ensure walkway has a running slope of 1:20 (5.00%) max. and a cross slope of 1:50 (2.00%) max.)	1	1200	\$1200

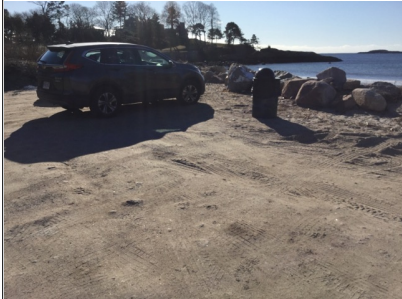
Total # of designated van accessible spaces	-	Provide a van accessible space that is at least 96" wide with a marked access aisle that is at least 96" wide. Provide a sign with the bottom of the sign 60" min. above the ground and the top 96" max. above the ground. Add the designation "Van Accessible" to the sign.	1	800	\$800
