## Manchester-by-the-Sea, Massachusetts

January 2021

## Municipal Buildings

## Town of Manchester-by-the-Sea ADA Transition Plan

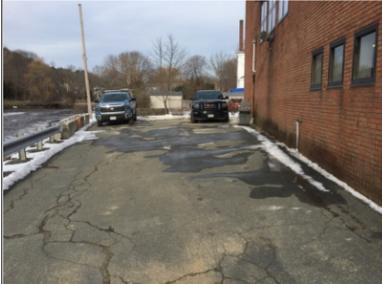
Total # of designated van accessible spaces Vehicle space < 132" wide at van space Access aisle < 60" wide at car/van space Sign not provided Sign does not have the designation "Van Accessible"	-	Provide a van accessible space that is at least 132" wide with an access aisle that is at least 60" wide. Provide a sign with the bottom of the sign 60" min. above the ground and the top 96" max. above the ground. Add the designation "Van Accessible" to the sign.	1	1850	\$1850

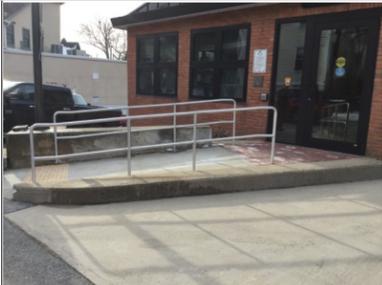
<b>Exterior Ramp</b>												
3	Main Entrance	Ext.		Exterior Ramp	N/A

Handrails do not extend 12" past top & bottom	-	Alter handrails to extend horizontally above the landing for 12" min. beyond the top and bottom of ramp runs.	2	800	\$1600
<b>Entrance</b>												
4	Employee Entrance	Ext.		Entrance	Secondary Entrance

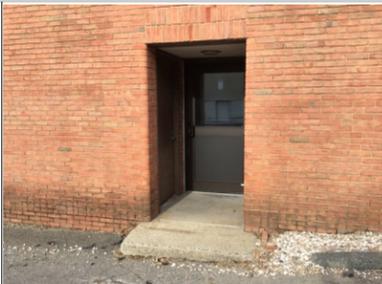
Entrance not on an accessible route Directional sign to accessible entrance not provided	- -	Provide a directional sign indicating the location of the nearest accessible entrance.	1	346	\$346
<b>Access to Goods and Services</b>

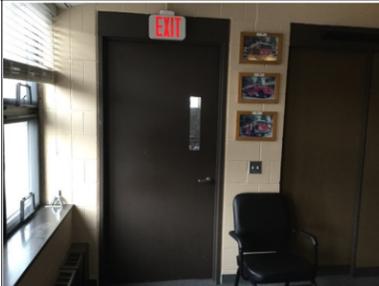
Tactile exit sign not provided Directional sign to accessible emergency exit not provided	-	Ensure a tactile exit sign with raised characters and braille is provided at exit door. Mount sign between 48"- 60" above finished floor located on the latch side of the door. Provide a directional sign indicating the location of the nearest emergency exit.	1	232	\$232
7	Exit to Parking	B		Means of Egress	N/A

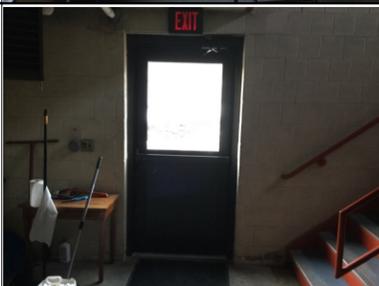
Tactile exit sign not provided Directional sign to accessible emergency exit not provided	- -	Ensure a tactile exit sign with raised characters and braille is provided at exit door. Mount sign between 48"- 60" above finished floor located on the latch side of the door. Provide a directional sign indicating the location of the nearest emergency exit.	1	232	\$232

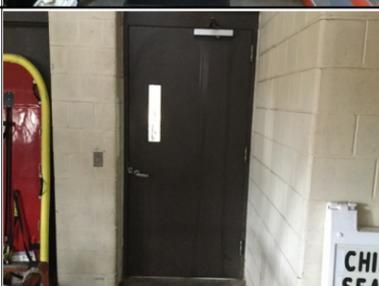
8	Exit to Apparatus	B		Means of Egress	N/A

Tactile exit sign not provided Illuminated ISA symbol not provided (MAAB)	- -	Ensure tactile exit signs with raised characters and braille are provided at exit doors. Mount signs between 48"- 60" above finished floor located on the latch side of the door. Provide an illuminated International Symbol of Accessibility.	1	432	\$432
9	Towards Meeting Room	1		Means of Egress	N/A

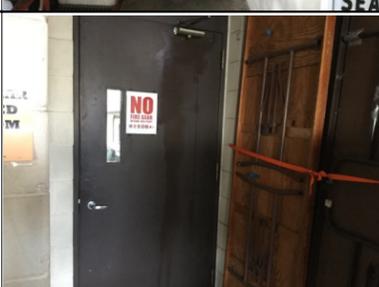
Floor level designation not provided	-	Provide a sign on the interior of the stairway enclosure indicating the floor level.	1	232	\$232

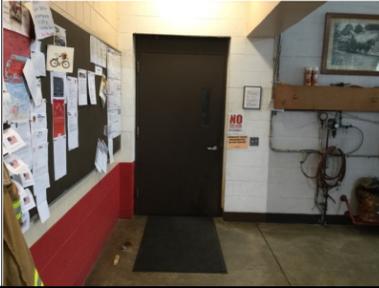
Mat not securely attached Door requires > 5 lbs. of force to open	- 10 lbs	Secure the mat. Adjust closers so doors do not require more than 5 pounds of force to open.	2	Labor	\$0
12	Men's Toilet Room			Doors, Doorways, & Gates	Toilet Room

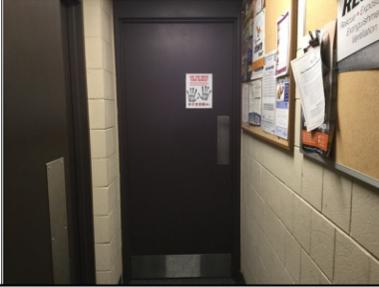
Door requires > 5 lbs. of force to open	-	Adjust closers so doors do not require more than 5 pounds of force to open.	1	Labor	\$0
<b>Signage</b>												
13	Men's Toilet Room	1		Signage	Designation

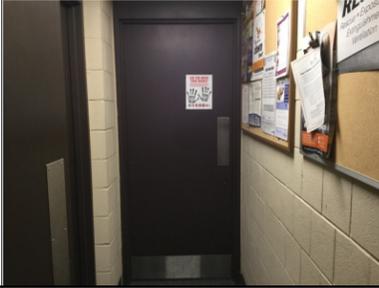
Signage is not provided	- -	Locate compliant signage alongside the door on the latch side.	1	232	\$232

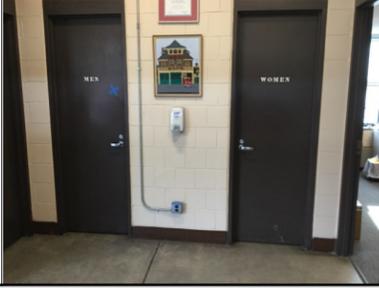
14	Men's and Women's Toilet Room	1		Signage	Designation

Raised characters not provided on sign Raised characters < 48" or > 60" above ground Sign not located on the latch side of the door Directional sign to access toilet not provided	- - - -	Provide text with raised characters duplicated in braille on sign. Mount signs between 48" min. and 60" max. above finished floor. Locate sign alongside the door on the latch side. Install a sign indicating the location of the nearest accessible toilet room.	3	232	\$696
<b>Toilet &amp; Bathing Rooms</b>

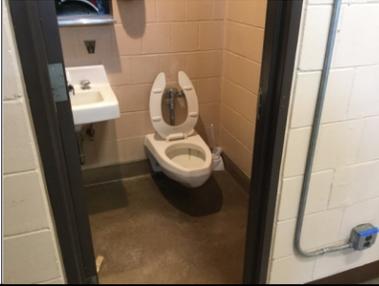
Turning space not provided Accessible plumbing fixtures or stalls not provided	- -	Provide one accessible single-user toilet room.  See ID #15.	1	-	\$0
17	Men's Toilet Room	1		Overall Access	Toilet Room

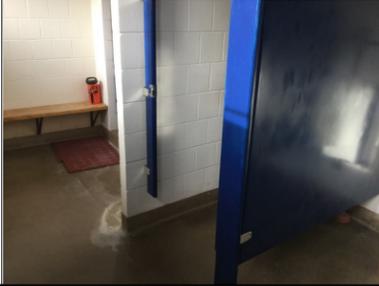
Accessible plumbing fixtures or stalls not provided	-	Provide one accessible wheelchair compartment.	1	6182	\$6182
<b>Lavatory</b>												
18	Men's Toilet Room	1		Lavatory	N/A

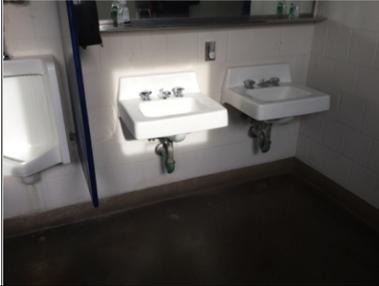
Faucet is not operable with a closed fist Plumbing underneath is exposed Mirror above lavatory w/reflective surface > 40"	- - 48"	Provide a faucet that can be operable with one hand and not require tight grasping, pinching, or twisting of the wrist for at least one lavatory. Insulate or otherwise configure pipes to prevent contact, for at least one lavatory. Lower mirror so that the bottom surface is at 40" max. above finished floor.	1	1334	\$1334

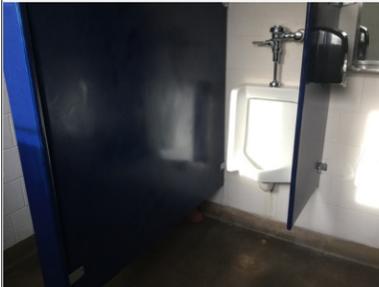
<b>Urinal</b>												
19	Men's Toilet Room	1		Urinal	N/A

Rim > 17" high	-	Provide an urinal with the rim no higher than 17" above the finished floor.	1	3248	\$3248

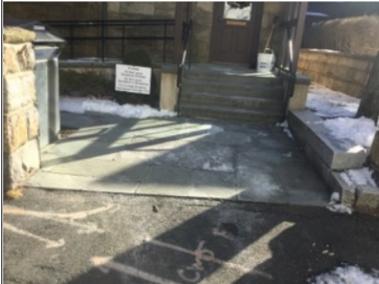
Level changes > 1/4"	1"	Alter change in level to be 1/4" high max.  (Cost for a 3'x3' concrete patch.)	1	144	\$144
3	By Ramp	Ext.		Exterior Access Route	Exterior

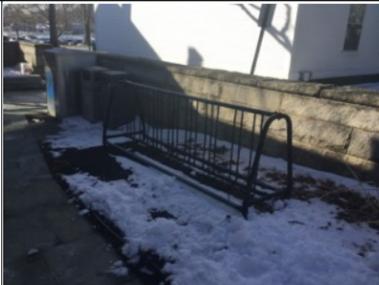
Accessible route not provided	-	Ensure an accessible route is provided to the bike rack.  (Cost for a 3'x3' concrete patch.)	1	144	\$144
4	Front of Library Near Union Street	Ext.		Exterior Access Route	Walkway

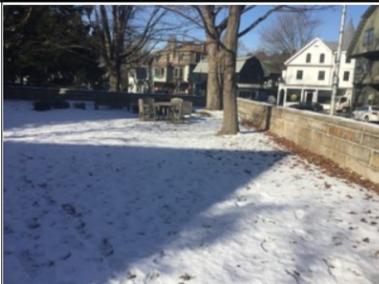
Accessible route not provided	-	Ensure an accessible route is provided to the table and chairs in front of library along Union Street.  (Cost based on a 48" wide 30' long stone dust walkway to table area.)	1	960	\$960

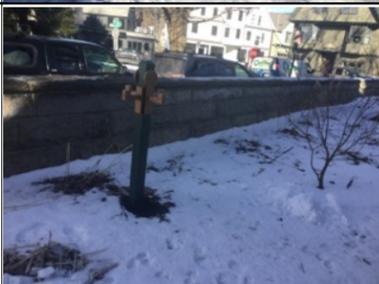
5	Near Church Street Ramp	Ext.		Exterior Access Route	Walkway

Accessible route not provided	-	Ensure an accessible route is provided to the pet tie-up area.  (Cost based on a 48" wide x 6' long stone dust path.)	1	192	\$192
<b>Access to Goods and Services</b>

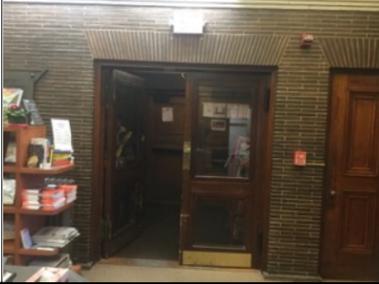
Tactile exit sign not provided Illuminated Int. Symbol of Acc. not provided	-	Ensure tactile exit signs with raised characters and braille are provided at exit doors. Mount signs between 48"- 60" above finished floor located on the latch side of the door. Provide a sign with an illuminated International Symbol of Accessibility (ISA).	1	432	\$432

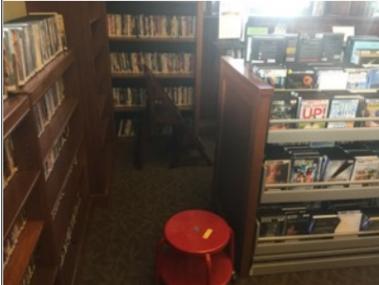
<b>Interior Access Route</b>												
8	Main Room	1		Interior Access Route	N/A

Route < 36" wide	30"	Ensure that a clear width of 36" min. is maintained at the accessible route (shift location of large stand).	1	Labor	\$0
9	Path to Stairs to Mezzanine	1		Interior Access Route	N/A

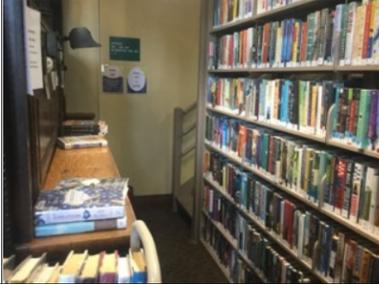
Route < 36" wide	33"	Ensure that a clear width of 36" min. is maintained at the accessible route (relocate items to create a 36" min. wide path to stairs).	1	Labor	\$0
10	Friends of Library Volunteer Area	1		Interior Access Route	N/A

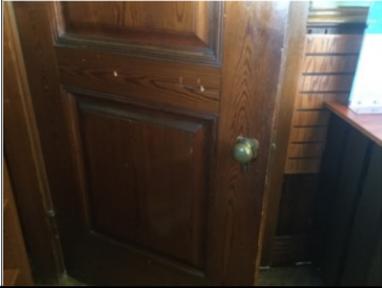
Hardware not operable with a closed fist	-	Provide hardware that can be operable with one hand and not require tight grasping, pinching, or twisting of the wrist.	1	484	\$484
13	Single-User Toilet Room	1		Doors, Doorways, & Gates	Toilet Room

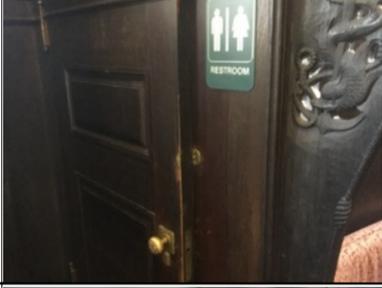
Hardware not operable with a closed fist	-	Provide hardware that can be operable with one hand and not require tight grasping, pinching, or twisting of the wrist.	1	484	\$484
14	Friends of Library Volunteer Area	b		Doors, Doorways, & Gates	Other

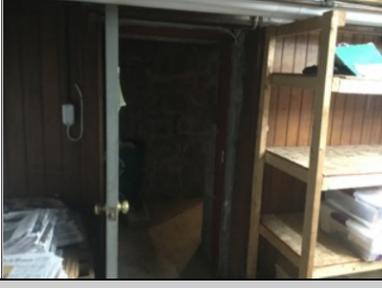
Hardware not operable with a closed fist	-	Provide hardware that can be operable with one hand and not require tight grasping, pinching, or twisting of the wrist.	1	484	\$484

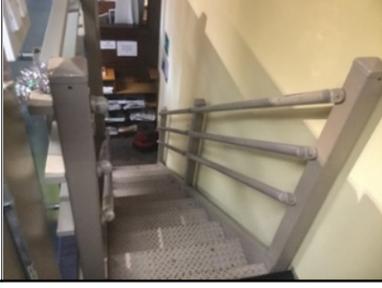
<b>Stairways</b>												
15	Mezzanine	M		Stairways	Interior

Handrails do not extend 12" from stairs	-	Top: Ensure handrails extend horizontally above the landing for 12" min. beginning above the first riser nosing. Bottom: Ensure handrails extend to one tread depth beyond the last riser.  (Cost based on welding extensions on existing railing at top and bottom of stairs.)	4	142	\$568

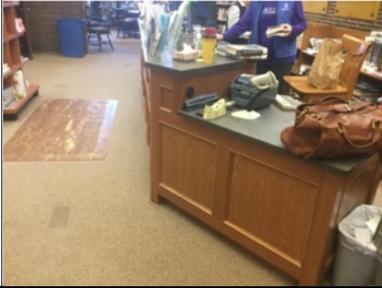
Keep accessible service counter clear of stored and displayed items.	1	Labor	\$0
<b>Benches</b>												
18	Front of Library Near Union Street	Ext.		Benches	N/A

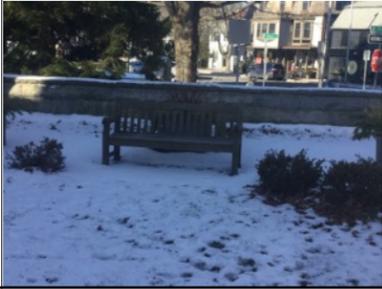
No accessible route to 20% of benches 20% of benches have clear space < 36" x 48"	- -	Provide an accessible route to bench in this area. Ensure bench has a stable, firm and slip resistant clear floor space of 36" wide min. by 48" deep min. adjacent to the bench at one end. (Cost based on a 48" wide 15' long stone dust walkway to table area.)	1	480	\$480
<b>Toilet &amp; Bathing Rooms</b>

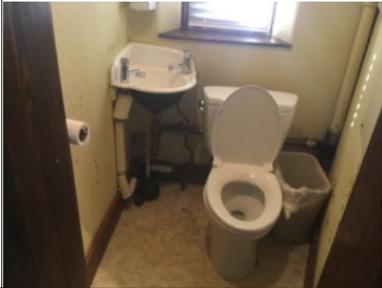
<b>Overall Access</b>												
19	Single-User Toilet Room	1		Overall Access	Toilet Room

Turning space not provided	-	Add an accessible single-user toilet room.	1	24604	\$24604
<b>Best Practice</b>

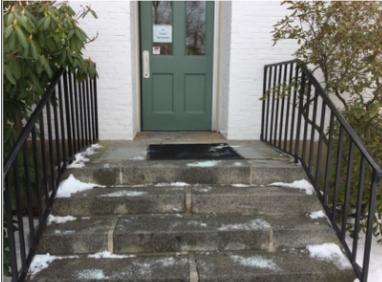
Entrance not on an accessible route Directional sign to accessible entrance not provided Mat not securely attached	- - -	Provide a directional sign indicating the location of the nearest accessible entrance. Secure the mat.	1	346	\$346
<b>Access to Goods and Services</b>

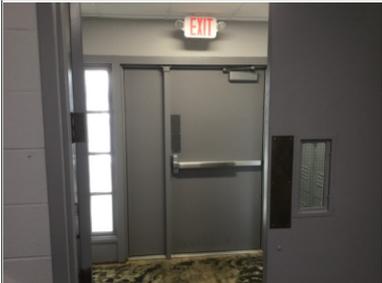
<b>Means of Egress</b>												
4	Emergency Exit	G		Means of Egress	N/A

Tactile exit sign not provided Emergency exit not on an accessible route Directional sign to accessible emergency exit not provided	- - -	Ensure a tactile exit sign with raised characters and braille is provided at exit door. Mount signs between 48"- 60" above finished floor located on the latch side of the door. Provide a directional sign indicating the location of the nearest emergency exit.	1	232	\$232

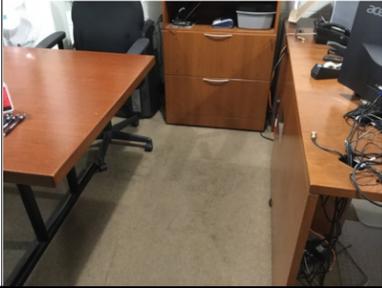
Route < 36" wide	-	Rearrange furniture to ensure that a clear width of 36" min. is maintained at the accessible route.	1	Labor	\$0
7	Police Station - Meeting Room	1		Interior Access Route	N/A

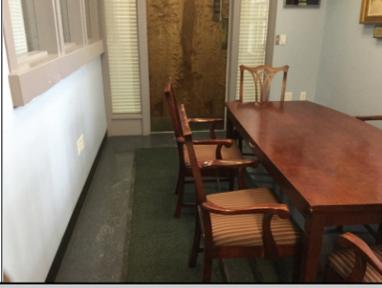
Route < 36" wide	29.5"	Rearrange furniture to ensure that a clear width of 36" min. is maintained at the accessible route.	1	Labor	\$0

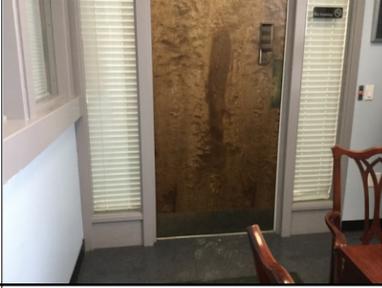
<b>Doors, Doorways, &amp; Gates</b>												
8	Police Station - Meeting Room	1		Doors, Doorways, & Gates	Meeting Room

Maneuvering clearance(s) not provided	-	Rearrange furniture to ensure that the maneuvering clearance is maintained at the door.	1	Labor	\$0
9	Police Station - Meeting Room	1		Doors, Doorways, & Gates	Office

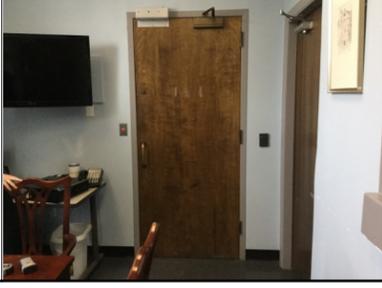
Maneuvering clearance(s) not provided Door requires > 5 lbs. of force to open	- 7 lbs	Rearrange furniture to maintain the maneuvering clearance at the door. Adjust closers so doors do not require more than 5 pounds of force to open.	1	Labor	\$0

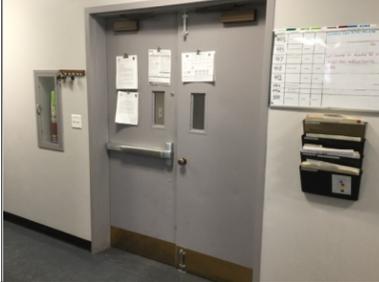
Signage is not provided	-	Locate signage alongside the door on the latch side.	1	232	\$232
12	Female /Juvenile Holding Cell	G		Signage	Designation

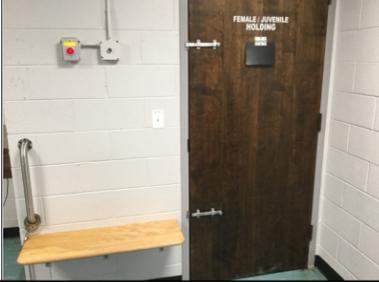
Raised characters not provided on sign Braille not provided on sign Sign not located on the latch side of the door	- - -	Provide text with raised characters duplicated in braille on sign. Provide braille on sign. Locate sign alongside the door on the latch side.	1	232	\$232

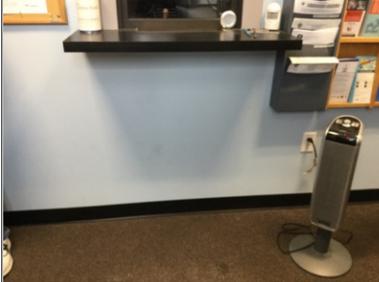
<b>Service Counter</b>												
13	Lobby	1		Service Counter	234

Counter > 36" high	41.5"	Provide a counter that is 36" max. above the finished floor.	1	880	\$880
<b>Detention Facilities</b>												
14	Male Holding Cells	G		Detention Facilities	Men's

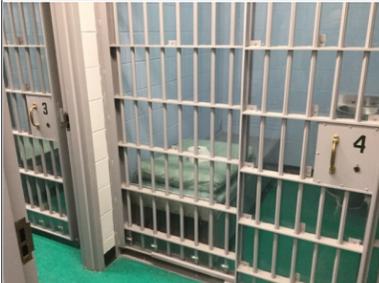
< 3% of holding cells have mobility features	-	Ensure that at least one holding cell has mobility features.	1	-	\$0

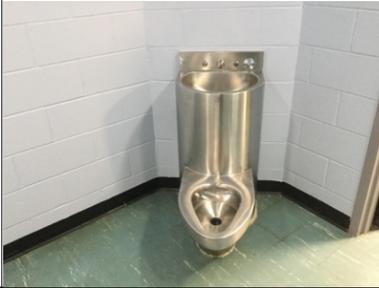
Mobility cell lacks access to accessible toilet/lavatory	-	Ensure an accessible toilet room is provided.	1	10010	\$10010
<b>Toilet &amp; Bathing Rooms</b>												
<b>Overall Access</b>												
17	Bathing Room	G		Overall Access	Bathing Room

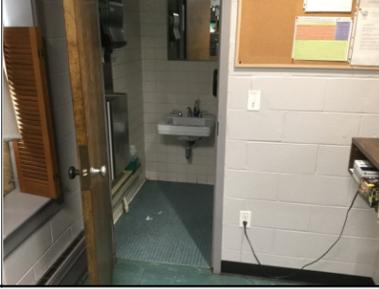
Turning space not provided Accessible plumbing fixtures or stalls not provided	- -	Provide an accessible bathing room.	1	24604	\$24604

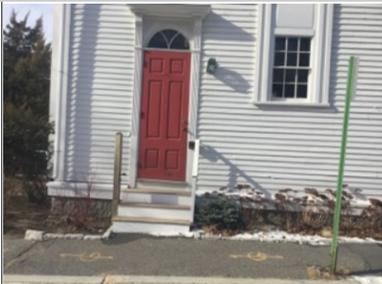
<b>Entrance</b>												
4	Entrance to Museum and Meeting Room	Ext		Entrance	Main Entrance

Entrance not on an accessible route Directional sign to accessible entrance not provided Hardware not operable with a closed fist	- -	Provide a directional sign indicating the location of the nearest accessible entrance. Provide hardware that can be operable with one hand and not require tight grasping, pinching, or twisting of the wrist.	1	830	\$830
<b>Access to Goods and Services</b>

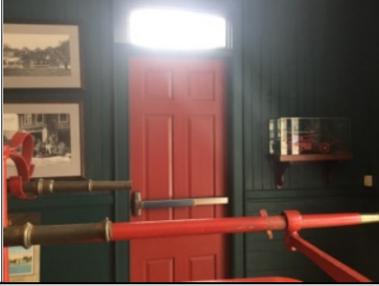
Illuminated exit sign not provided Tactile exit sign not provided Illuminated Int. Symbol of Acc. not provided (MAAB)	- -	Ensure illuminated exit signs are provided at exits and exit doors. Ensure tactile exit signs with raised characters and braille are provided at exit doors. Mount signs between 48"- 60" above finished floor located on the latch side of the door. Provide an illuminated International Symbol of Accessibility (ISA).	1	964	\$964

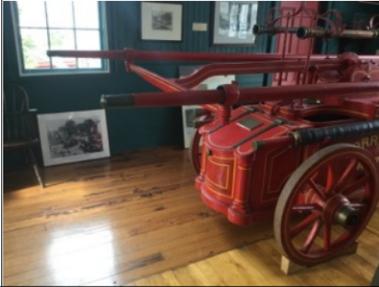
<b>Interior Access Route</b>												
7	Museum	1		Interior Access Route	N/A

Obstructed by protruding objects	19"	Provide a cane-detectable barrier.	1	306	\$306
<b>Doors, Doorways, &amp; Gates</b>												
8	Accessible/ Rear Museum Entrance	Ext		Doors, Doorways, & Gates	Other

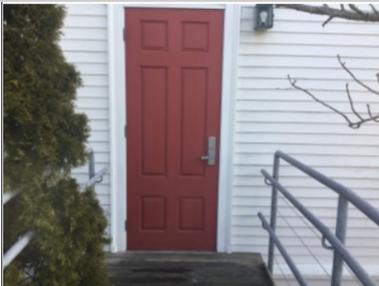
Maneuvering clearance(s) not provided	14"	Provide an automatic door opener.	1	3060	\$3060
9	Single-User Toilet Room in Museum and Meeting Space	1		Doors, Doorways, & Gates	Toilet Room

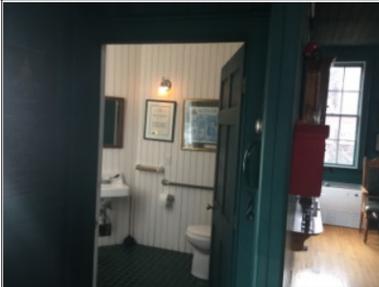
Hardware not operable with a closed fist	-	Provide hardware that can be operable with one hand and not require tight grasping, pinching, or twisting of the wrist.	1	484	\$484

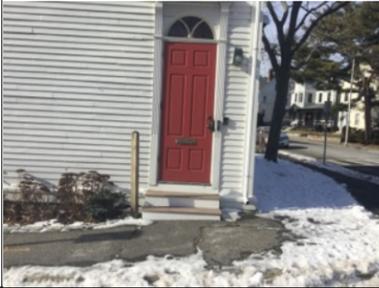
Hardware not operable with a closed fist	-	Provide hardware that can be operable with one hand and not require tight grasping, pinching, or twisting of the wrist.	1	484	\$484
<b>Operable Parts</b>												
12	By Ground Floor Exit from Conservation and Planning Offices	1		Operable Parts	Clothes Rod/Hooks

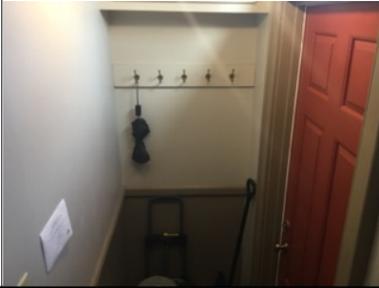
Side reach > 54"	72"	Relocate coat hooks so that they are between 15" - 48" above finished floor.	1	256	\$256
13	Single-User Toilet Room	1		Operable Parts	Clothes Rod/Hooks

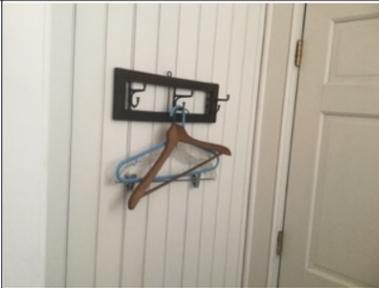
Side reach > 54"	62"	Relocate coat hooks so that they are between 15" - 48" above finished floor.	1	256	\$256

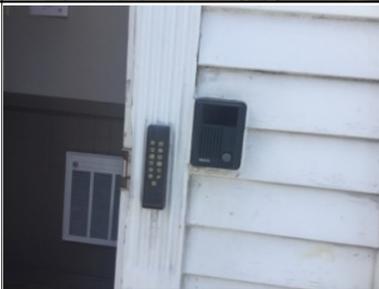
14	Entrance to Conservation and Planning Offices	Ext		Operable Parts	Equipment

Side reach > 54"	61"	Relocate intercom and doorbell so that controls are between 15" - 48" above finished floor.	1	884	\$884

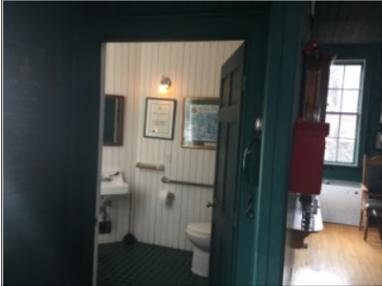
International Symbol of Acc. not provided Hardware not operable with a closed fist	-	Provide hardware that can be operable with one hand and not require tight grasping, pinching, or twisting of the wrist. Provide a sign with the International Symbol of Accessibility.	1	716	\$716
<b>Lavatory</b>												
17	Single-User Toilet Room	1		Lavatory	N/A

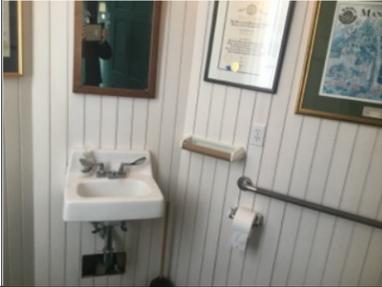
Plumbing underneath is exposed Mirror above lavatory w/reflective surface > 40"	- 48"	Insulate or otherwise configure pipes to prevent contact, for at least one lavatory. Lower mirror so that the bottom surface is at 40" max. above finished floor.	1	352	\$348

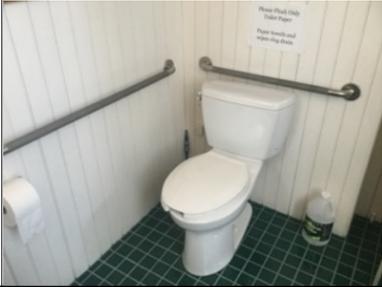
Flush control not on open side Toilet paper dispenser is not compliant	- 16"	Relocate the flush control to the open side. Relocate toilet paper so that it is 15" min. high, located under the grab bar, and between 7" and 9" from the front of the toilet.	1	1080	\$1080
<b>Additional Access</b>

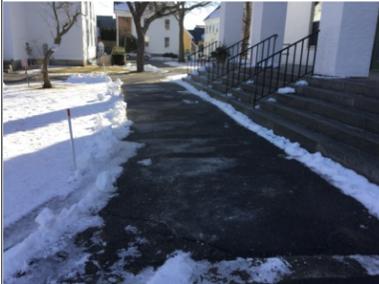
Cross slope > 1:50 (2.00%)	4.2%	Reduce cross slope to be no steeper than 1:50 (2.00%).  Note: This area is going to be redesigned.	1	-	\$0
3	Towards the Police Station	Ext.		Exterior Access Route	Walkway

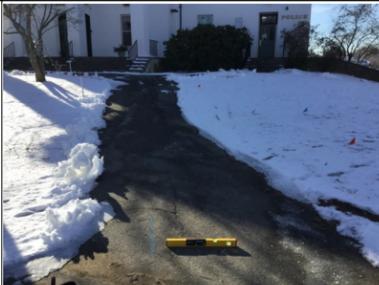
Running slope > 1:20 (5%)	13.3%	Reduce running slope to be no steeper than 1:20 (5%).  Note: This area is going to be redesigned.	1	-	\$0
4	Towards Accessible Entrance - East Side	Ext.		Exterior Access Route	Walkway

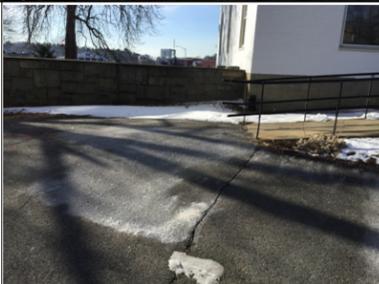
Running slope > 1:20 (5%)	9.5%	Reduce running slope to be no steeper than 1:20 (5%).  Note: This area is going to be redesigned.	1	-	\$0

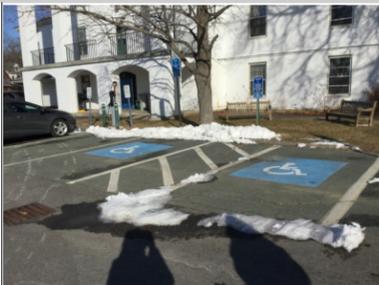
<b>Off-Street Parking Lot or Garage</b>												
5	Parking Lot	Ext		Off-Street Parking Lot or Garage	Visitor

Access aisle < 96" wide at van space	69"	Provide a marked access aisle that is at least 96" wide.	1	300	\$300

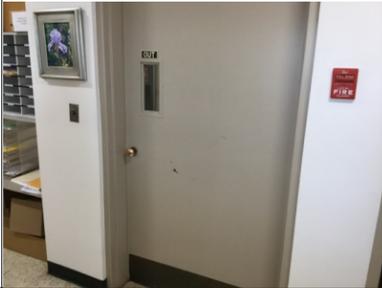
<b>Means of Egress</b>												
9	Exit - Near Selectmen Town Admin.	1		Means of Egress	N/A

Tactile exit sign not provided	-	Ensure a tactile exit sign with raised characters and braille is provided at exit door. Mount sign between 48"- 60" above finished floor located on the latch side of the door.	1	232	\$232

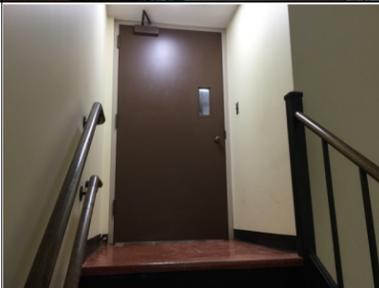
Floor level designation not provided	-	Provide a sign on the interior of the stairway enclosure indicating the floor level.	1	232	\$232

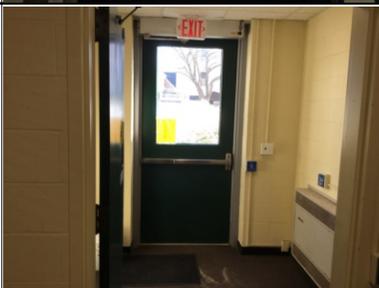
14	Towards Parking Lot	B		Means of Egress	N/A

Illuminated ISA symbol not provided (MAAB)	-	Provide an illuminated International Symbol of Accessibility.	1	200	\$200

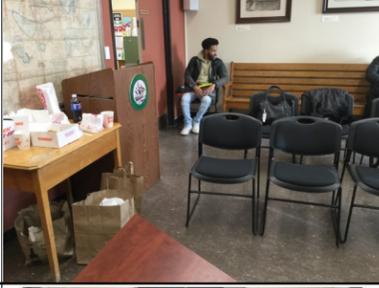
Route < 36" wide	-	Relocate chairs to ensure that a clear width of 36" min. is maintained at the accessible route.	1	Labor	\$0
18	Exit Near the Council on Aging	B		Interior Access Route	N/A

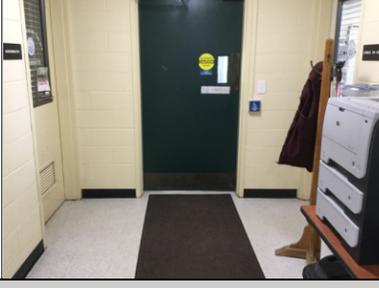
Mat not securely attached	-	Secure the mat.	1	Labor	\$0

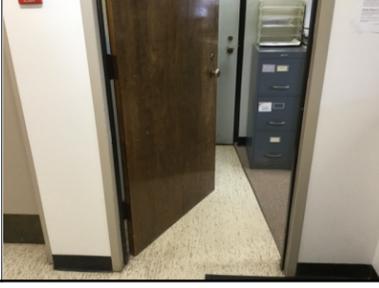
<b>Doors, Doorways, &amp; Gates</b>												
19	Selectmen Town Admin.	1	3	Doors, Doorways, & Gates	Office

Hardware not operable with a closed fist	-	Provide hardware that can be operable with one hand and not require tight grasping, pinching, or twisting of the wrist.	1	484	\$484

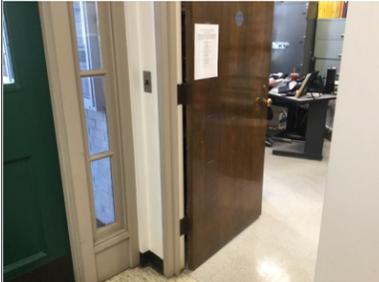
Hardware not operable with a closed fist	-	Provide hardware that can be operable with one hand and not require tight grasping, pinching, or twisting of the wrist.	1	484	\$484
22	Public Works Water & Sewer	2	6	Doors, Doorways, & Gates	Office

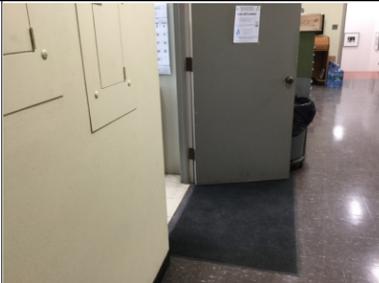
Mat not securely attached Hardware not operable with a closed fist	- -	Install an ADA-compliant walk-off mat. Provide hardware that can be operable with one hand and not require tight grasping, pinching, or twisting of the wrist.	1	484	\$484
23	Meeting Room	2	7	Doors, Doorways, & Gates	Meeting Room

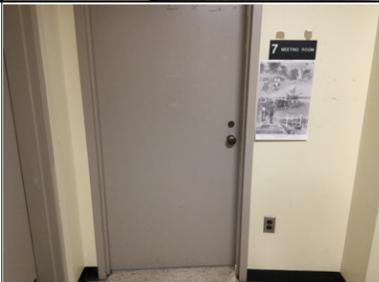
Hardware not operable with a closed fist	-	Provide hardware that can be operable with one hand and not require tight grasping, pinching, or twisting of the wrist.	1	484	\$484

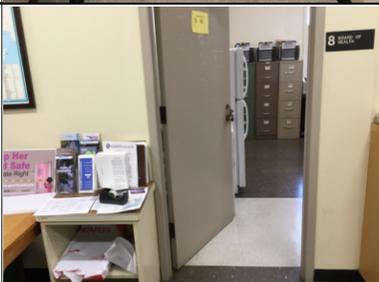
24	Board of Health	2	8	Doors, Doorways, & Gates	Office

Hardware not operable with a closed fist	-	Provide hardware that can be operable with one hand and not require tight grasping, pinching, or twisting of the wrist.	1	484	\$484

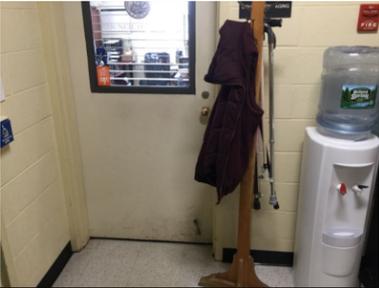
Maneuvering clearance(s) not provided Hardware not operable with a closed fist	- -	Remove coat hook to maintain the maneuvering clearance at the door. Provide hardware that can be operable with one hand and not require tight grasping, pinching, or twisting of the wrist.	1	484	\$484
27	Council on Aging	B		Doors, Doorways, & Gates	Office

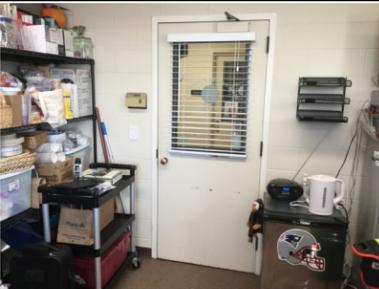
Maneuvering clearance(s) not provided Door requires > 5 lbs. of force to open	- 10 lbs	Relocate table to maintain the maneuvering clearance at the door. Adjust closers so doors do not require more than 5 pounds of force to open.	1	Labor	\$0

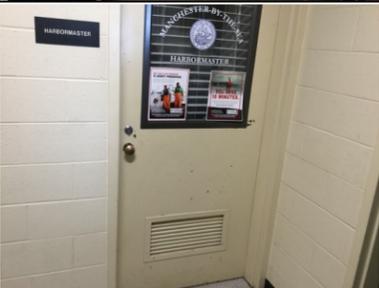
28	Harbormaster	B		Doors, Doorways, & Gates	Office

Hardware not operable with a closed fist	-	Provide hardware that can be operable with one hand and not require tight grasping, pinching, or twisting of the wrist.	1	484	\$484
29	Harbormaster	B		Doors, Doorways, & Gates	Office

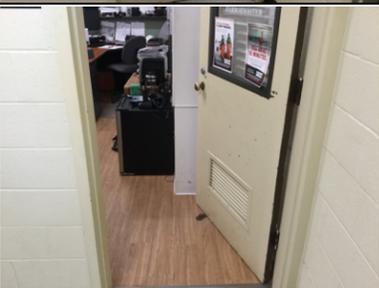
Door requires > 5 lbs. of force to open	10 lbs	Adjust closers so doors do not require more than 5 pounds of force to open.	1	Labor	\$0

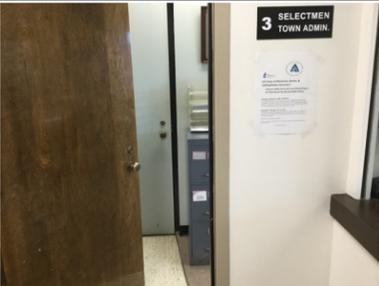
Raised characters not provided on sign Raised characters < 48" or > 60" above ground Braille not provided on sign	- 63.5" -	Provide text with raised characters duplicated in braille on sign. Mount sign so that the baseline of the lowest tactile character is 48" min. above finished floor and the baseline of the highest tactile character is 60" max. above finished floor.	1	232	\$232
32	Assessors	1	2	Signage	Designation

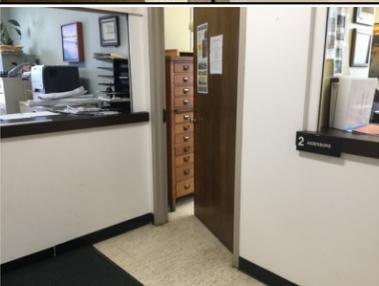
Raised characters < 48" or > 60" above ground Sign not located on the latch side of the door	38.5" -	Mount signs so that the baseline of the lowest tactile character is 48" min. above finished floor and the baseline of the highest tactile character is 60" max. above finished floor. Locate sign at permanent rooms alongside the door on the latch side.	1	Labor	\$0

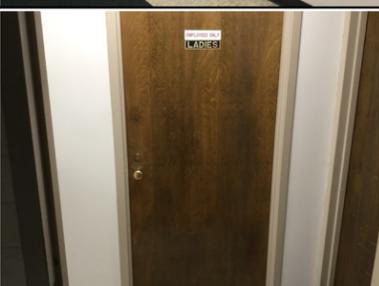
33	Employee Toilet Room	1		Signage	Designation

Sign not located on the latch side of the door Directional sign to access. toilet not provided	- -	Locate sign alongside the door on the latch side. Install a sign indicating the location of the nearest accessible toilet room.	1	232	\$232
34	Men's Toilet Room	1		Signage	Designation

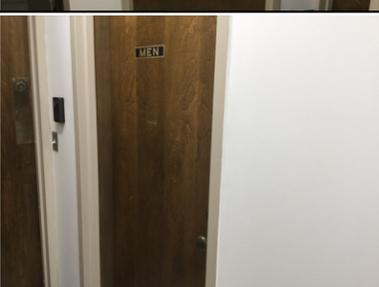
Sign not located on the latch side of the door Directional sign to access. toilet not provided	- -	Locate sign alongside the door on the latch side. Install a sign indicating the location of the nearest accessible toilet room.	1	232	\$232

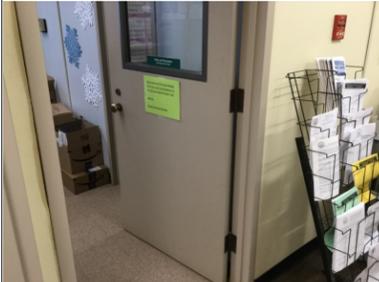
Raised characters not provided on sign Braille not provided on sign Sign not located on the latch side of the door	- - -	Provide text with raised characters duplicated in braille on sign. Locate sign at permanent rooms alongside the door on the latch side.	1	232	\$232
37	Public Works Water & Sewer	2	6	Signage	Designation

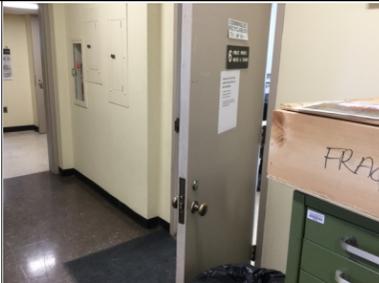
Sign not located on the latch side of the door	-	Locate sign at permanent rooms alongside the door on the latch side.	1	Labor	\$0
38	Selectmen's Meeting Room	2	5	Signage	Designation

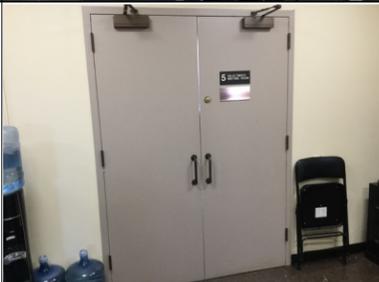
Sign not located on the latch side of the door	-	Locate sign on the inactive door (left hand door).	1	Labor	\$0

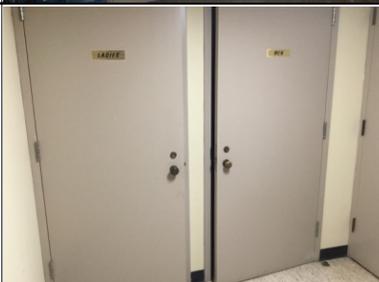
39	Men's and Women's Toilet Rooms	2		Signage	Designation

Sign not located on the latch side of the door Directional sign to access. toilet not provided	- -	Locate signs on the nearest adjacent wall Install a sign indicating the location of the nearest accessible toilet room.	3	232	\$696

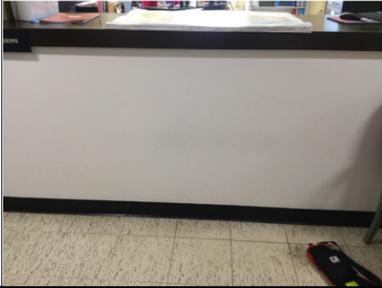
Counter > 36" high	42"	Provide a counter that is 36" max. above the ground or finished floor.	1	880	\$880
42	Collector Treasures	1	1	Service Counter	N/A

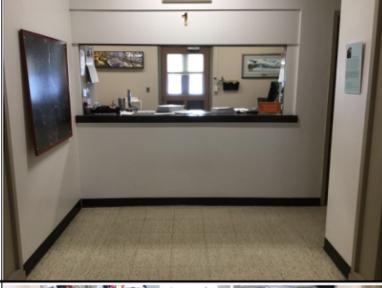
Counter > 36" high	42"	Provide a counter that is 36" max. above the ground or finished floor.	1	880	\$880
43	Selectmen Town Administration	1	3	Service Counter	N/A

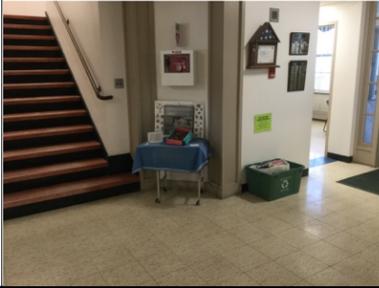
Reach < 15" or > 48"(forward/side approach)	59"	Mount AED cabinet 48" max. above finished floor.	1	256	\$256
47	Hallway	1		Operable Parts	Other

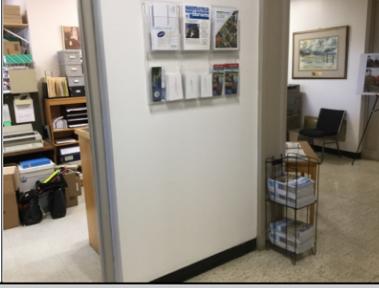
Reach < 15" or > 48"(forward/side approach)	72.5"	Mount flyers rack 48" max. above finished floor.	1	256	\$256
<b>Dining or Work Surfaces</b>												
48	Hallway	B		Dining or Work Surfaces	Work Surface

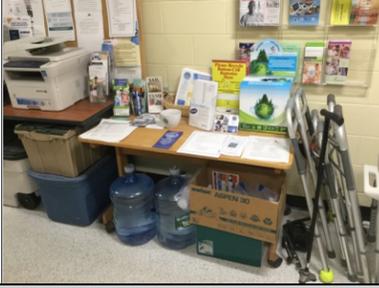
Knee or toe clearance not provided	-	Remove items to maintain knee and toe clearance at the work surface.	1	Labor	\$0
<b>Assembly Area</b>												
49	Meeting Room	2	7	Assembly Area	N/A

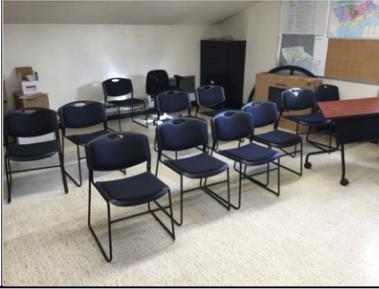
Assistive listening devices not provided	-	If audible communication is integral to the use of the space, provide an assistive listening system.	1	1214	\$1214

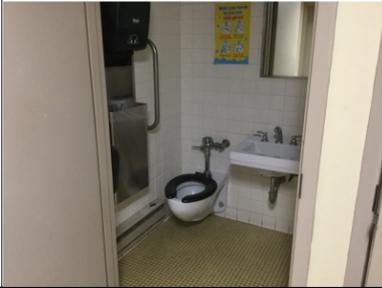
Turning space not provided Accessible plumbing fixtures or stalls not provided	- -	Provide an accessible single-user toilet room.	1	24604	\$24604
<b>Lavatory</b>												
52	Single-User Toilet Room	1		Lavatory	N/A

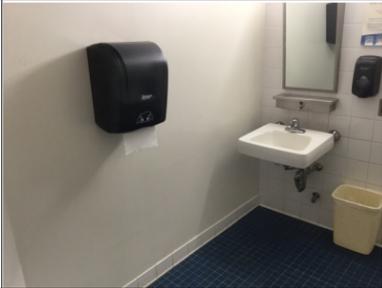
Plumbing underneath is exposed Mirror above lavatory w/reflective surface > 40"	- 42.5"	Insulate or otherwise configure pipes to prevent contact, for at least one lavatory. Lower mirror so that the bottom surface is at 40" max. above finished floor.	1	348	\$348

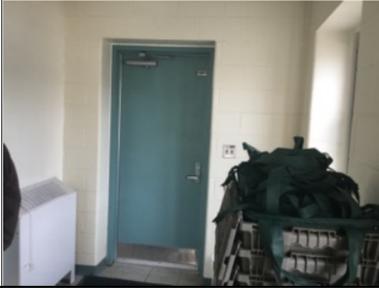
<b>Emergency Exit</b>												
2	Main Entrance Vestibule	1		Emergency Exit	N/A

Tactile exit sign not provided Emergency exit not on an accessible route Directional sign to accessible emergency exit not provided	- -	Ensure tactile exit signs with raised characters and braille are provided at exit doors. Mount signs between 48"- 60" above finished floor located on the latch side of the door. Provide a directional sign indicating the location of the nearest accessible emergency exit.	2	232	\$464
<b>Access to Goods and Services</b>												
<b>Means of Egress</b>												
3	Main Building Path Back Towards Main Entrance and Egress	1		Means of Egress	N/A

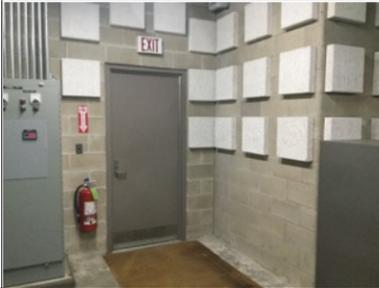
Tactile exit sign not provided	-	Ensure tactile exit signs with raised characters and braille are provided at exit doors. Mount signs between 48"- 60" above finished floor located on the latch side of the door.	1	232	\$232
4	Exit to Vestibule and Ramp			Means of Egress	N/A

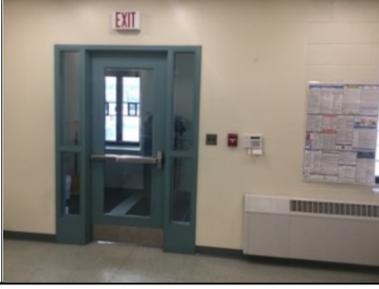
Tactile exit sign not provided	-	Ensure tactile exit signs with raised characters and braille are provided at exit doors. Mount signs between 48"- 60" above finished floor located on the latch side of the door.	1	232	\$232

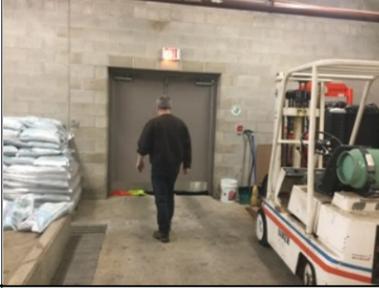
Tactile exit sign not provided Illuminated Int. Symbol of Acc. not provided (MAAB)	-	Ensure tactile exit signs with raised characters and braille are provided at exit doors. Mount signs between 48"- 60" above finished floor located on the latch side of the door. Provide an illuminated International Symbol of Accessibility.	1	432	\$432
6	Exit to Ramp	1	A	Means of Egress	N/A

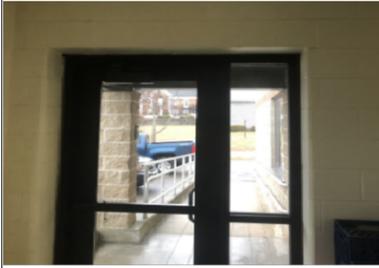
Tactile exit sign not provided Illuminated Int. Symbol of Acc. not provided (MAAB)	-	Ensure tactile exit signs with raised characters and braille are provided at exit doors. Mount signs between 48"- 60" above finished floor located on the latch side of the door. Provide an illuminated exit sign with an illuminated International Symbol of Accessibility.	2	216	\$432

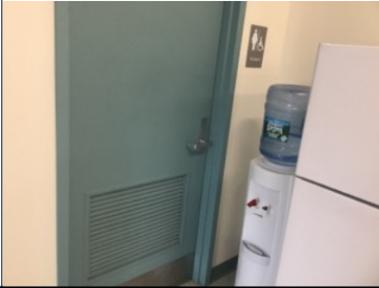
<b>Doors, Doorways, &amp; Gates</b>												
7	Women's Toilet Room			Doors, Doorways, & Gates	Toilet Room

Maneuvering clearance(s) not provided	-	Relocate water cooler and refrigerator so as not to obstruct maneuvering clearance at door.	1	Labor	\$0
8	Men's Toilet Room	1		Doors, Doorways, & Gates	Toilet Room

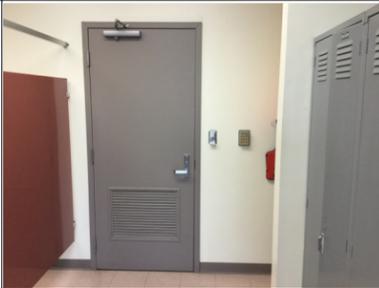
Door requires > 5 lbs. of force to open	10 lbs	Adjust closers so doors do not require more than 5 pounds of force to open.	1	Labor	\$0
<b>Ramps</b>												
9	Main Entrance to Main Building	Ext.		Ramps	Exterior

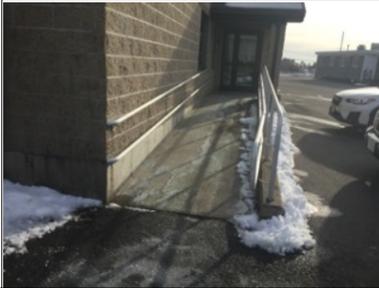
Handrails do not extend 12" past top & bottom Level changes > 1/4"	-	Alter handrails to extend horizontally above the landing for 12" min. beyond the bottom of ramp run on one side. Alter change in level to be 1/4" high max.  (Cost based on welding on one rail extension and a 3'x3' asphalt patch at base of ramp.)	1	178	\$178

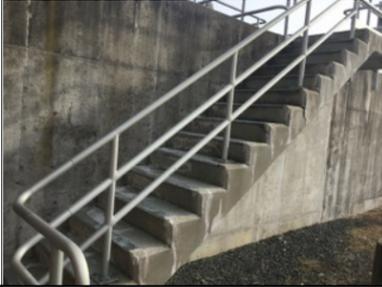
Handrail not provided on both sides Accessible route not provided	-	Provide handrail on one side. During tours, provide information (photos, text) about aeration area at an accessible location.  (Cost based on one 30' wall-mounted metal handrail.)	1	2220	\$2220
11	Clarifier Tanks	Ext.		Stairways	Exterior

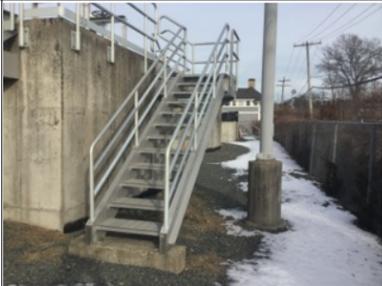
Handrails do not extend 12" from stairs Accessible route not provided	-	Bottom of stairs: Ensure handrails extend to one tread depth beyond the last riser. During tours, provide information (photos, text) about clarifier tanks at an accessible location. (Cost based on welding on rail extensions.)	2	142	\$284
<b>Kitchens and Kitchenettes</b>												
12	Main Building			Kitchens and Kitchenettes	N/A

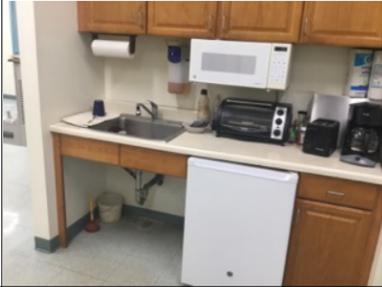
Plumbing underneath is exposed	-	Insulate or otherwise configure pipes to prevent contact.	1	92	\$92

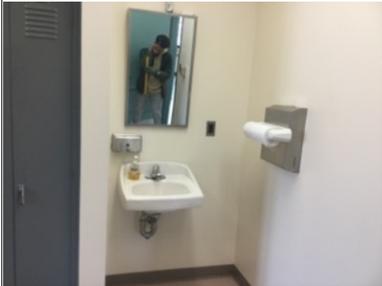
<b>Toilet &amp; Bathing Rooms</b>												
<b>Lavatory</b>												
13	Women's Toilet Room			Lavatory	N/A

Plumbing underneath is exposed Dispenser acts as a protruding object	-	Insulate or otherwise configure pipes to prevent contact, for at least one lavatory. Relocate plastic paper towel dispenser out of the circulation path.	1	798	\$798

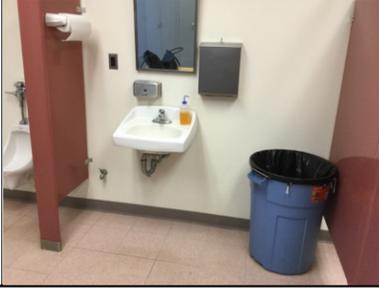
Plumbing underneath is exposed Mirror above lavatory w/reflective surface > 40" Dispensers not within reach range	- 48" 60"	Insulate or otherwise configure pipes to prevent contact, for at least one lavatory. Lower mirror so that the bottom surface is at 40" max. above finished floor. Relocate dispenser to 42" max. above the floor.	1	1058	\$1058
<b>Toilet Compartment</b>												
15	Men's Toilet Room			Toilet Compartment	Accessible Compartment

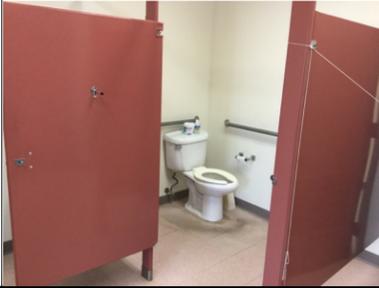
Door has malfunctioning self-closing hinge	-	Repair hinge.	1	Labor	\$0
<b>Best Practice</b>												
<b>Exterior Route to Ramp Landing</b>												
16	Parking Near Exterior Ramp	Ext.		Exterior Route to Ramp Landing	N/A

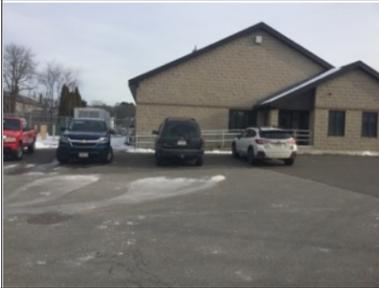
Recommend providing striping by the exterior ramp landing so access to the landing is not obstructed by parked cars.	1	-	\$0
