# **Tucks Point Facility Phase 2: Pier Replacement & Rotunda Preservation**

**Pier Replacement & Rotunda Preservation  
Conceptual Alternatives**

The Town of Manchester-by-the-Sea

June 20, 2023 | Foth

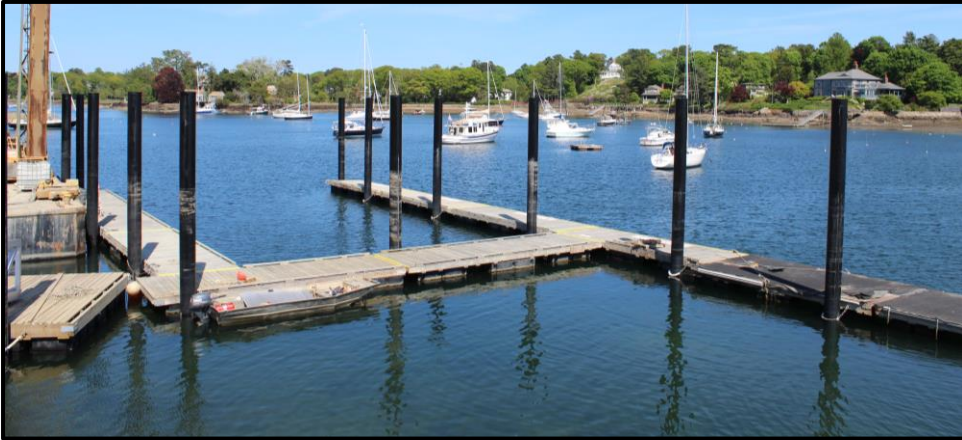
Rock Socketed Piles previously Installed at the Site

- ◆ Steel rock socketed piles are required due to weak overburden soils and poor quality/high bedrock conditions (same as encountered in Phase 1)
- ◆ The slope of the pier must be ADA compliant (5% grade)
- ◆ Pier Deck El. 19' above Mean Low Water (MLW) for long-term resiliency against flooding (BFE 5' above 100-year FEMA) and future sea-level rise (NOAA projections – “Intermediate Scenario”)
- ◆ The pier must tie into Phase 1 gangway landing and existing backland
- ◆ Rotunda and historic aesthetics to be preserved

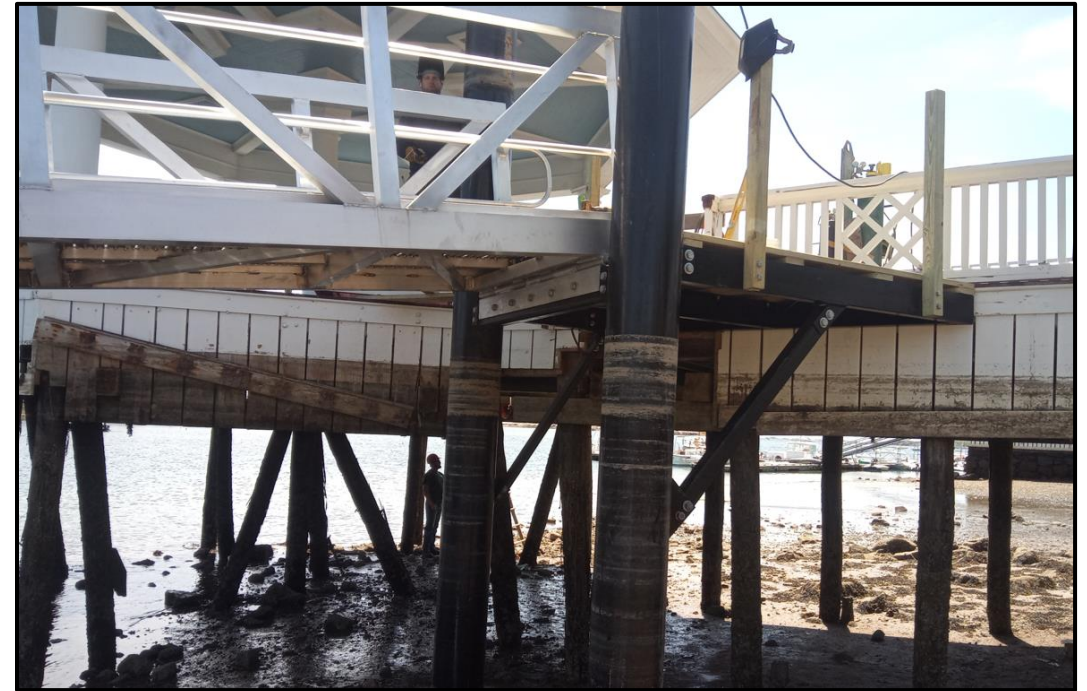
Existing Gangway Connection to be Raised with Pier  
(Timber Façade to be replaced in-kind on new Pier and Rotunda)
